Inspection Report

Dan Moulton
Moultons Chinchilla Ranch
976 14th Avenue S W
Rochester, MN 55902

Customer ID: **2401**
Certificate: **41-B-0239**
Site: 001
DAN MOULTON

Type: ROUTINE INSPECTION
Date: Jun-22-2016

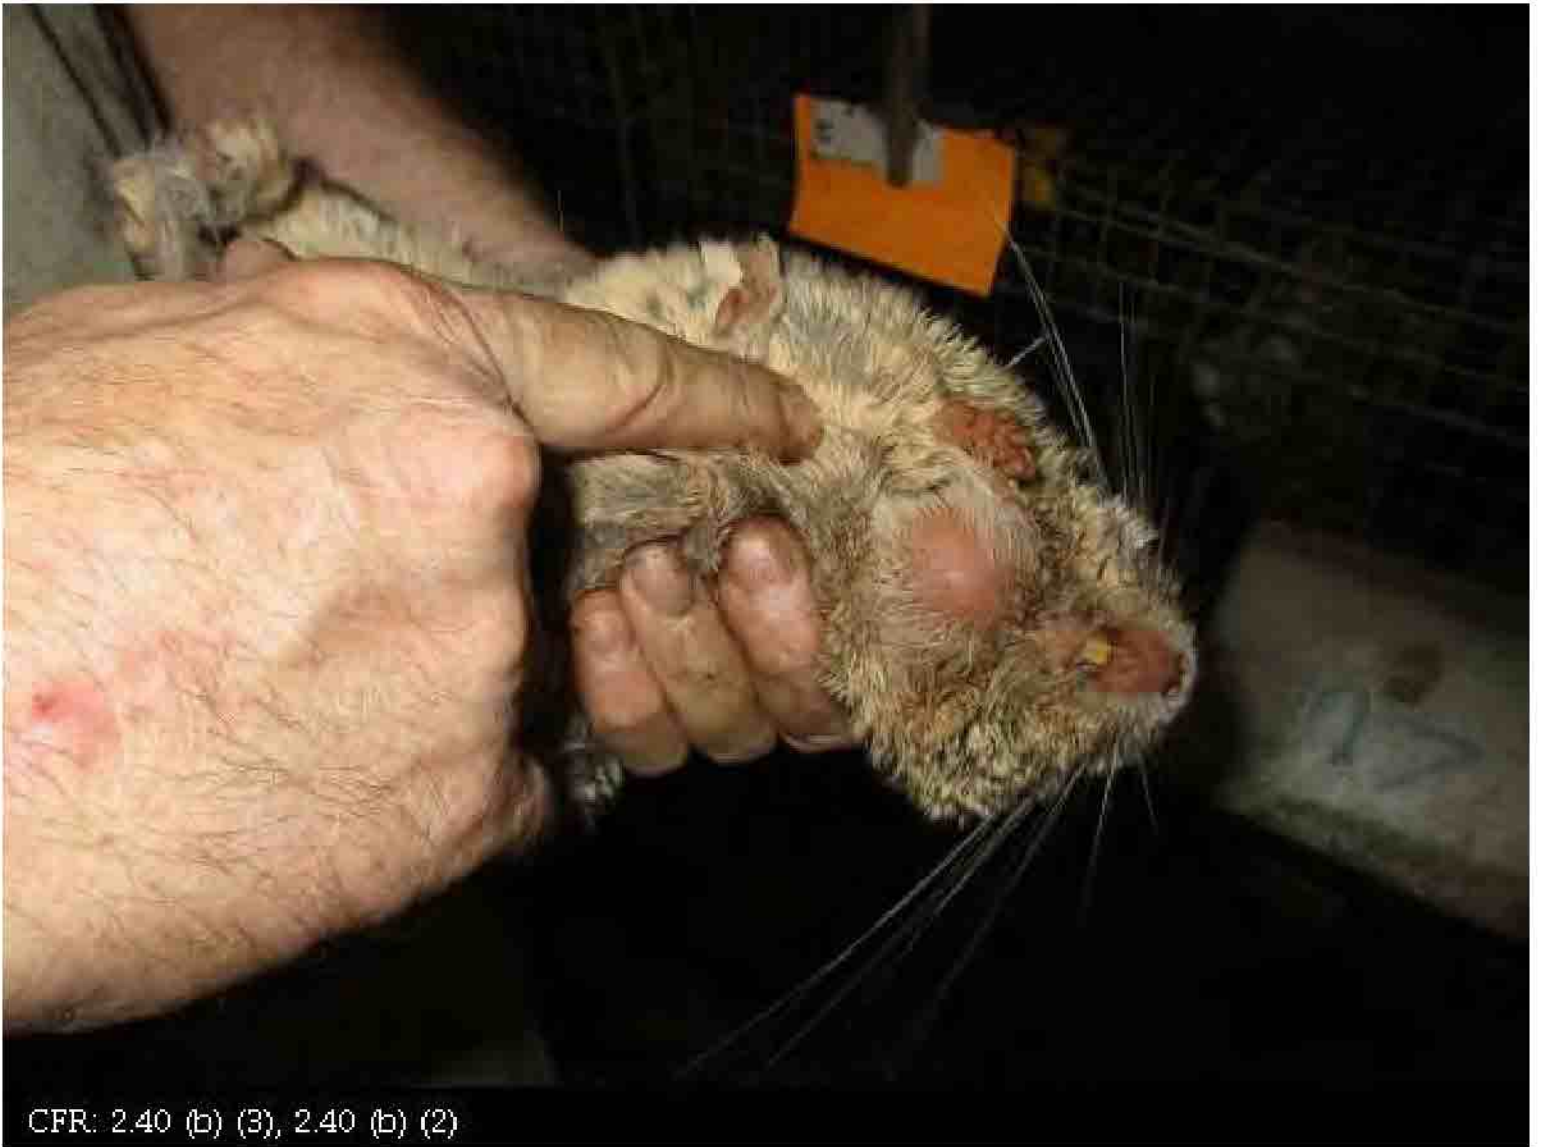
- Female beige with ear tag GROS 352 had a large hairless swelling on the area under its chin.

Photographer:	Kevin Wilken	Legal Name:	41-B-0239
Photo Taken:	Wed, Jun 22, '16	DAN MOULTON	
Inspection:	181161057380243		
Description:	Female beige, eartag GROS 352; hairless swelling under chin.

**Untreated medical problems can cause ongoing pain in affected animals and can be contagious to other animals in the building. The veterinarian must be contacted to properly diagnose and treat each animal's health problem and the facility must follow the recommended treatment. Documentation of the diagnosis and treatment plan for animals must be available for APHIS officials for future inspections.

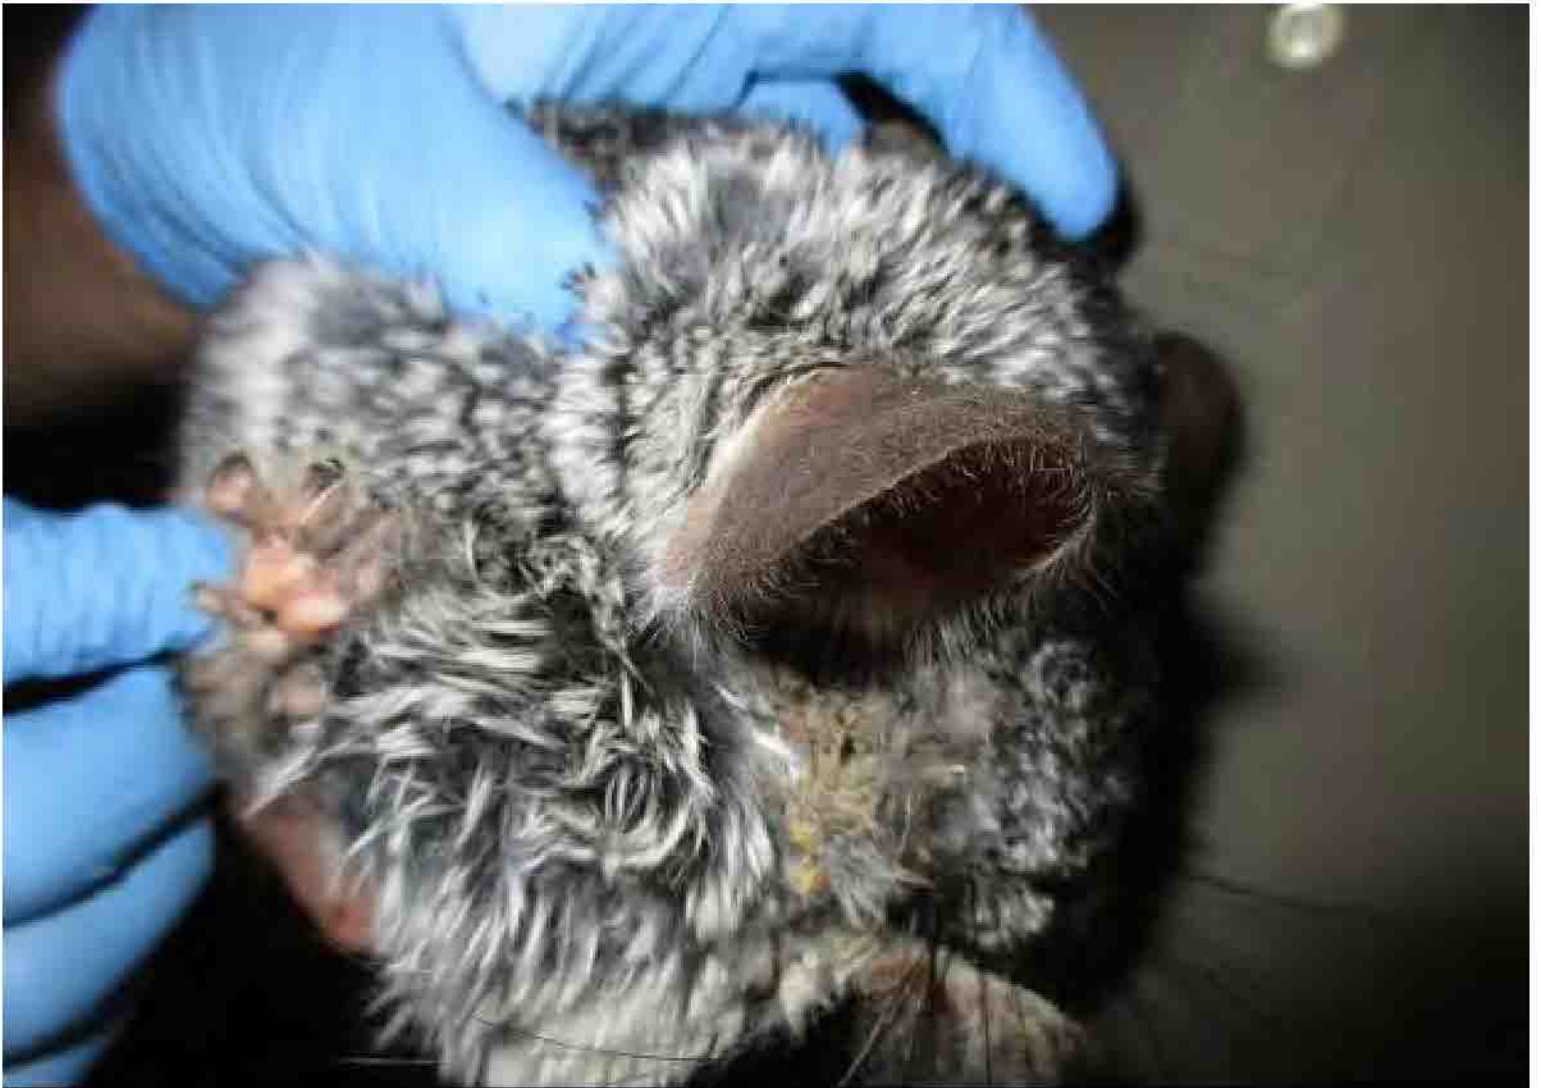
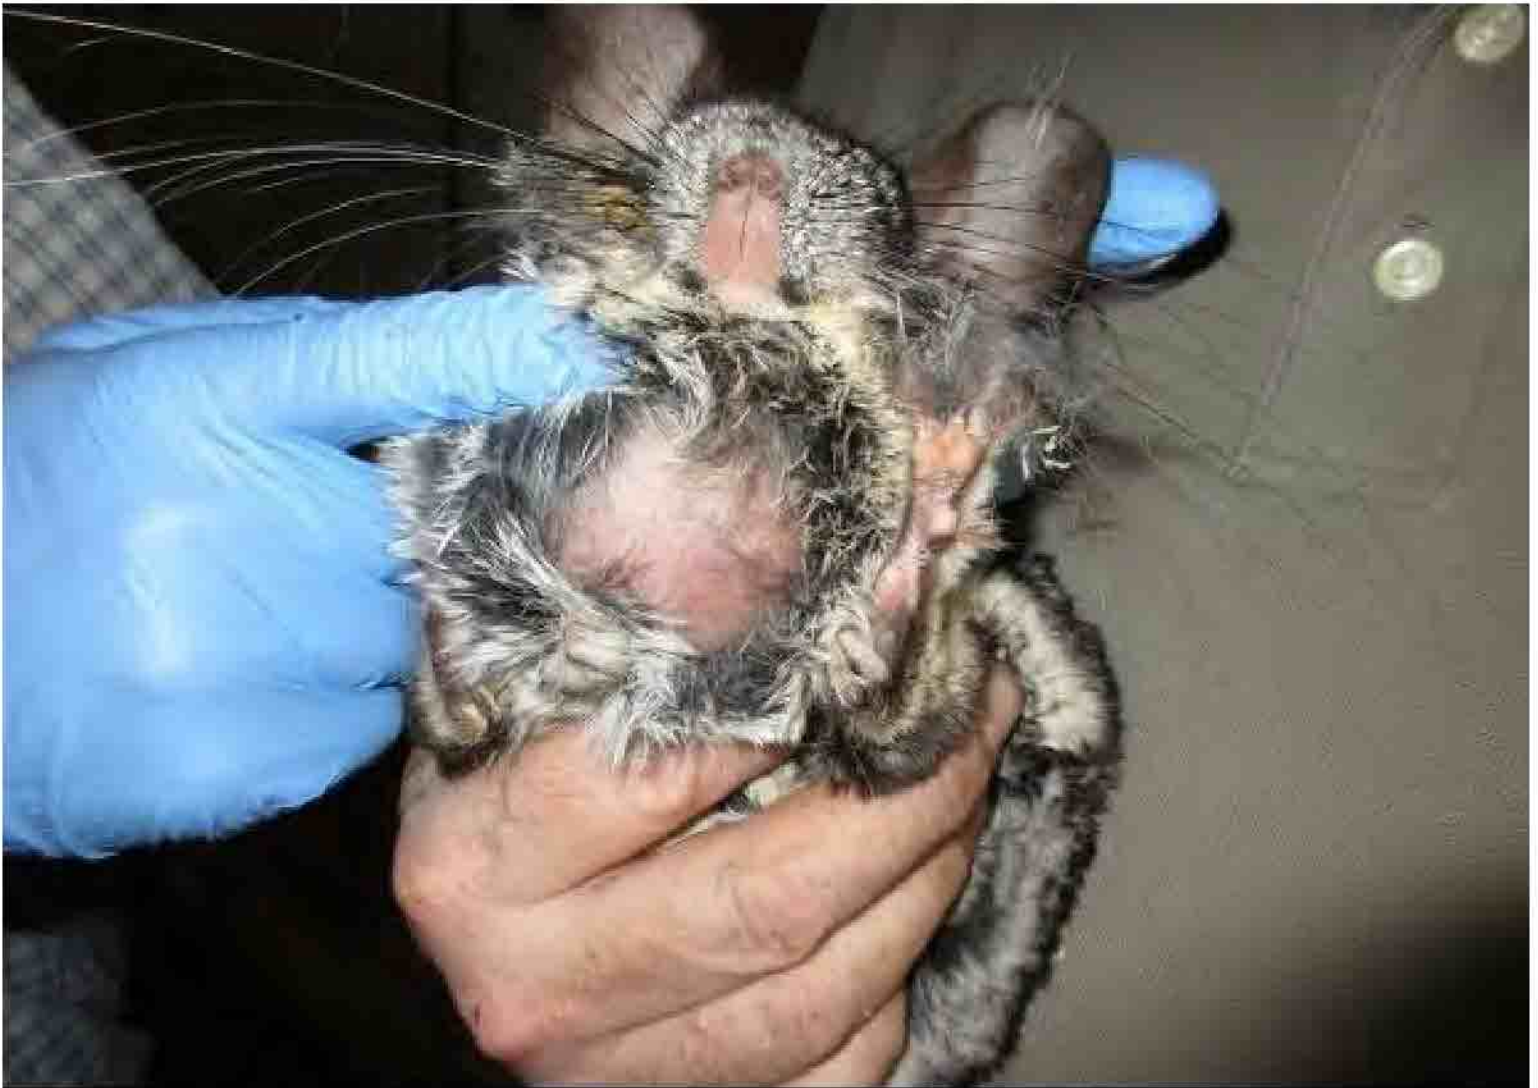
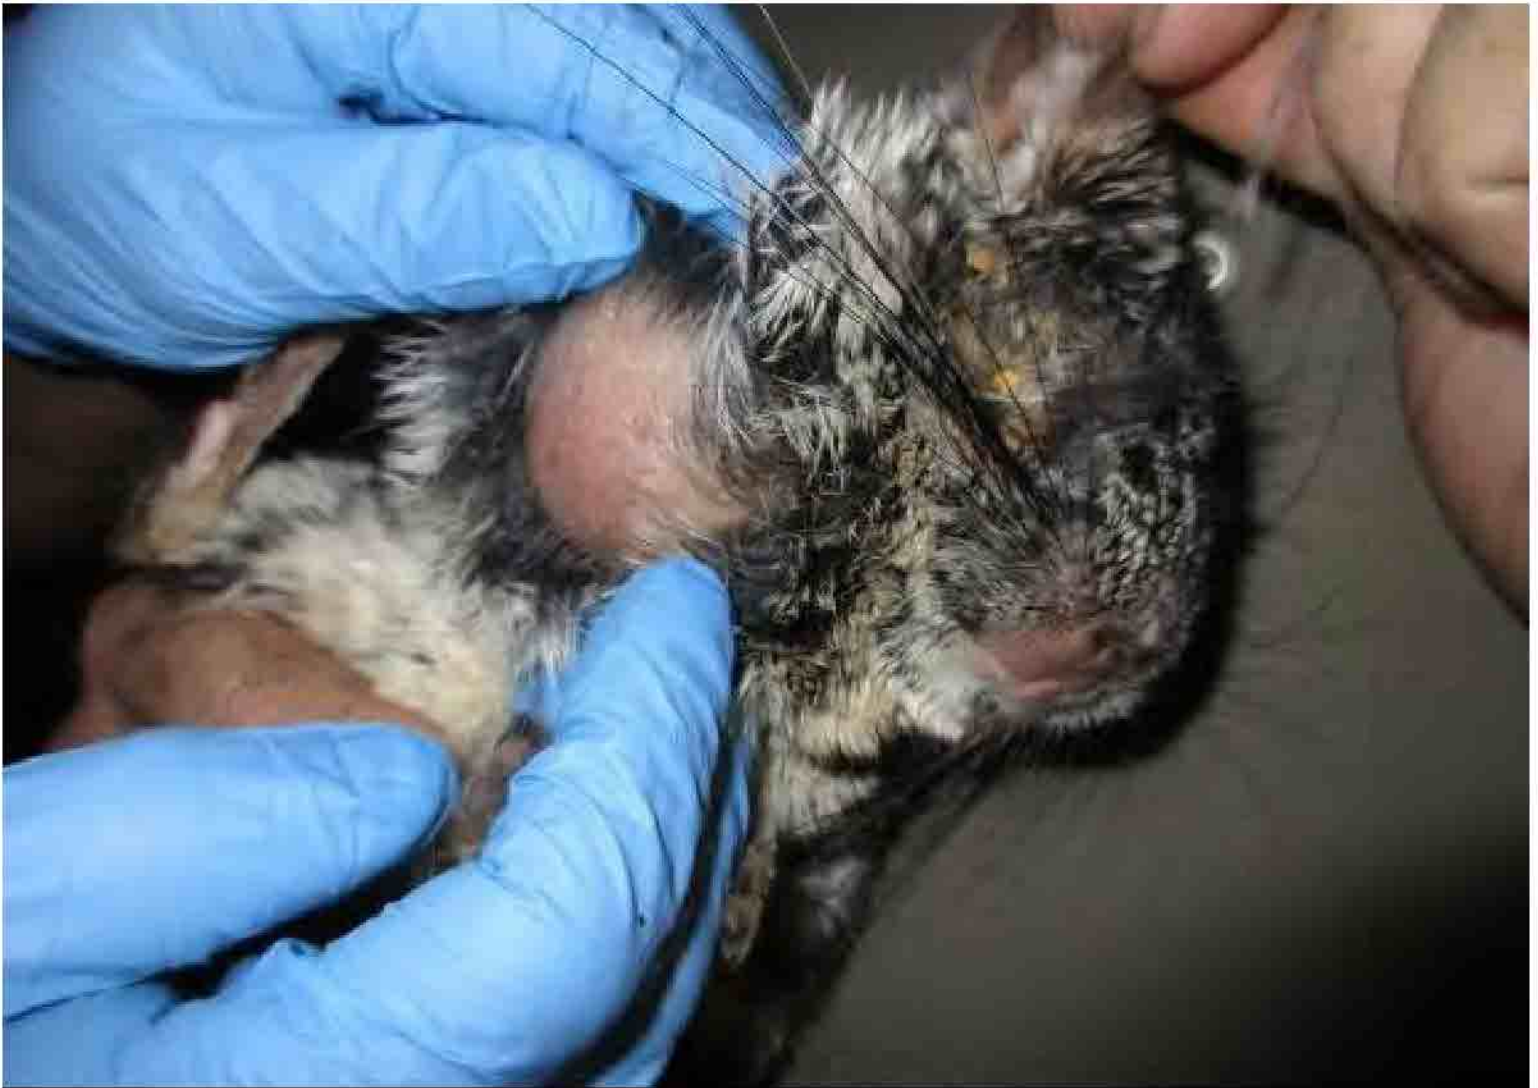
- Male grey (no id; housed in south stacked cages, west/front room) had a large hairless swelling under its chin and its right eye was crusted shut and had hair loss around it with a creamy pale discharge.

- Male grey (no id; housed in south stacked cages, west/front room) had a large hairless mass under its chin and its right eye had hair loss around it with a crusty and creamy pale discharge.

Photographer:	Kevin Wilken	Legal Name:	41-B-0239
Photo Taken:	Wed, Jun 22, '16	DAN MOULTON	
Inspection:	181161057380243		
Description:	Male grey (no id, in south stacked cages, west/front room); its right eye can't be seen because it is crusted shut.

Photographer:	Kevin Wilken	Legal Name:	41-B-0239
Photo Taken:	Wed, Jun 22, '16	DAN MOULTON	
Inspection:	181161057380243		
Description:	Male grey (no id in south stacked cages, west/front room); large hairless swelling under chin and note its right eye crusted over.

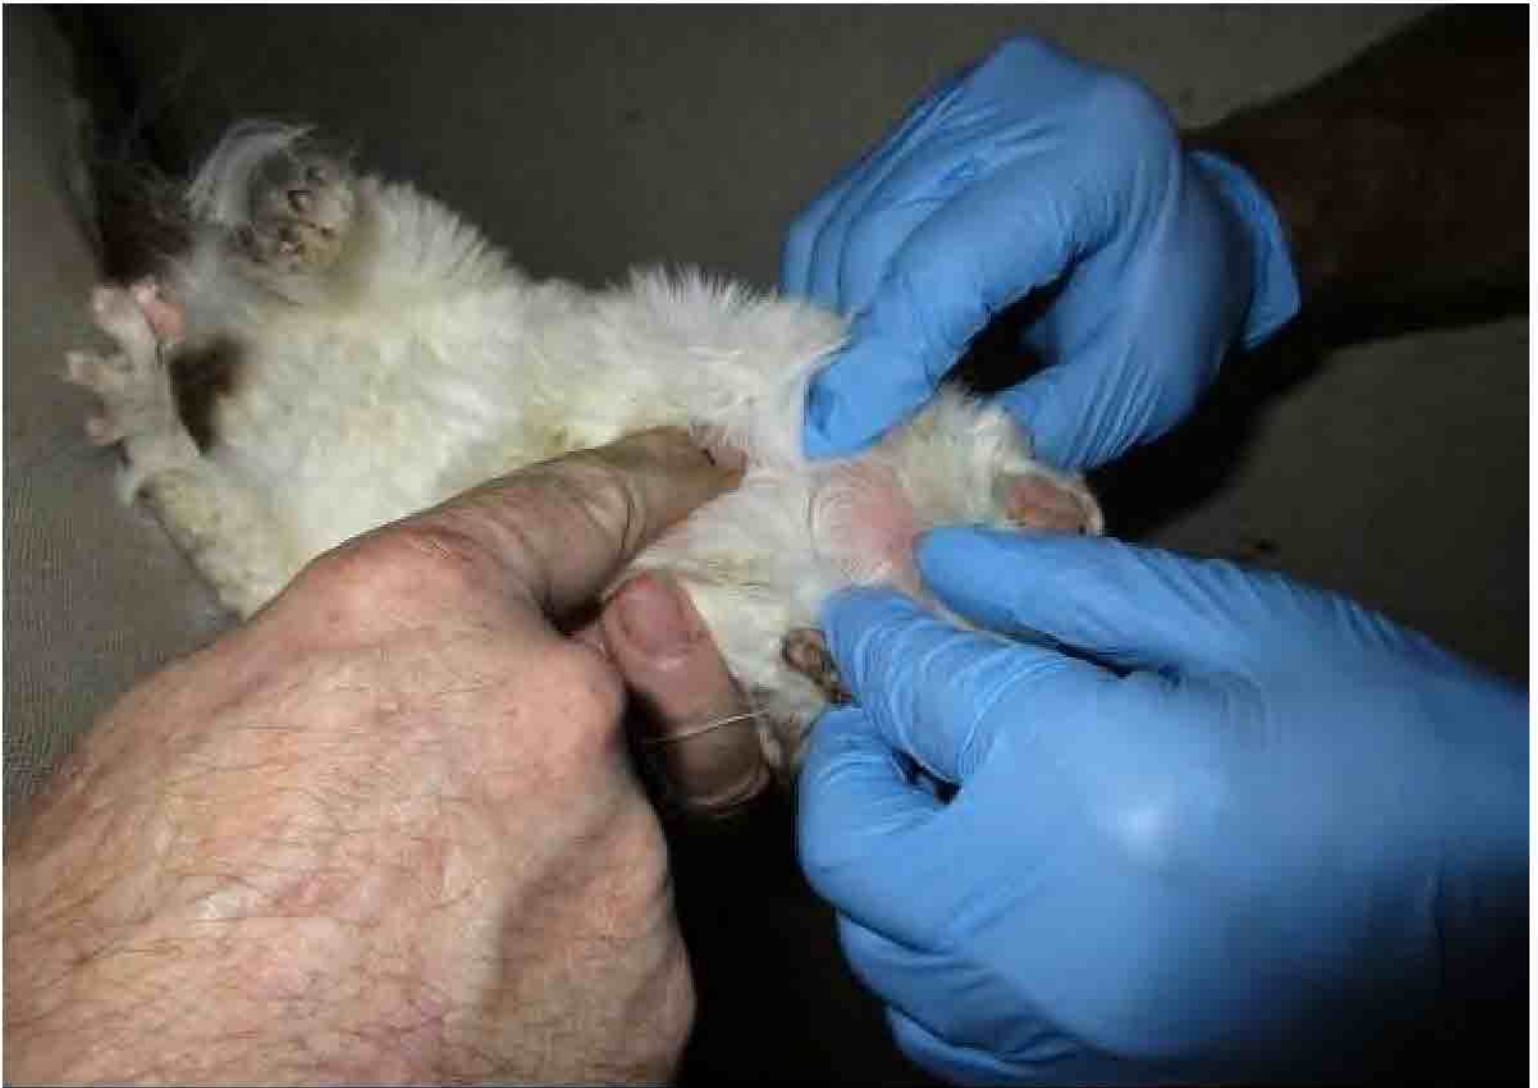
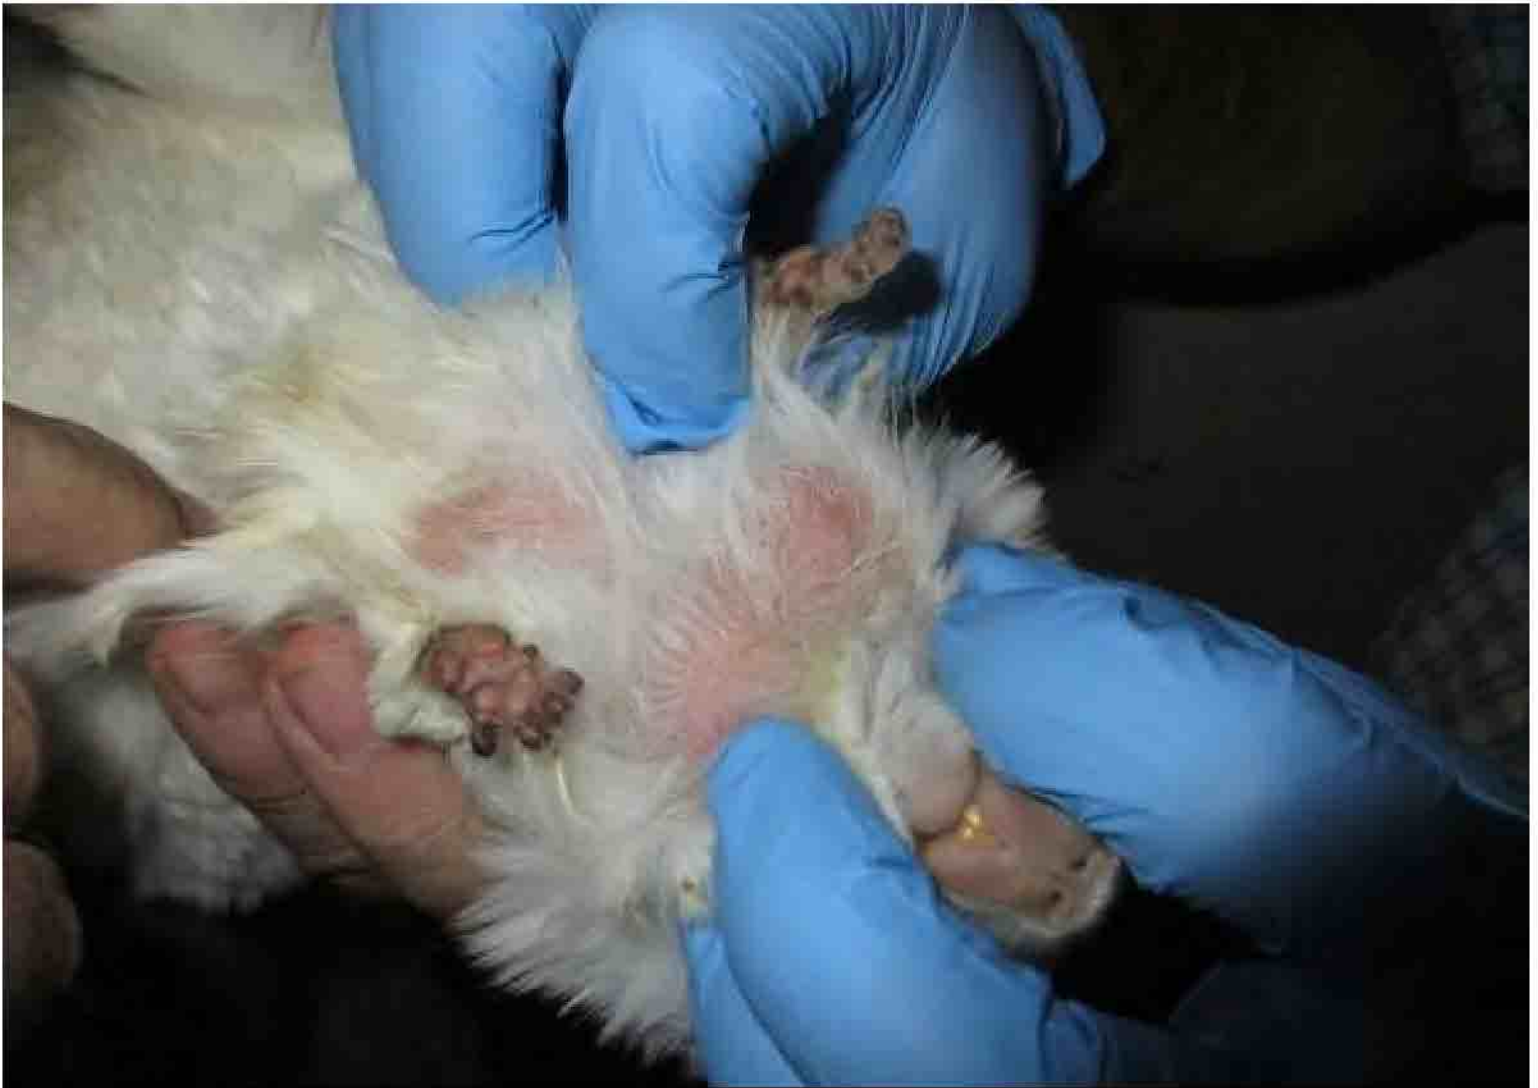
-White female in cage 168 on south stacked cages, tag 876 had a swollen area with hair-loss and the tissues felt thickened. Licensee said that this was just a 'plump' chinchilla. Given the other chinchillas with concerning chin swellings, the licensee must have this chinchilla observed by the veterinarian to determine if any treatment is necessary.

Photographer:	Kevin Wilken	Legal Name:	41-B-0239
Photo Taken:	Wed, Jun 22, '16	DAN MOULTON	
Inspection:	181161057380243		
Description:	White female in cage 168, ear tag 876; swollen area with hair loss under chin. Tissues felt thickened to VMO (gloved hands).

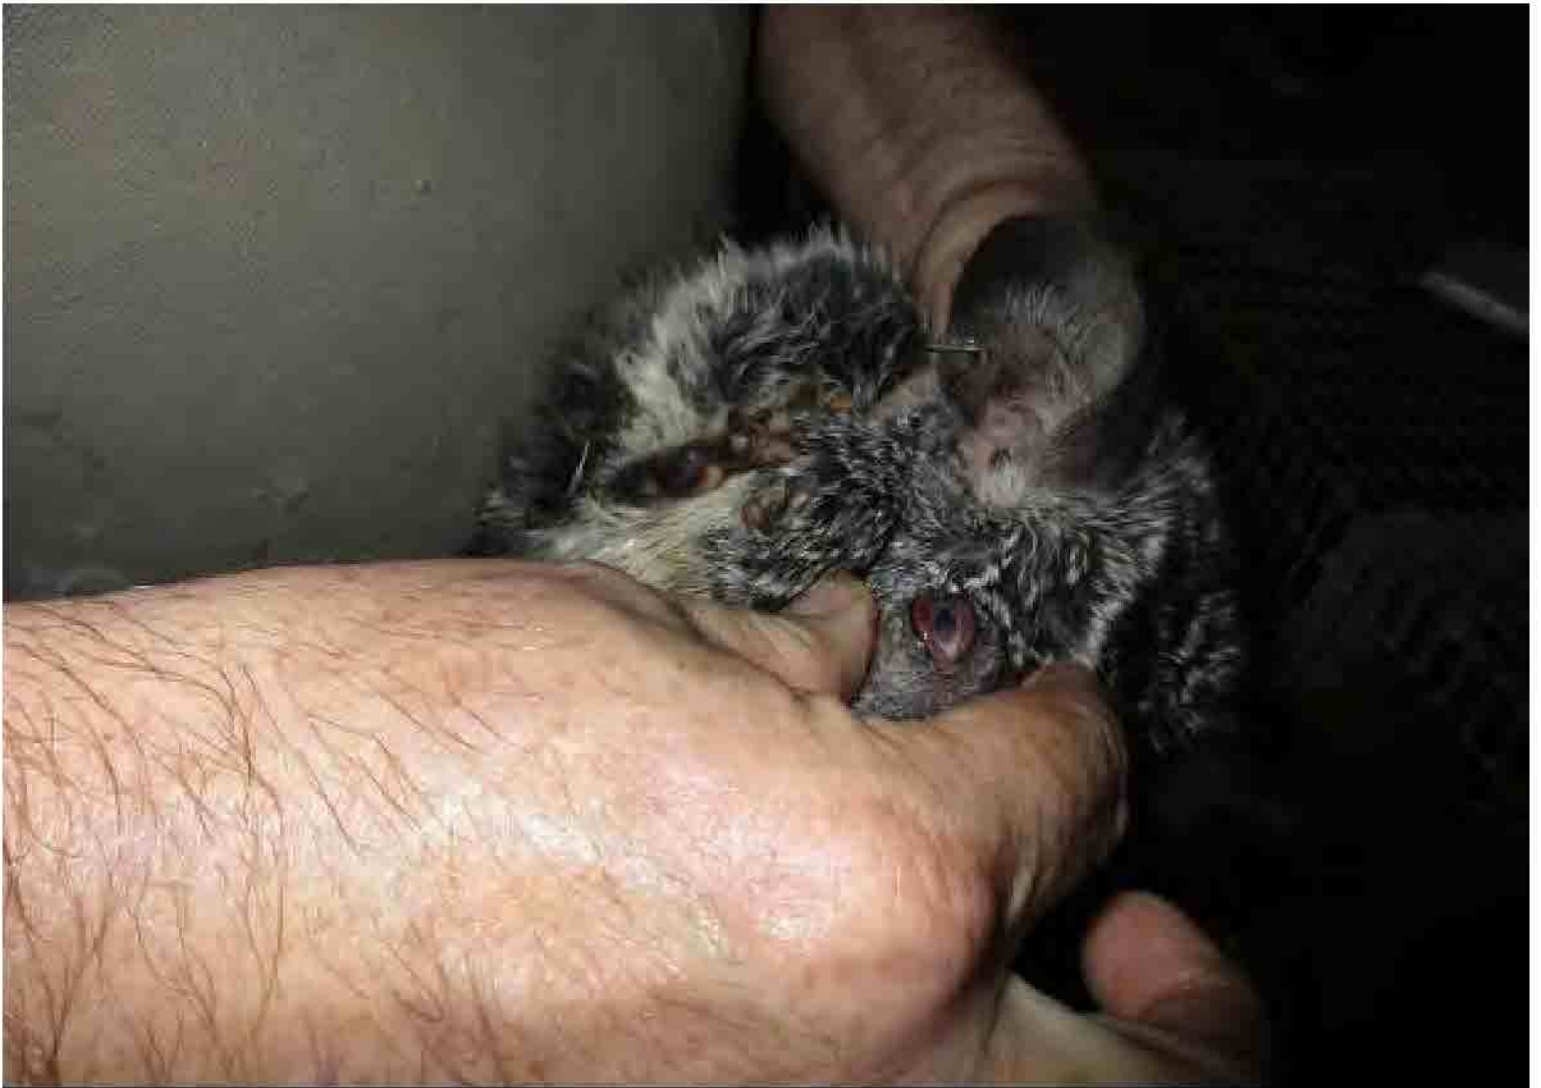
Photographer:	Kevin Wilken	Legal Name:	41-B-0239
Photo Taken:	Wed, Jun 22, '16	DAN MOULTON	
Inspection:	181161057380243		
Description:	Female grey-- ear tag 332; its right eye is swollen and had a pale creamy discharge.

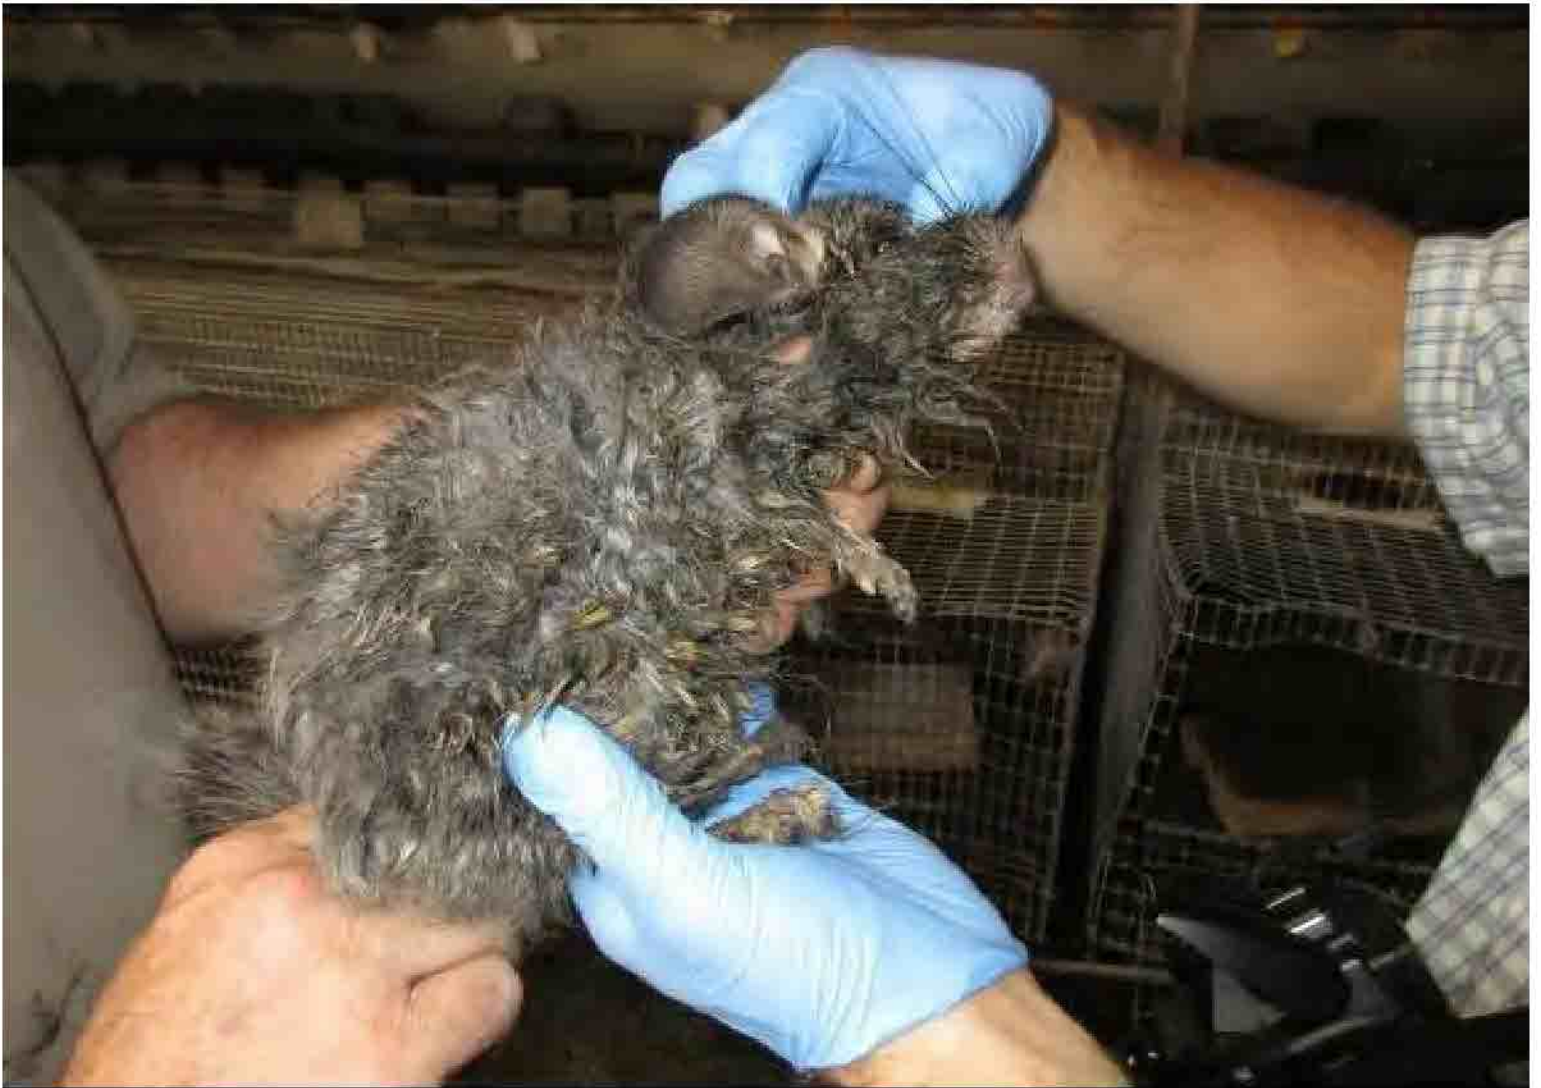
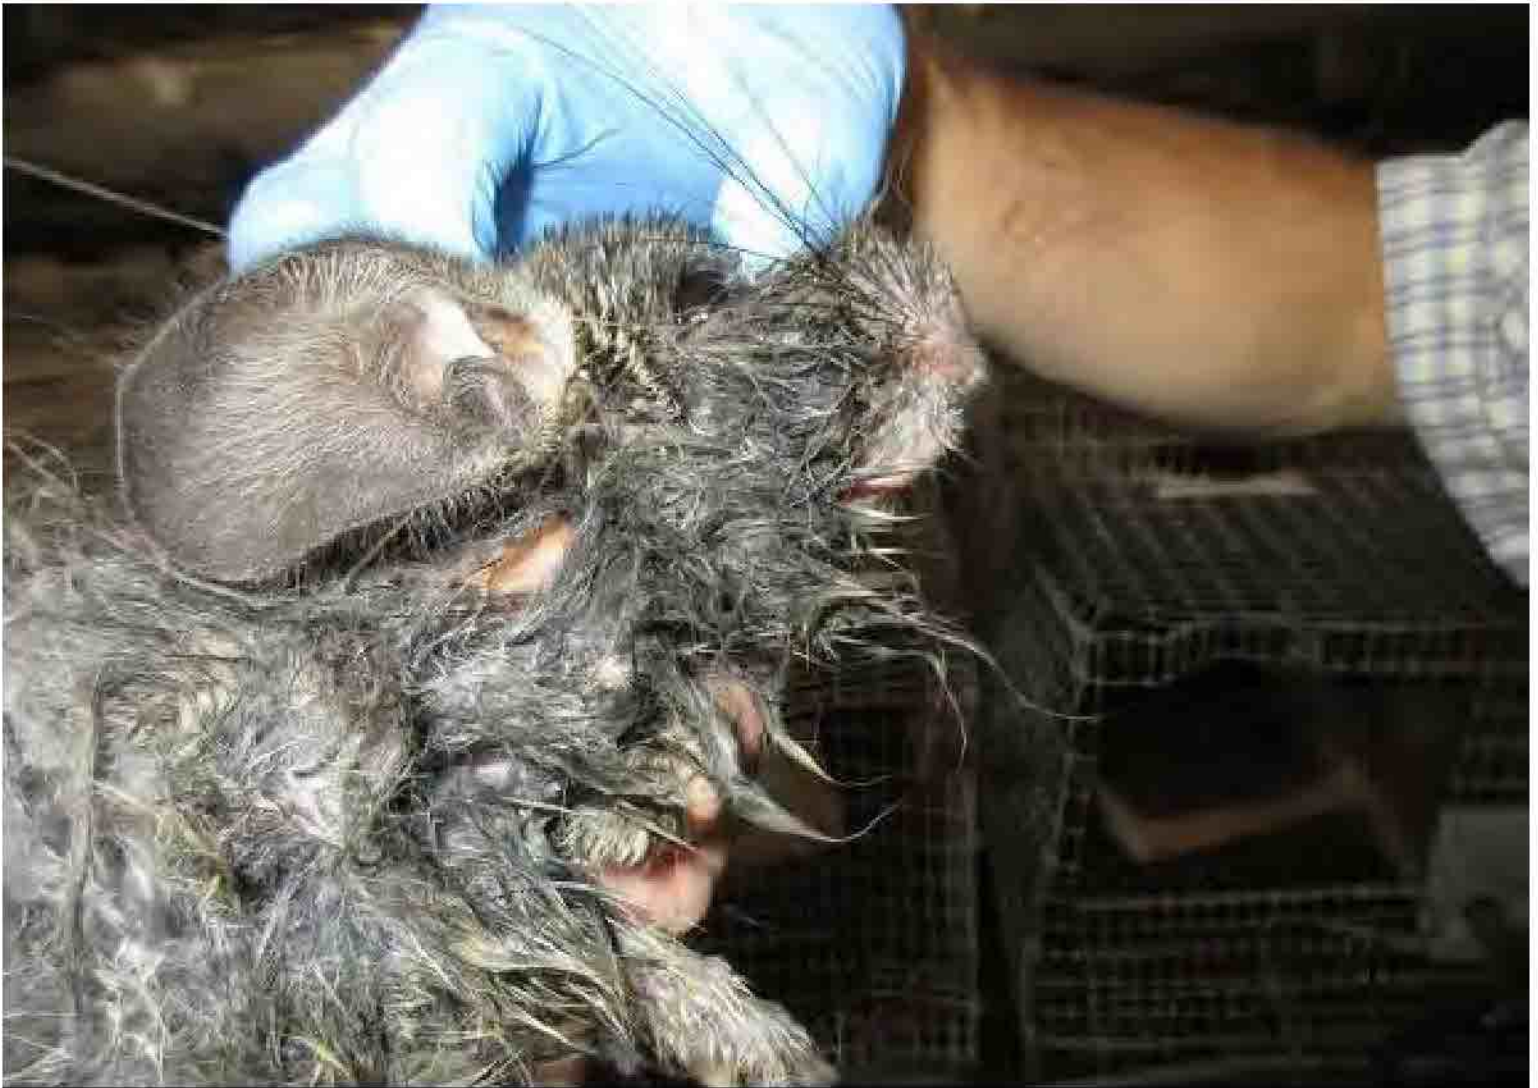
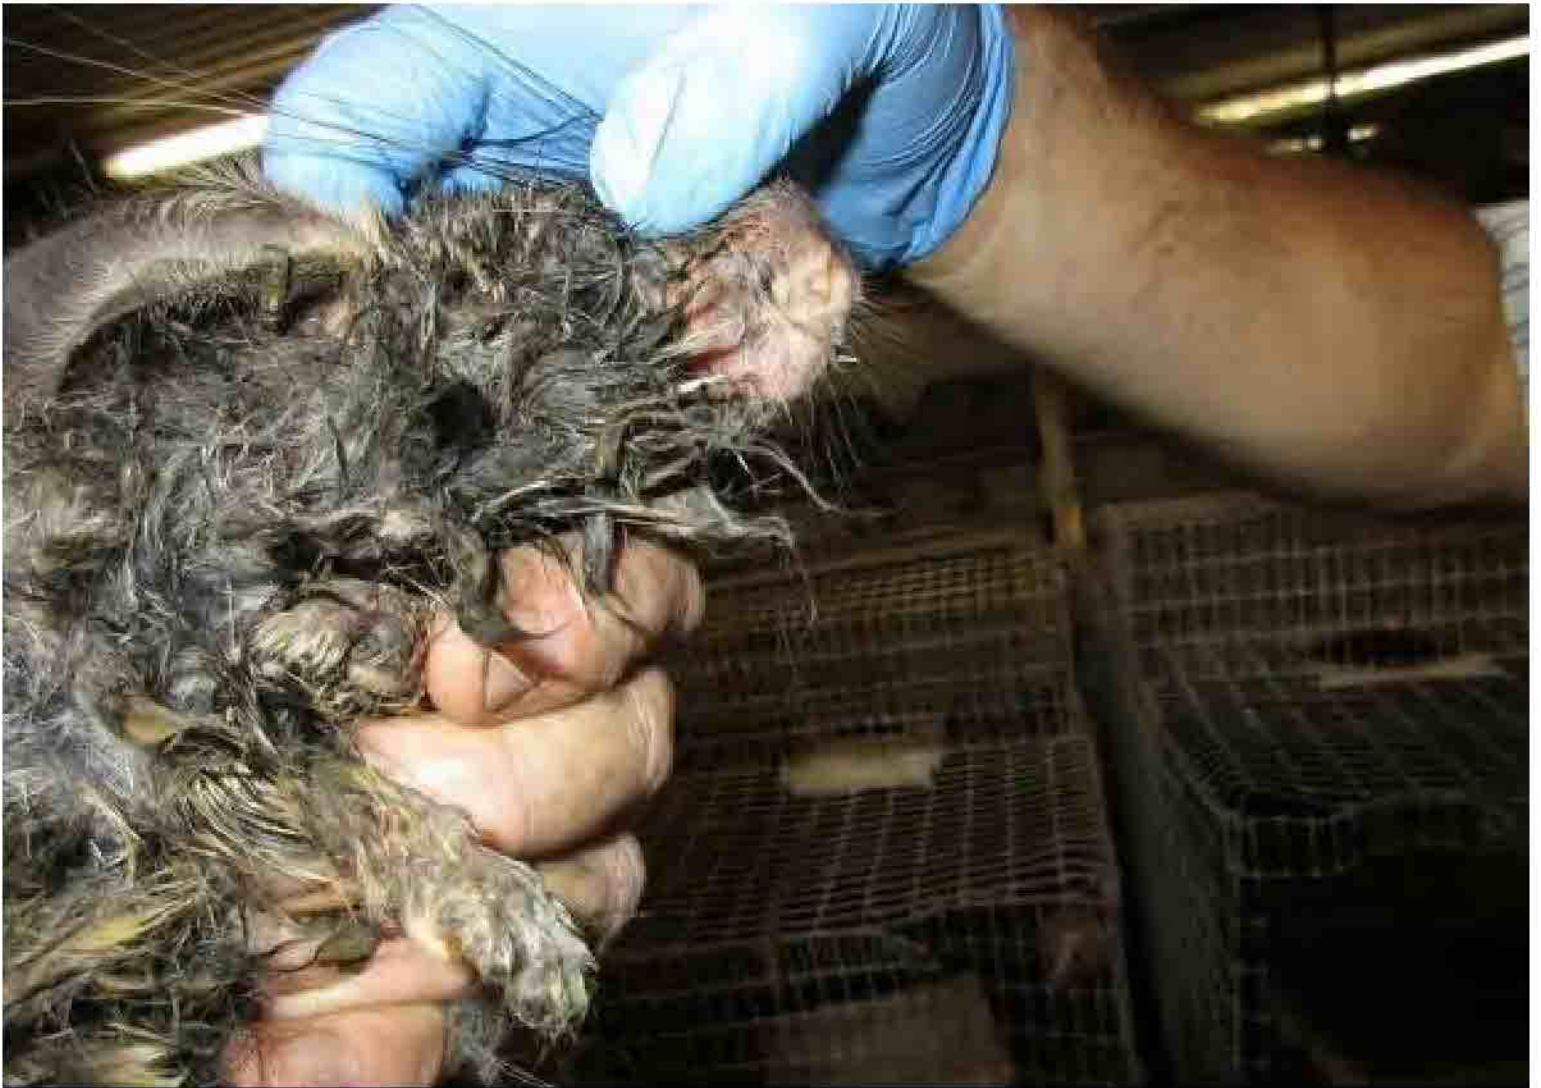
- Female grey with ear tag 332; its right eye was swollen and had a pale creamy discharge.
- Female black with ear tag GROS 313 had a soiled and unkempt hair coat, crusty eyes and hair loss around the lower jaw area. The licensee said that it appeared to have 'bone spurs' on the bottom jaw and may have bad back teeth. The combination of an unkempt hair coat, crusty eyes, and hair loss are suggestive of an underlying health condition that must be determined by the attending veterinarian and treated per the AV's recommendations.

Photographer:	Kevin Wilken	Legal Name:	41-B-0239
Photo Taken:	Wed, Jun 22, '16	DAN MOULTON	
Inspection:	181161057380243		
Description:	Female black; eartag GROS 313; note unkempt hair coat.

Photographer:	Kevin Wilken	Legal Name:	41-B-0239
Photo Taken:	Wed, Jun 22, '16	DAN MOULTON	
Inspection:	181161057380243		
Description:	Female black; eartag GROS 313; note unkempt hair coat and hair loss around mouth

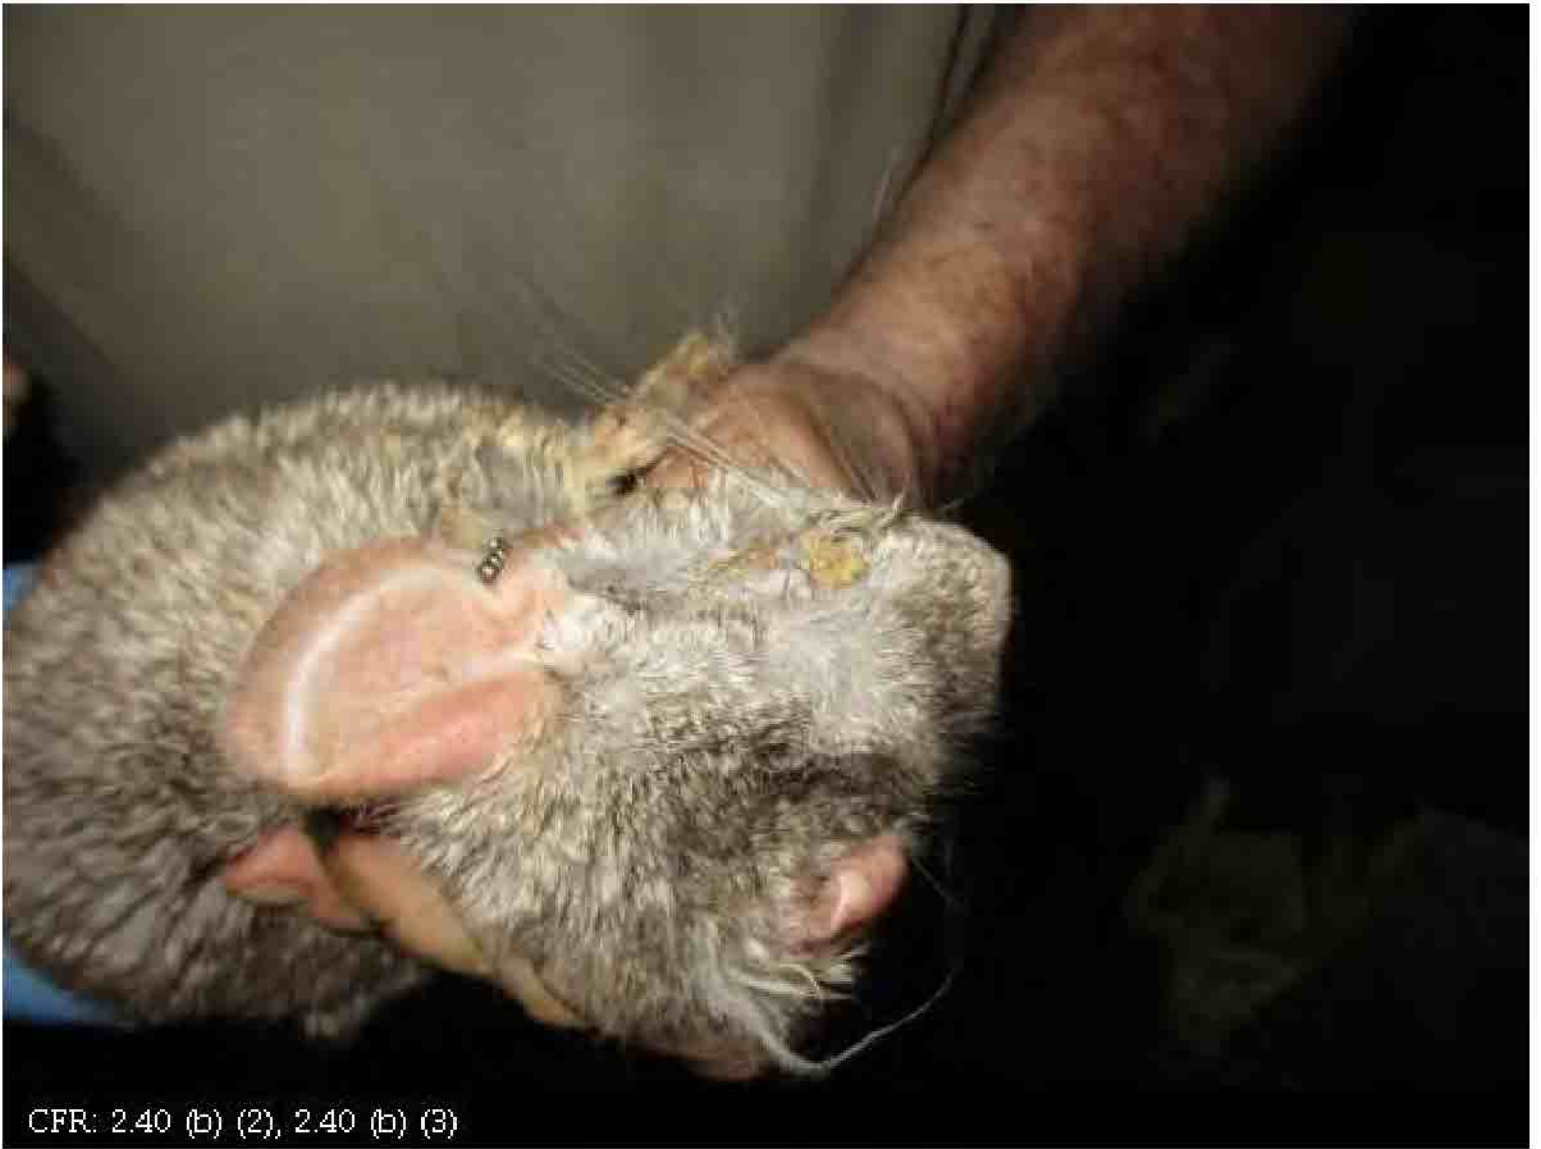
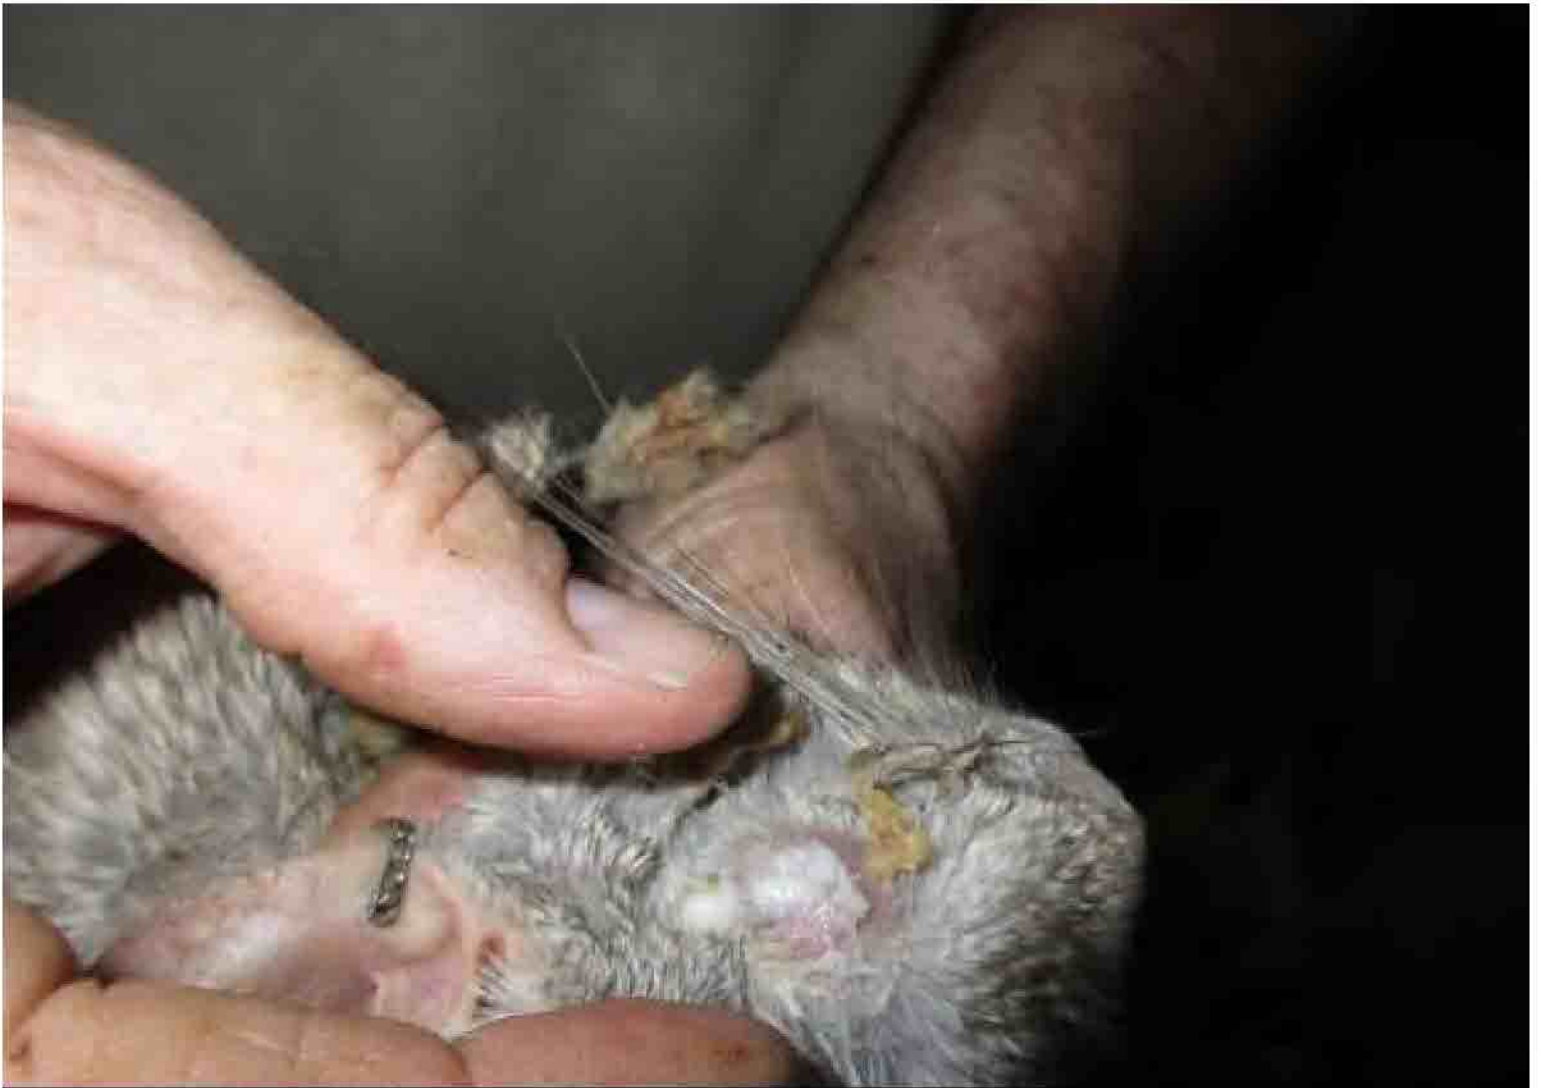
Photographer:	Kevin Wilken	Legal Name:	41-B-0239
Photo Taken:	Wed, Jun 22, '16	DAN MOULTON	
Inspection:	181161057380243		
Description:	Male beige with eartag GROS 329; its left eye was swollen and a pale creamy discharge.

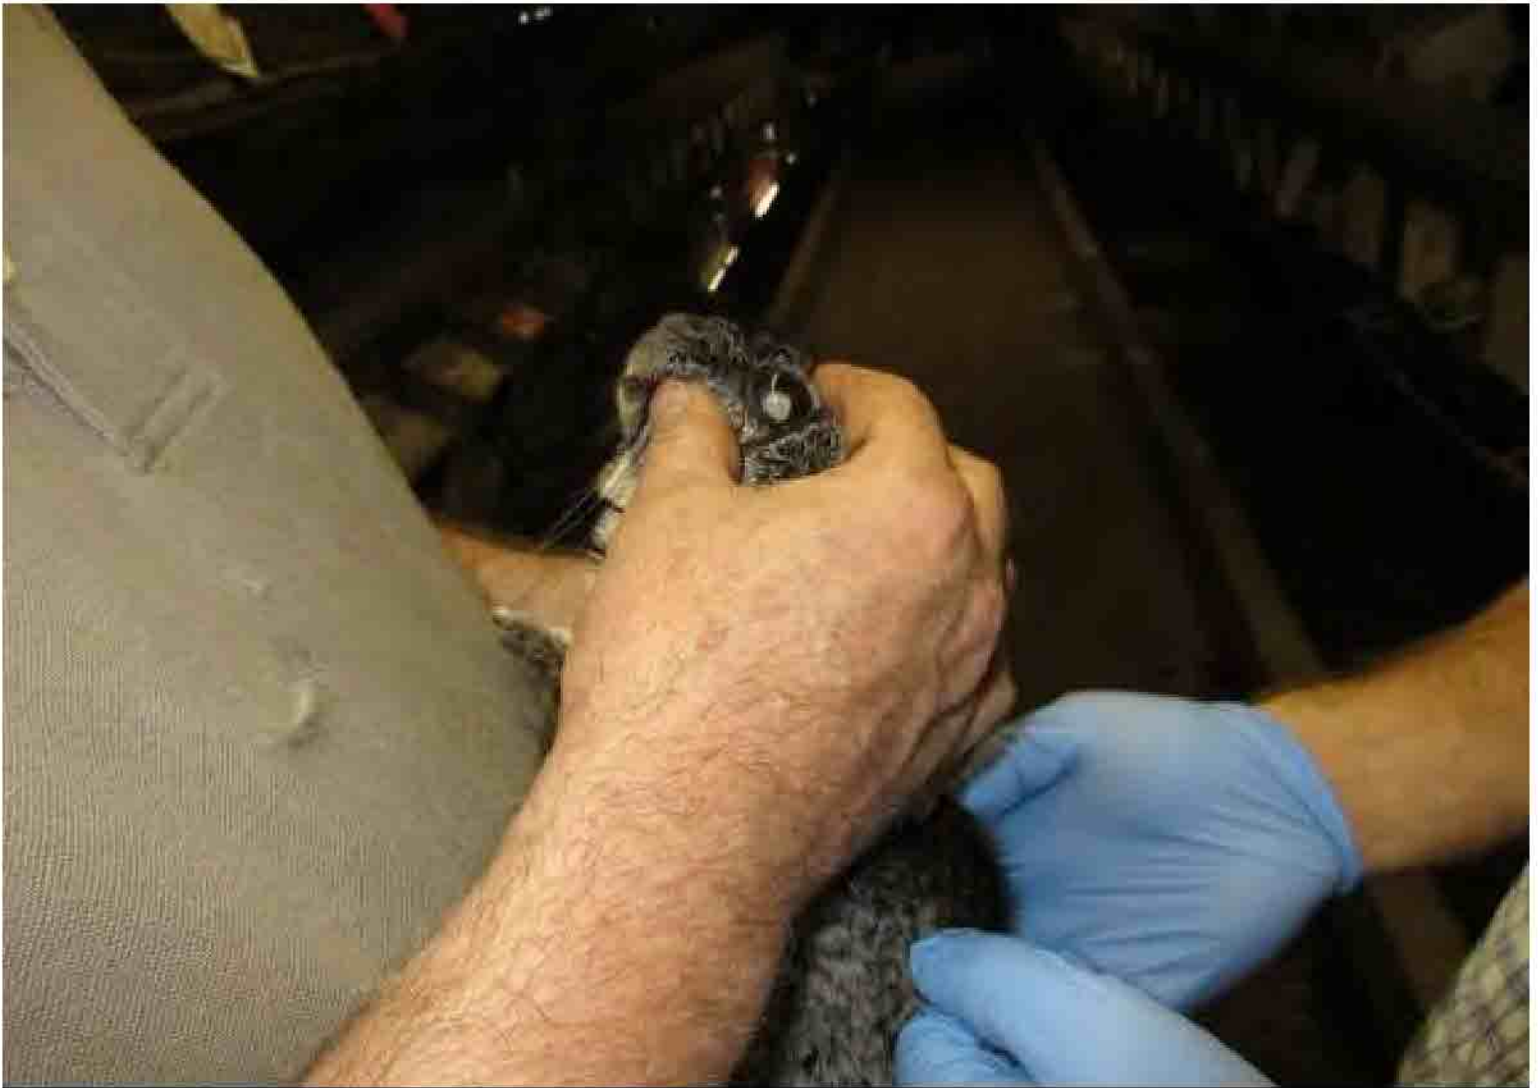
-Female grey with ear tag PMR 233; its left eye had an opaque mass inside of its eyeball. To ensure that this condition is not painful, the licensee must have the attending veterinarian observe this animal's condition and follow any treatment instructions.

Photographer:	Kevin Wilken	Legal Name:	41-B-0239
Photo Taken:	Wed, Jun 22, '16	DAN MOULTON	
Inspection:	181161057380243		
Description:	Female grey with eartag PMR 233; its left eyeball was noted to have an opaque mass inside it.
