Inspection Report

Dan Moulton
Moultons Chinchilla Ranch
976 14th Avenue S W
Rochester, MN 55902

Customer ID: **2401**
Certificate: **41-B-0239**
Site: 001
DAN MOULTON

Type: ROUTINE INSPECTION
Date: Jun-22-2016

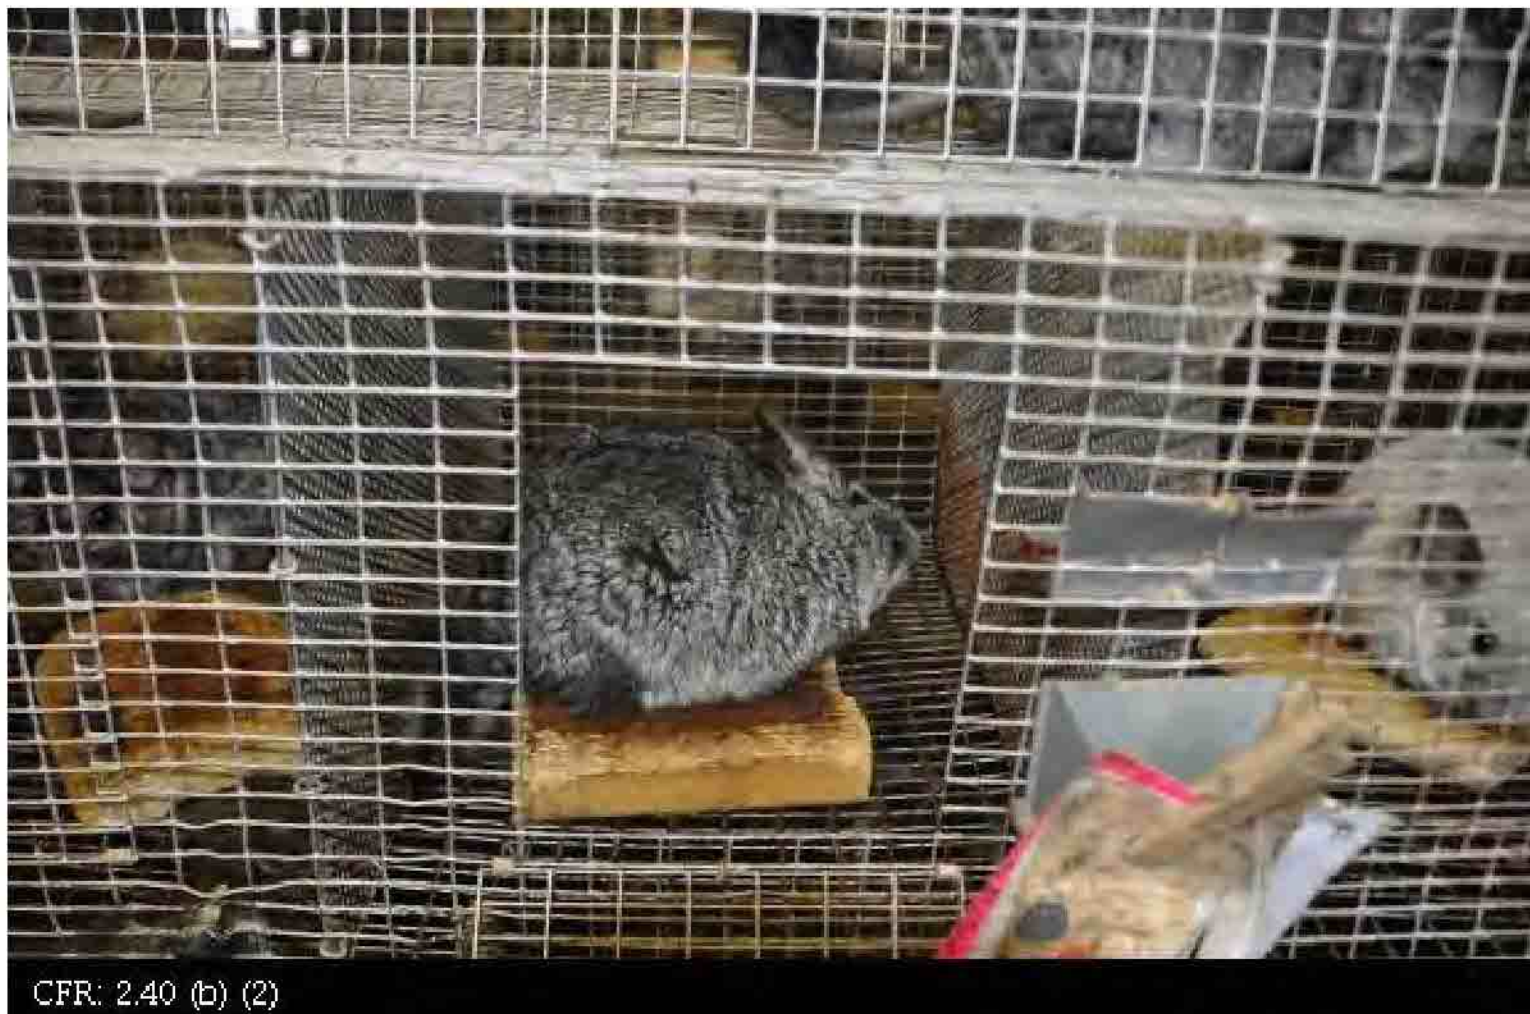
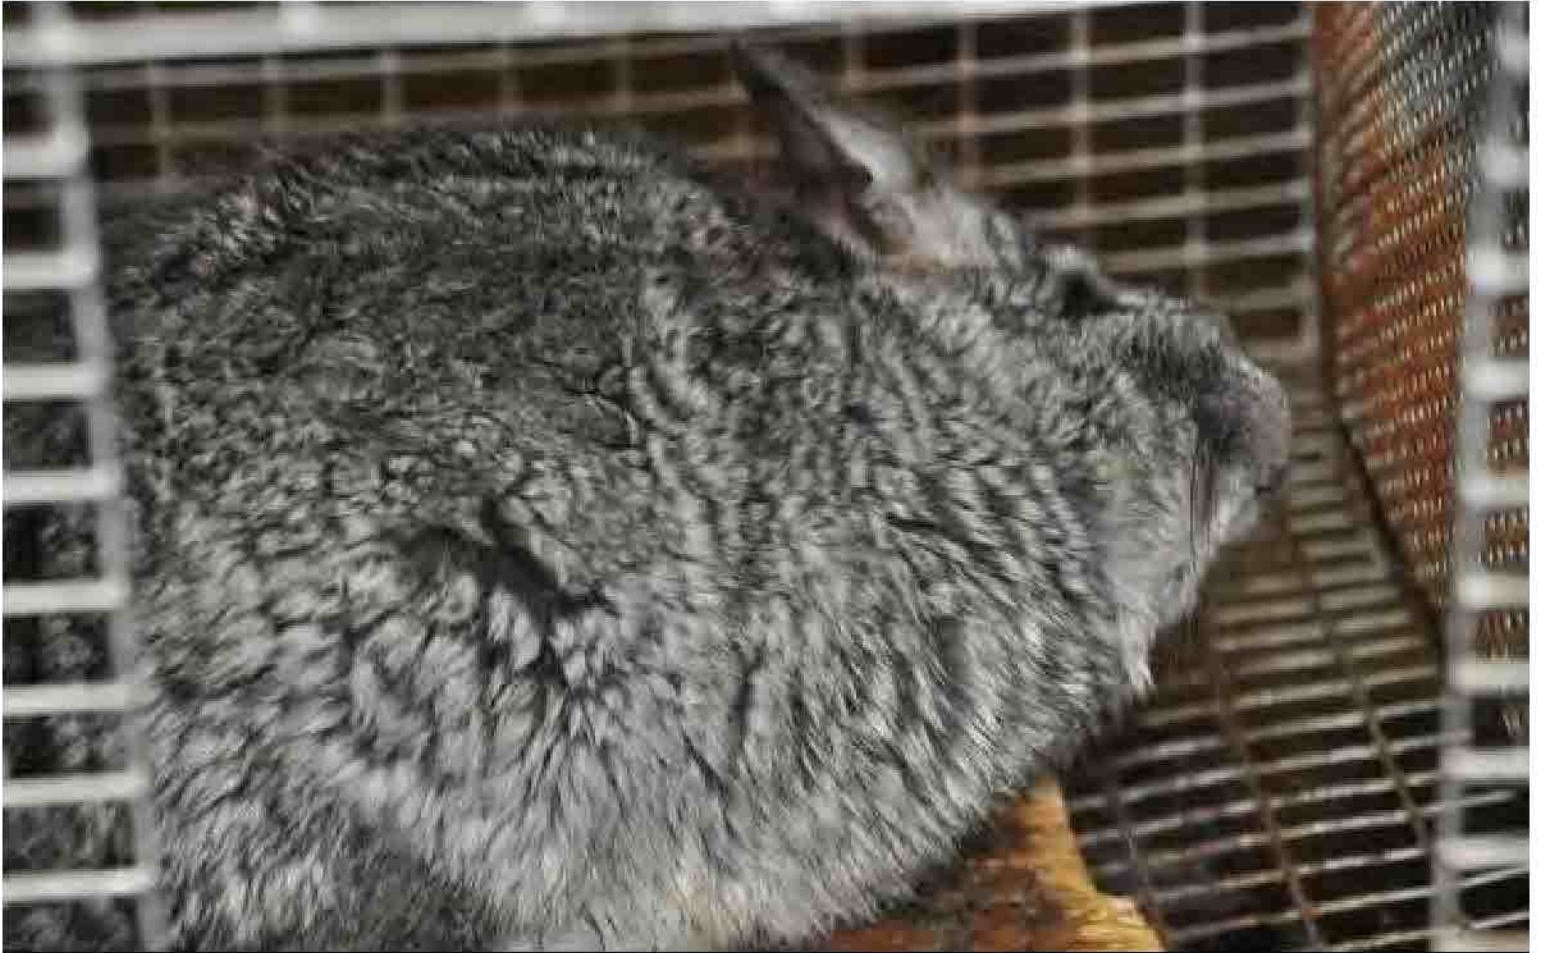
-Silver grey female (no ID, housed in front room, north side, row of cages facing the wall); had a left head tilt and when it moved, it would circle to its left. The licensee reports observing this problem about two months ago and has been observing it for improvement but the attending veterinarian has not been consulted to diagnose and guide any treatment for this animal.

Photographer:	Scott Welch	Legal Name:	41-B-0239
Photo Taken:	Wed, Jun 22, '16	DAN MOULTON	
Inspection:	181161057380243		
Description:	Silver grey female (no ID, housed in front room, north side, cages facing the wall); head tilted to the left.

**Untreated medical problems can cause ongoing pain in affected animals and can be contagious to other animals in the building. The veterinarian must be contacted to properly diagnose and treat each animal's health problem and the facility must follow the recommended treatment. Documentation of the diagnosis and treatment plan for animals must be available for APHIS officials for future inspections.

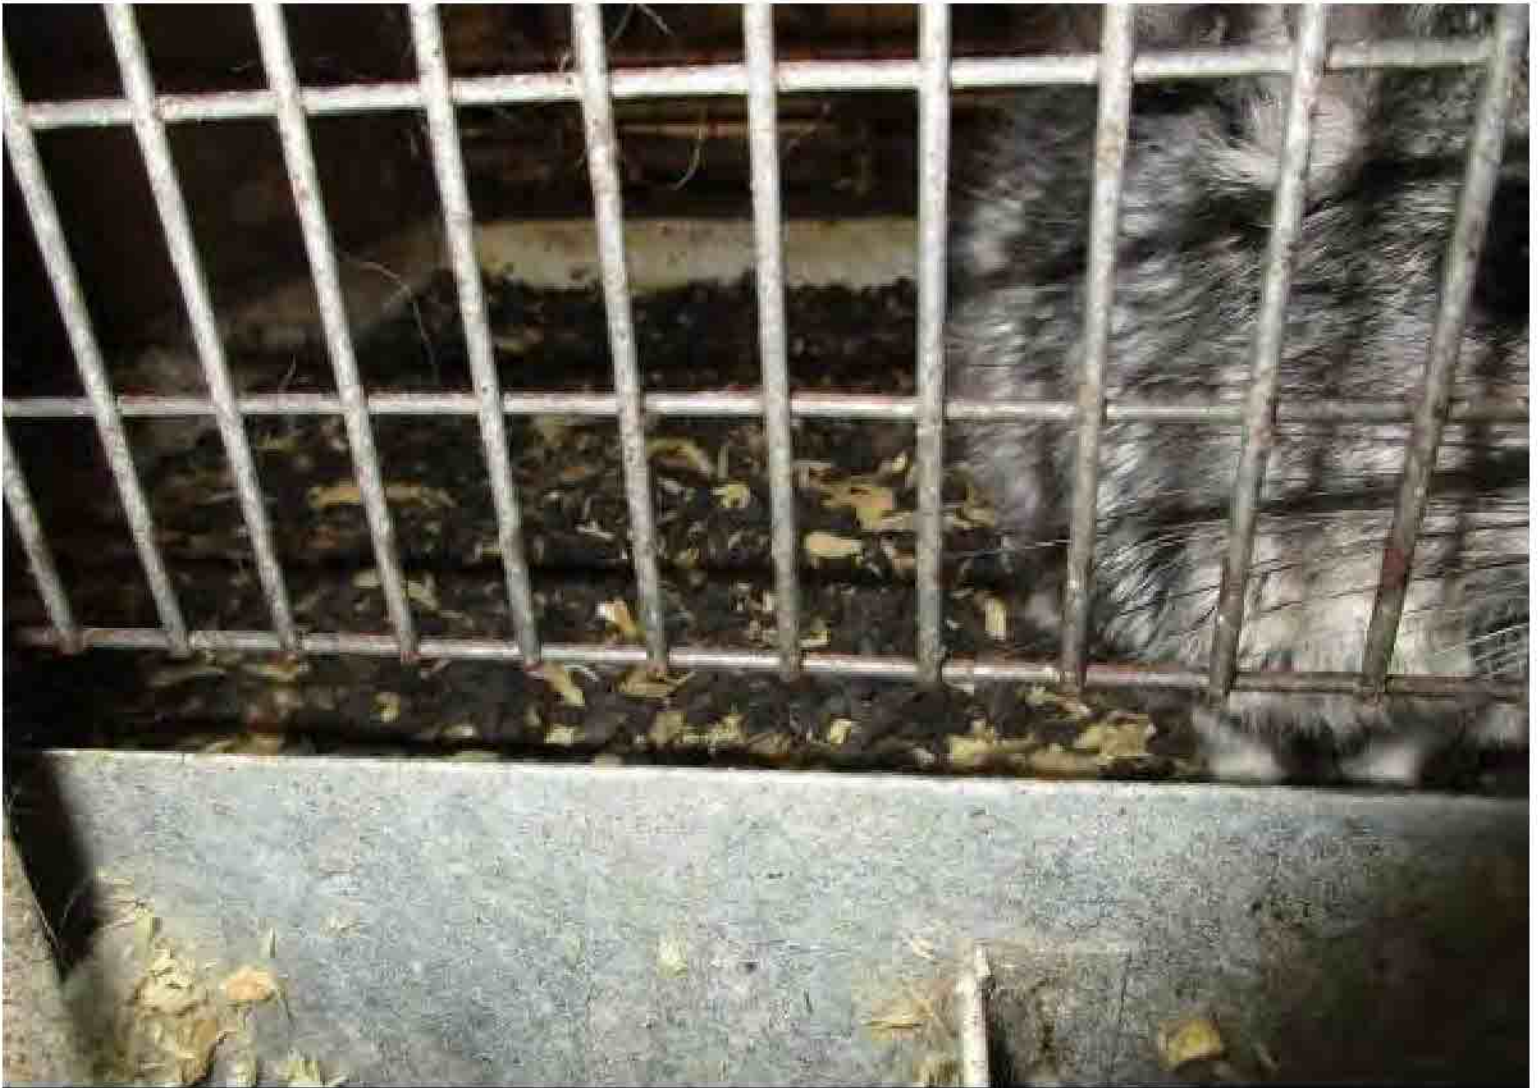
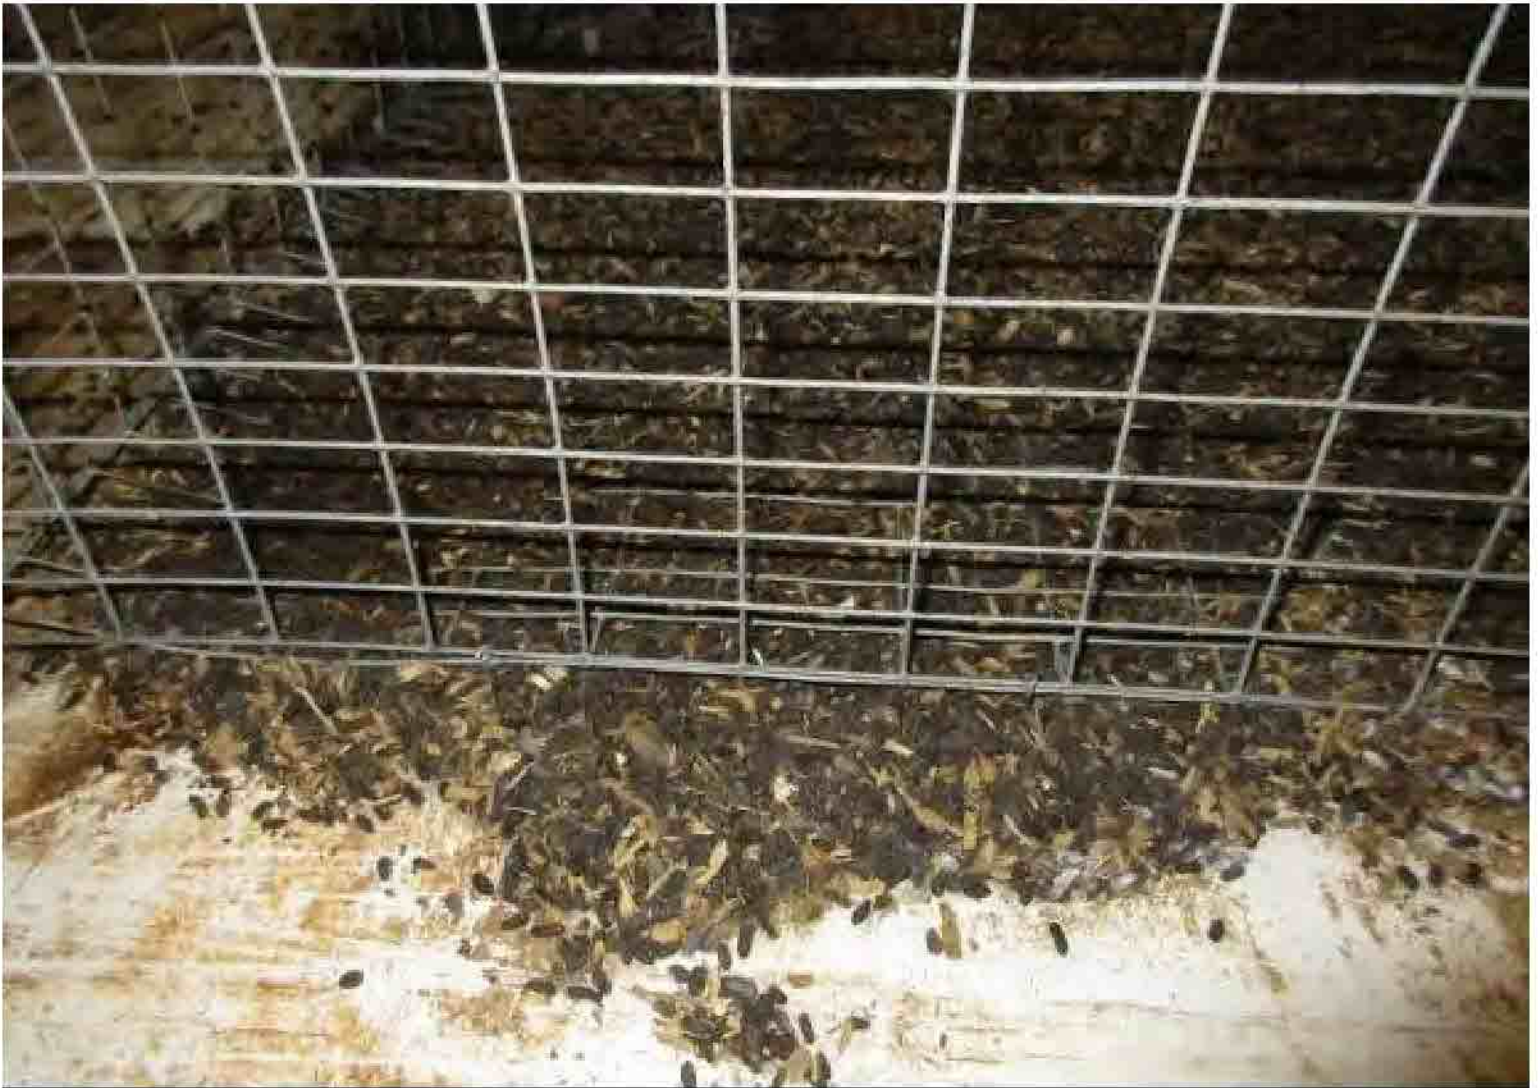
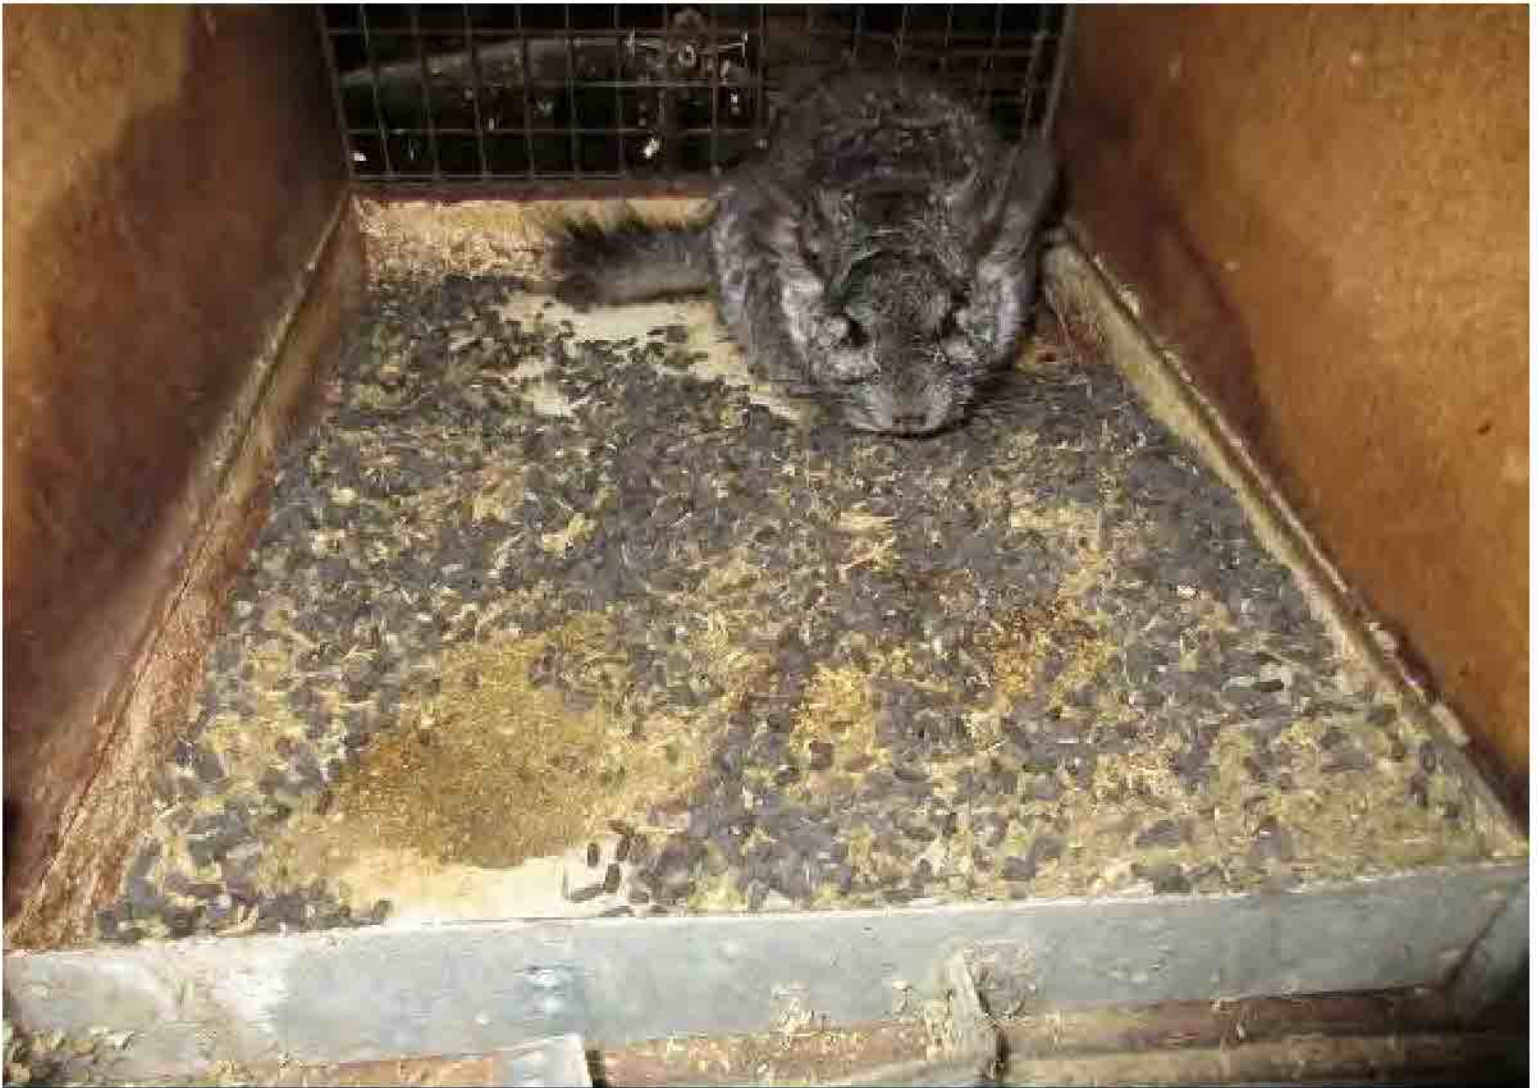
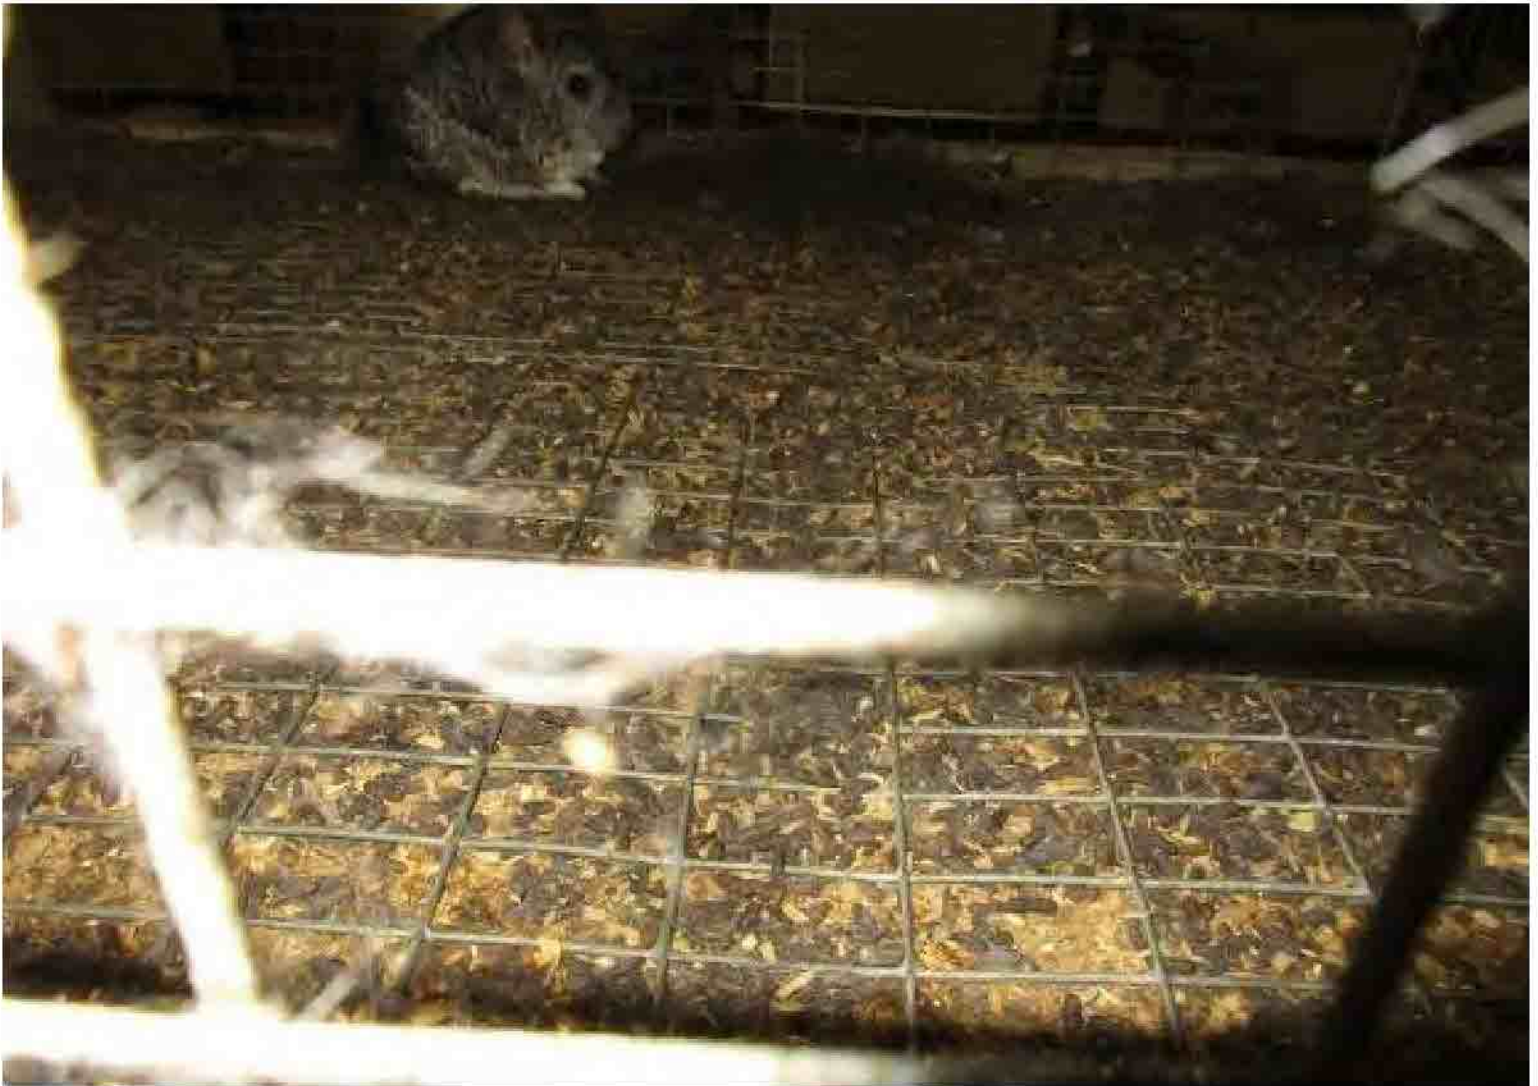
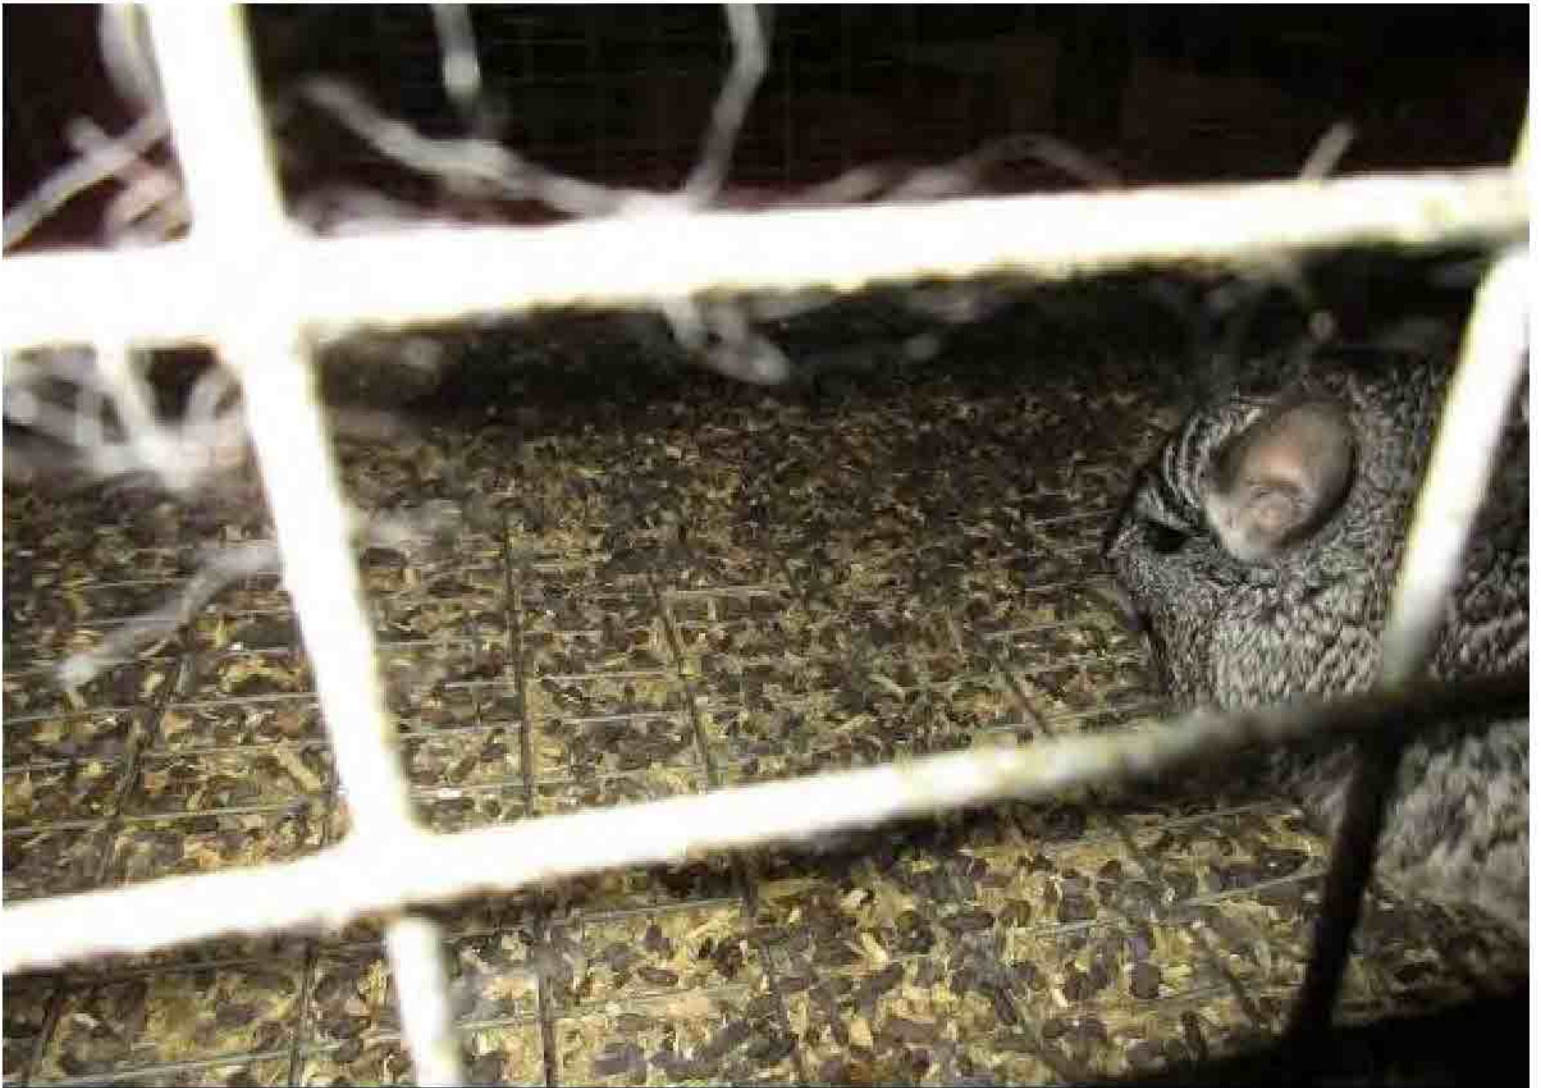
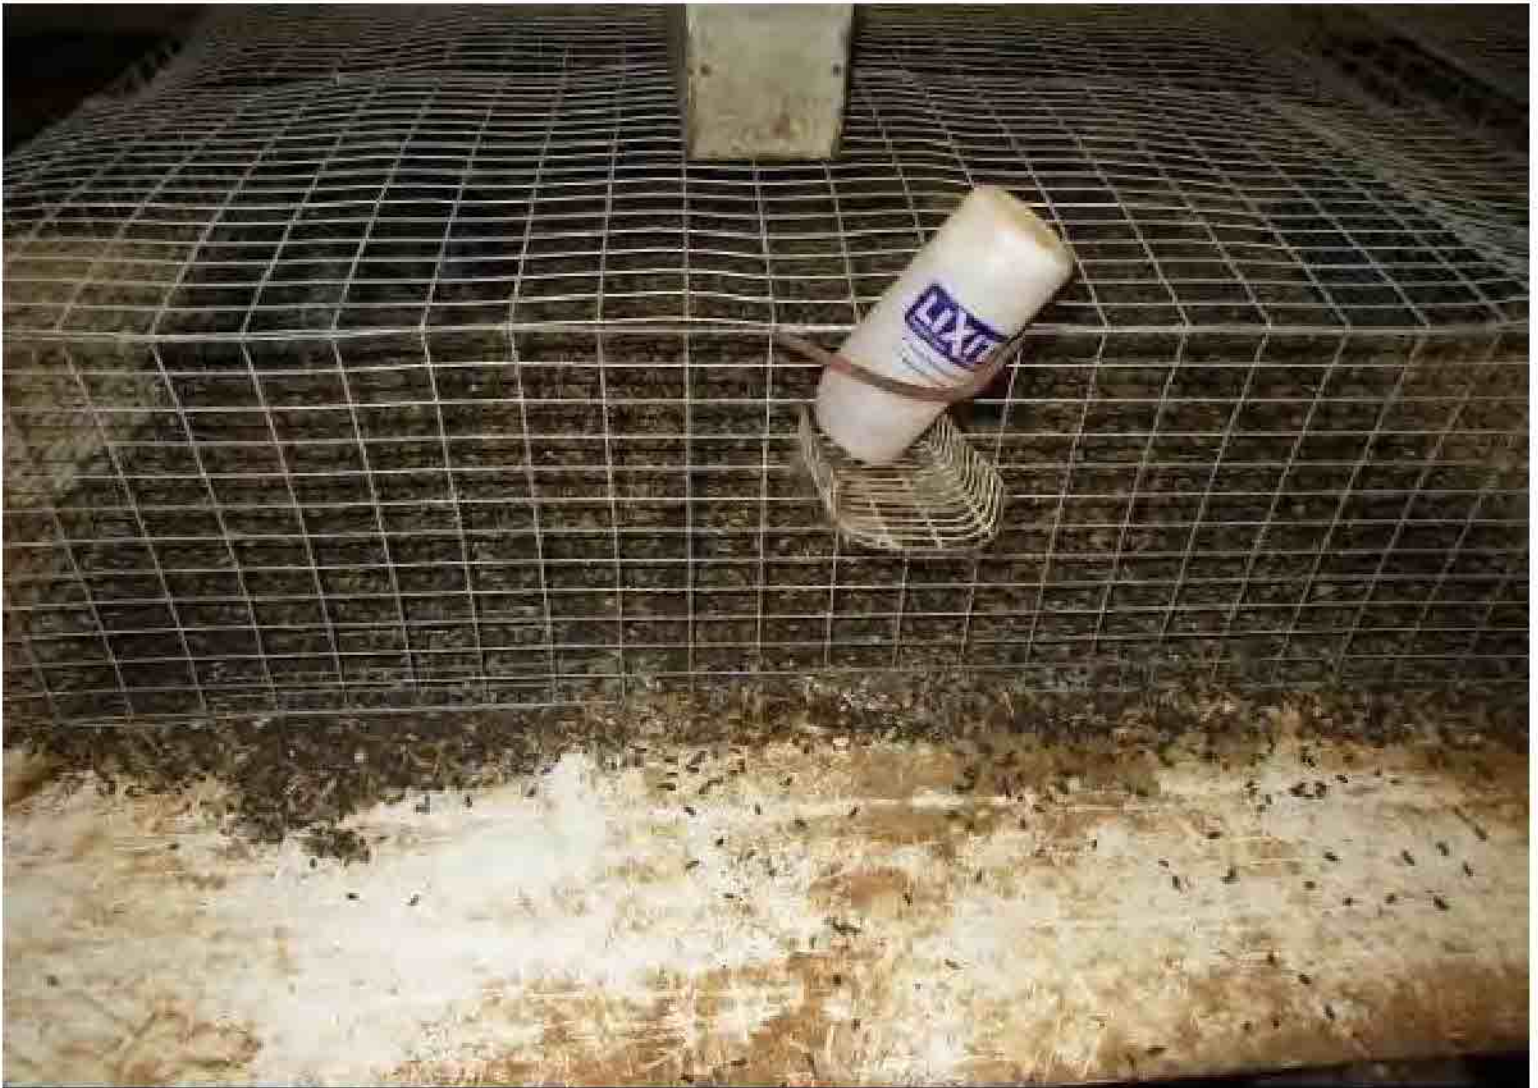
Enclosures in the front room in the middle group pens where about 20 chinchillas are housed and enclosures on the stacked enclosures on the south side of the front room housing approximately 10 chinchillas were noted to have an excessive amount of feces. The licensee stated that the enclosures had

not been cleaned out in about two and a half weeks. Excessive accumulations of feces can increase animals' risks for disease and does not provide for their comfort. Enclosures must be cleaned out as often as necessary to minimize excessive accumulations of feces and soiled bedding.

Photographer:	Kevin Wilken	Legal Name:	41-B-0239
Photo Taken:	Wed, Jun 22, '16	DAN MOULTON	
Inspection:	181161057380243		
Description:	Enclosure in front room, south side; representative of enclosures with excessive feces and soiled material.

Photographer:	Kevin Wilken	Legal Name:	41-B-0239
Photo Taken:	Wed, Jun 22, '16	DAN MOULTON	
Inspection:	181161057380243		
Description:	Front room middle pen, excessive feces.

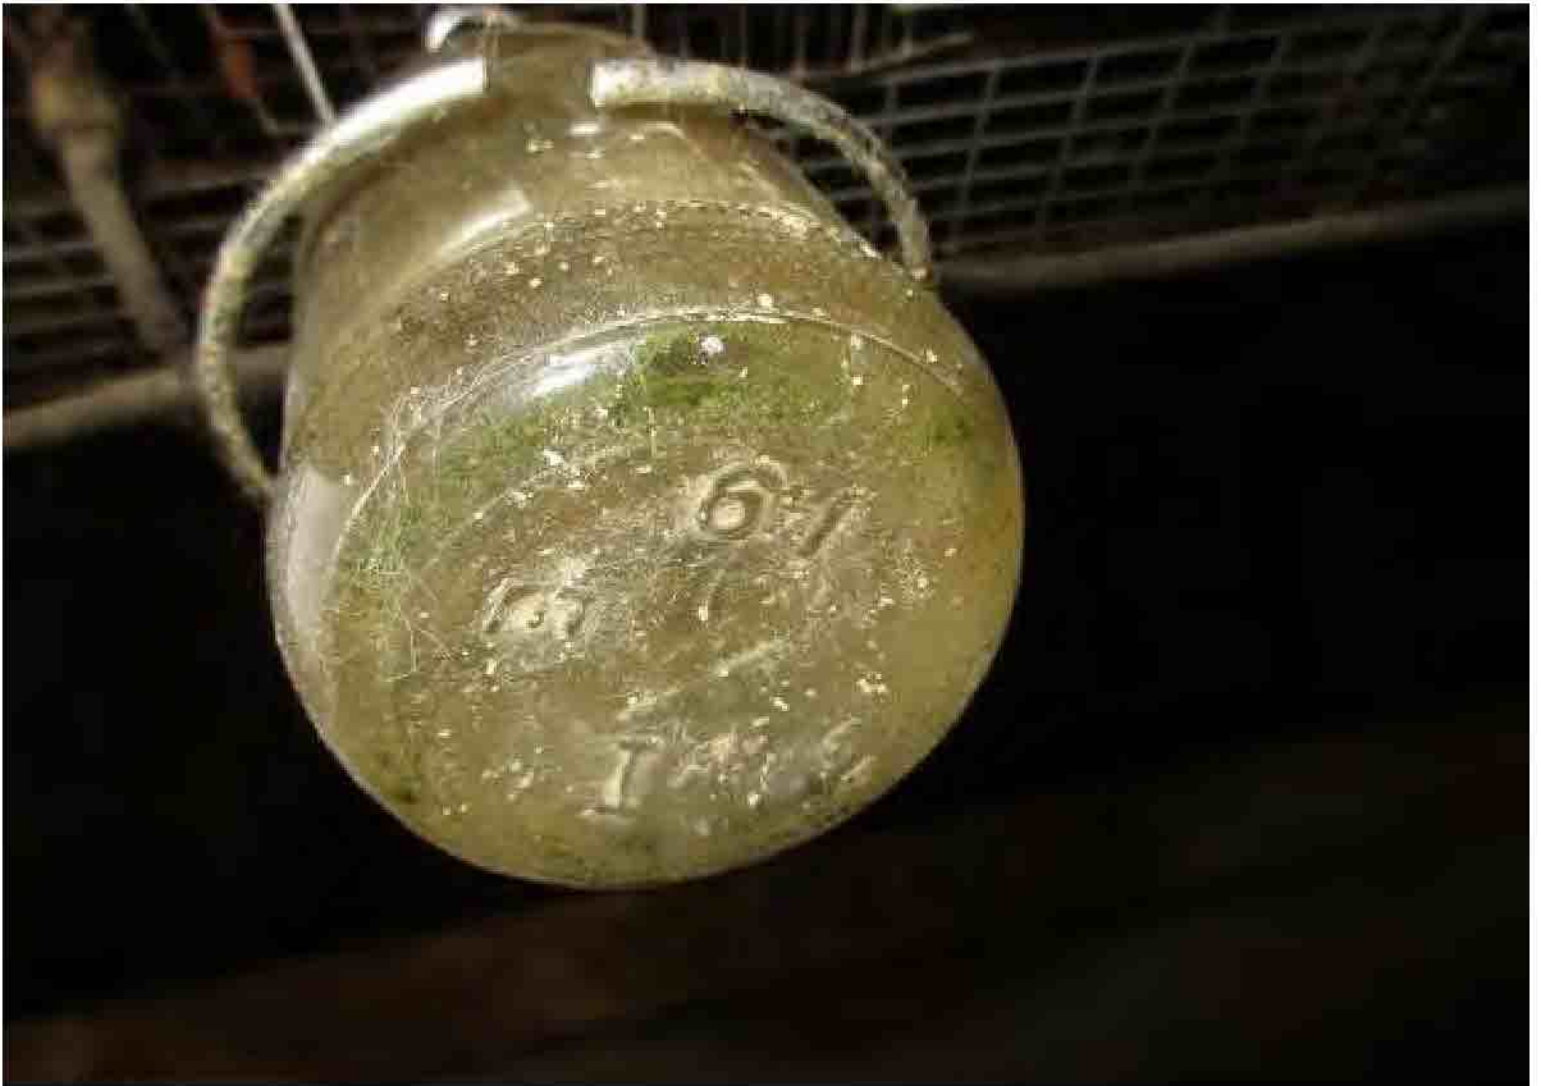
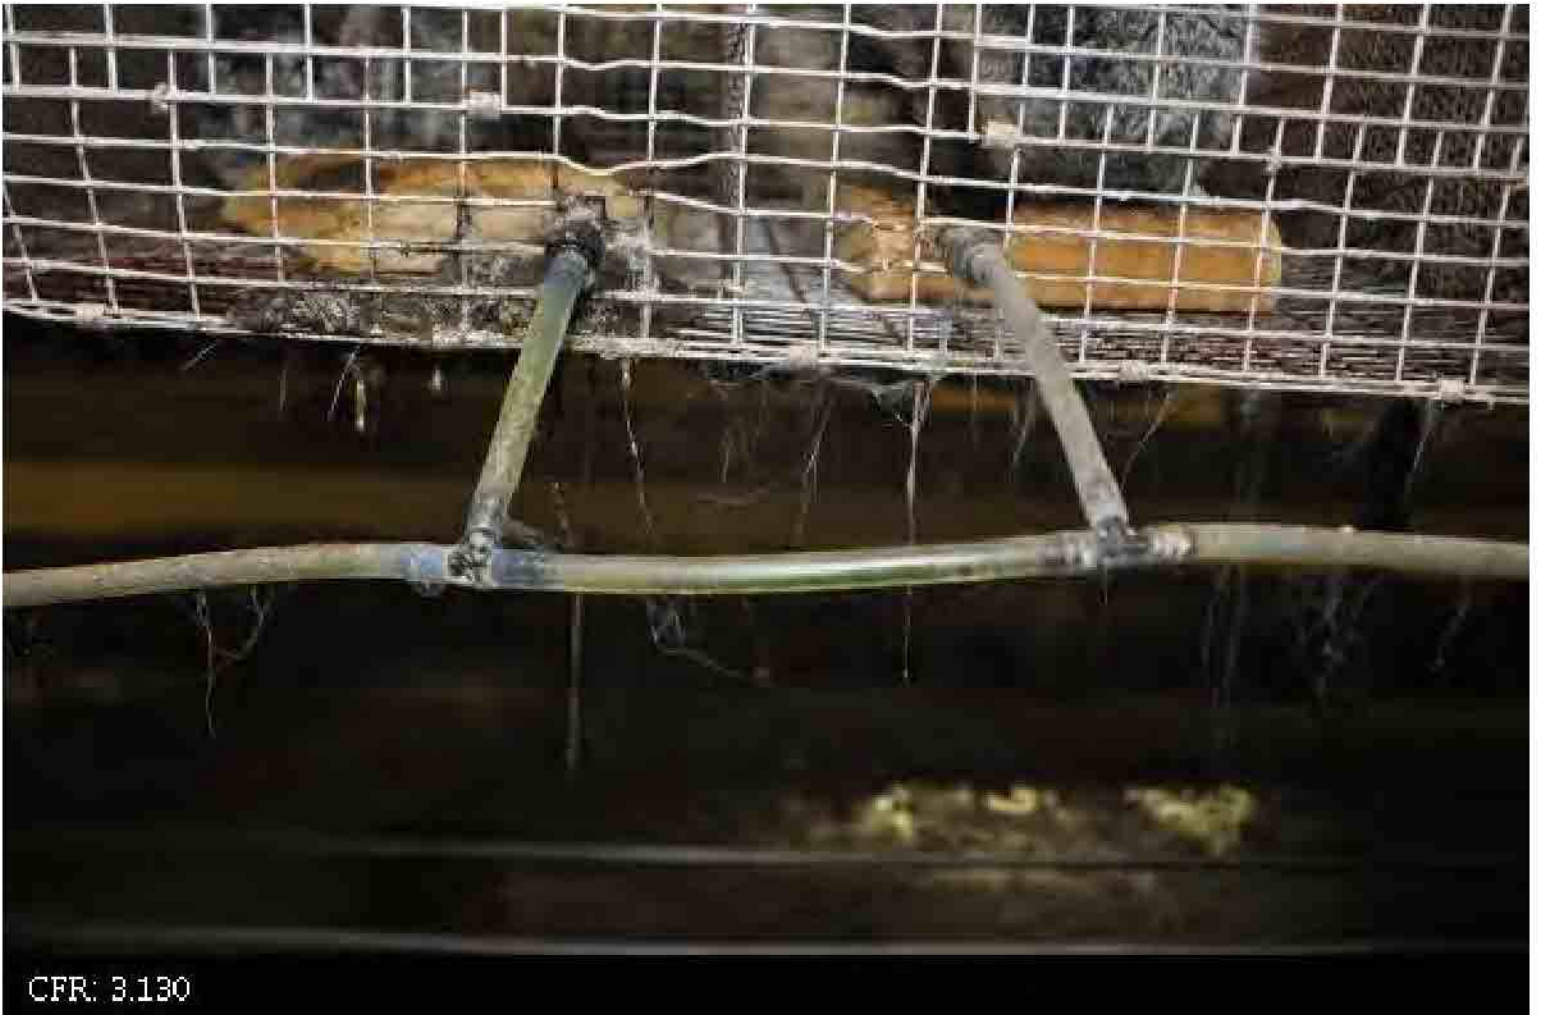
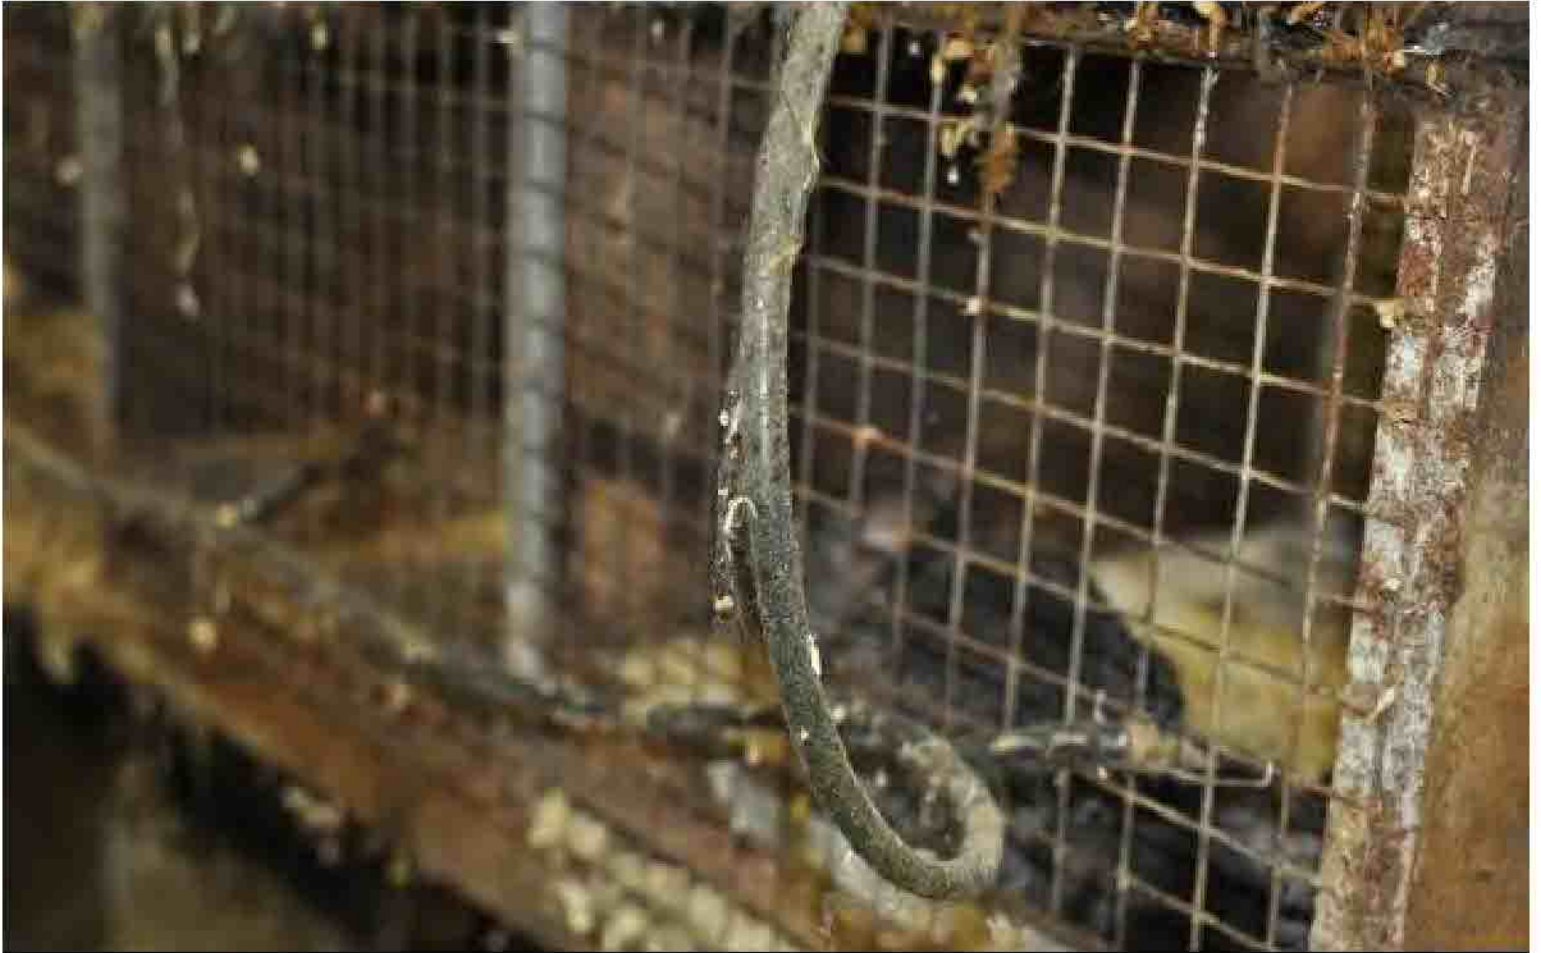
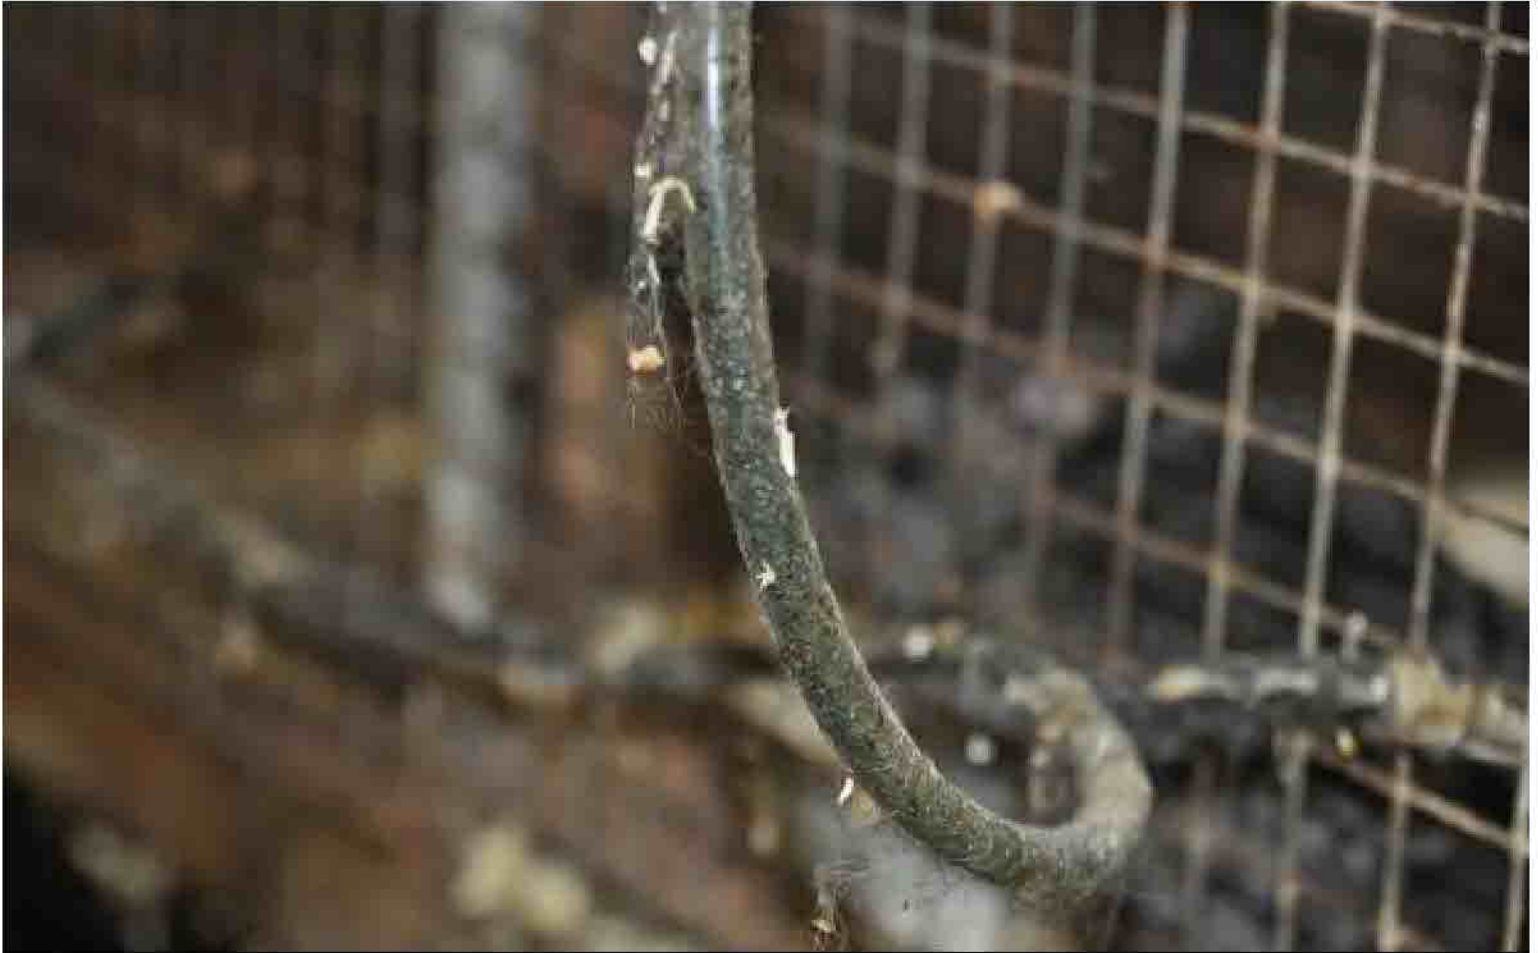
The water lines that provide water for the majority of the animals have sections where the tubing has a greenish appearance. The outside of the watering line continues to have some areas where an excessive buildup of hair and soiled material is present. At least one watering bottle had a greenish buildup inside of it. Unclean water receptacles may contaminate the water supply and cause many animals to get sick. To protect the health of the animals, clean and/or replace water lines, spouts, and bottles as often as necessary to assure a clean supply of water to the animals.

Photographer:	Kevin Wilken	Legal Name:	41-B-0239
Photo Taken:	Wed, Jun 22, '16	DAN MOULTON	
Inspection:	181161057380243		
Description:	Water bottle with greenish buildup inside.

Photographer:	Scott Welch	Legal Name:	41-B-0239
Photo Taken:	Wed, Jun 22, '16	DAN MOULTON	
Inspection:	181161057380243		
Description:	Water line facing north wall with greenish build-up inside.
