Inspection Report

Dan Moulton
Moultons Chinchilla Ranch
976 14th Avenue S W
Rochester, MN 55902

Customer ID: **2401**
Certificate: **41-B-0239**
Site: 001
DAN MOULTON

Type: ROUTINE INSPECTION
Date: Jun-22-2016

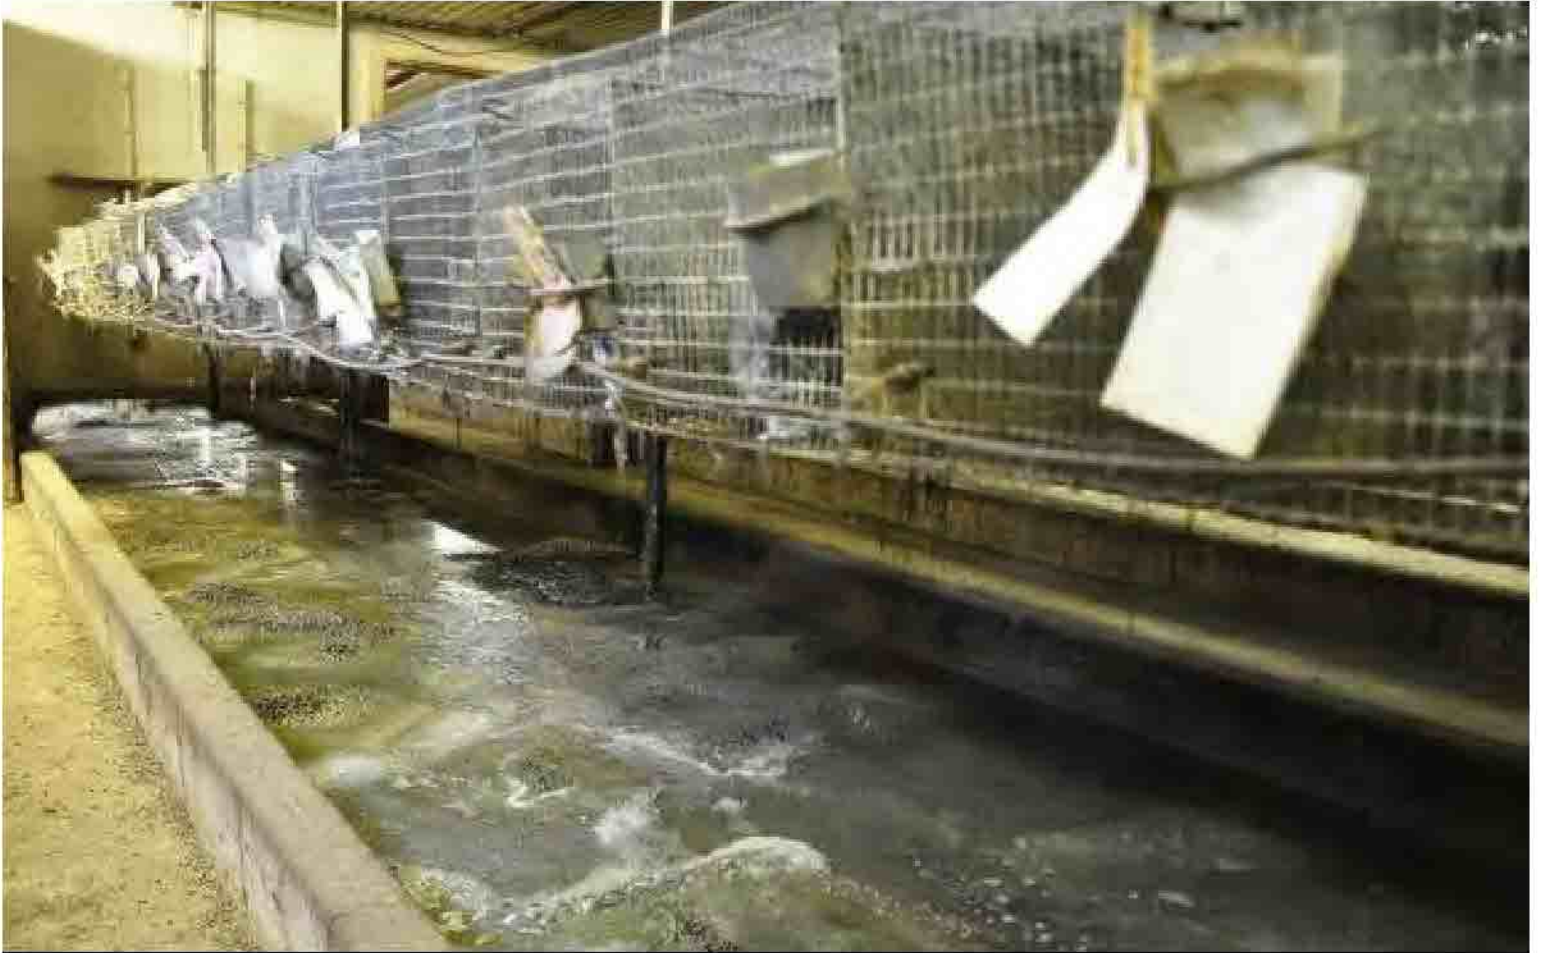
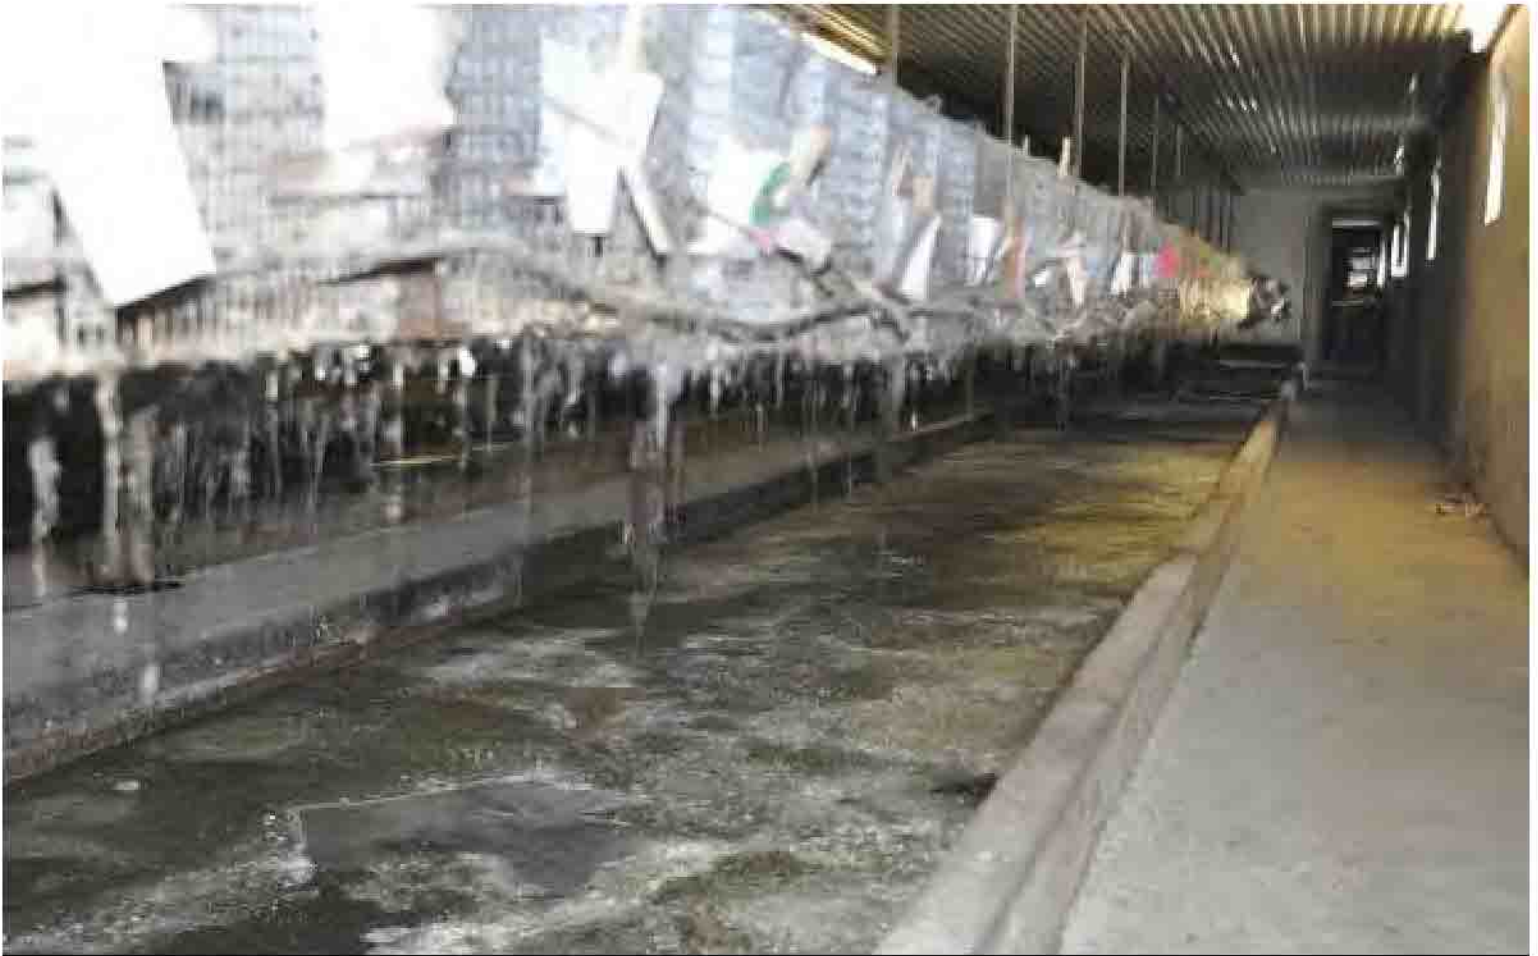
The facility's equipment to eliminate the excreta, waste, and used bedding from the gutter was not working properly at the time of inspection. There was a large buildup of excreta, waste, used bedding and water under the enclosures of animals located over the south gutter of the facility. This buildup of material created a strong ammonia smell and foul odor within the facility and a large number of small black flies were present in the middle room of the facility. This buildup of material and foul odors can cause sickness in animals and attract pests such as flies. Eliminate the excessive buildup of excreta, waste, used bedding and excess soiled water from the facility as often as necessary to minimize vermin infestation, odors, and disease hazards.

Photographer:	Scott Welch	Legal Name:	41-B-0239
Photo Taken:	Wed, Jun 22, '16	DAN MOULTON	
Inspection:	181161057380243		
Description:	Build up of soiled material in south gutter of facility; picture taken in middle room looking northwest.

Photographer:	Scott Welch	Legal Name:	41-B-0239
Photo Taken:	Wed, Jun 22, '16	DAN MOULTON	
Inspection:	181161057380243		
Description:	Build up of soiled material in south gutter of facility; picture taken in middle room looking east.

Note: The licensee reports having contacted the repairman prior to inspection and contacted the repairman during the inspection and scheduled repairs for Sunday 6/26/2016. The licensee must ensure that it is fixed by then. If the equipment breaks down again, additional methods must be used to remove soiled material from the building to protect the animals from excessive odors and disease hazards.

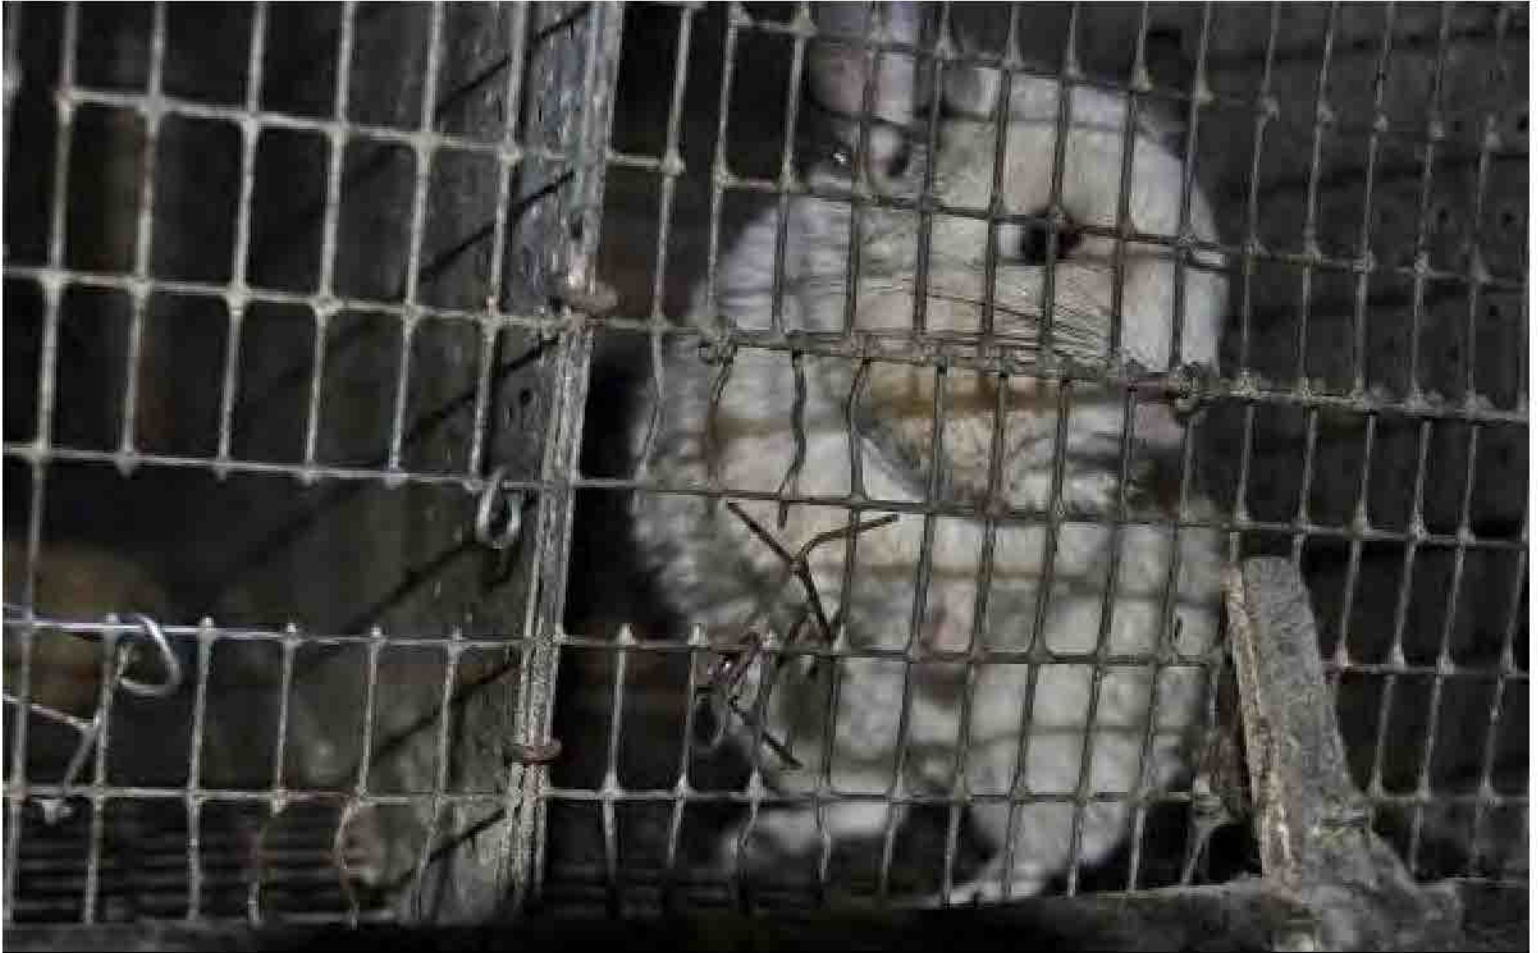
Two enclosures had wire points that the animals could contact. Two chinchillas were affected. Sharp metal points inside the enclosure can result in animal injuries. The facility must be maintained in good repair to contain and protect animals from injury.

Photographer:	Scott Welch	Legal Name:	41-B-0239
Photo Taken:	Wed, Jun 22, '16	DAN MOULTON	
Inspection:	181161057380243		
Description:	Piece of broken panel with sharp wire points; similar piece is present in enclosure to left white chinchilla and noted in bottom left of photo.

Note: The licensee corrected the sharp metal points during the inspection.

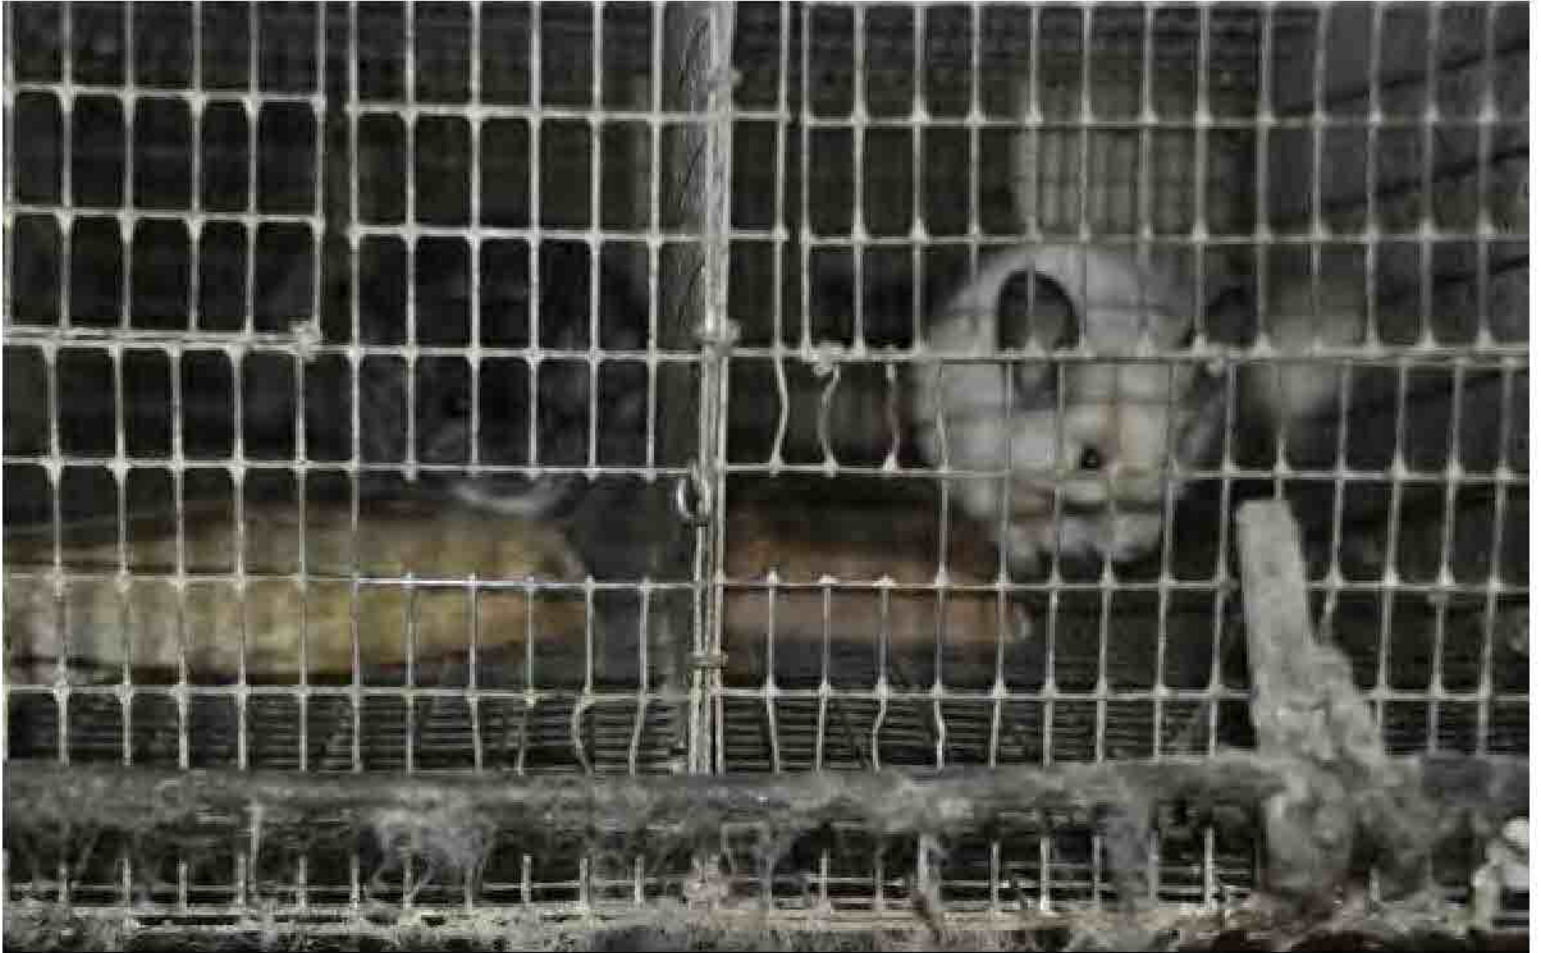
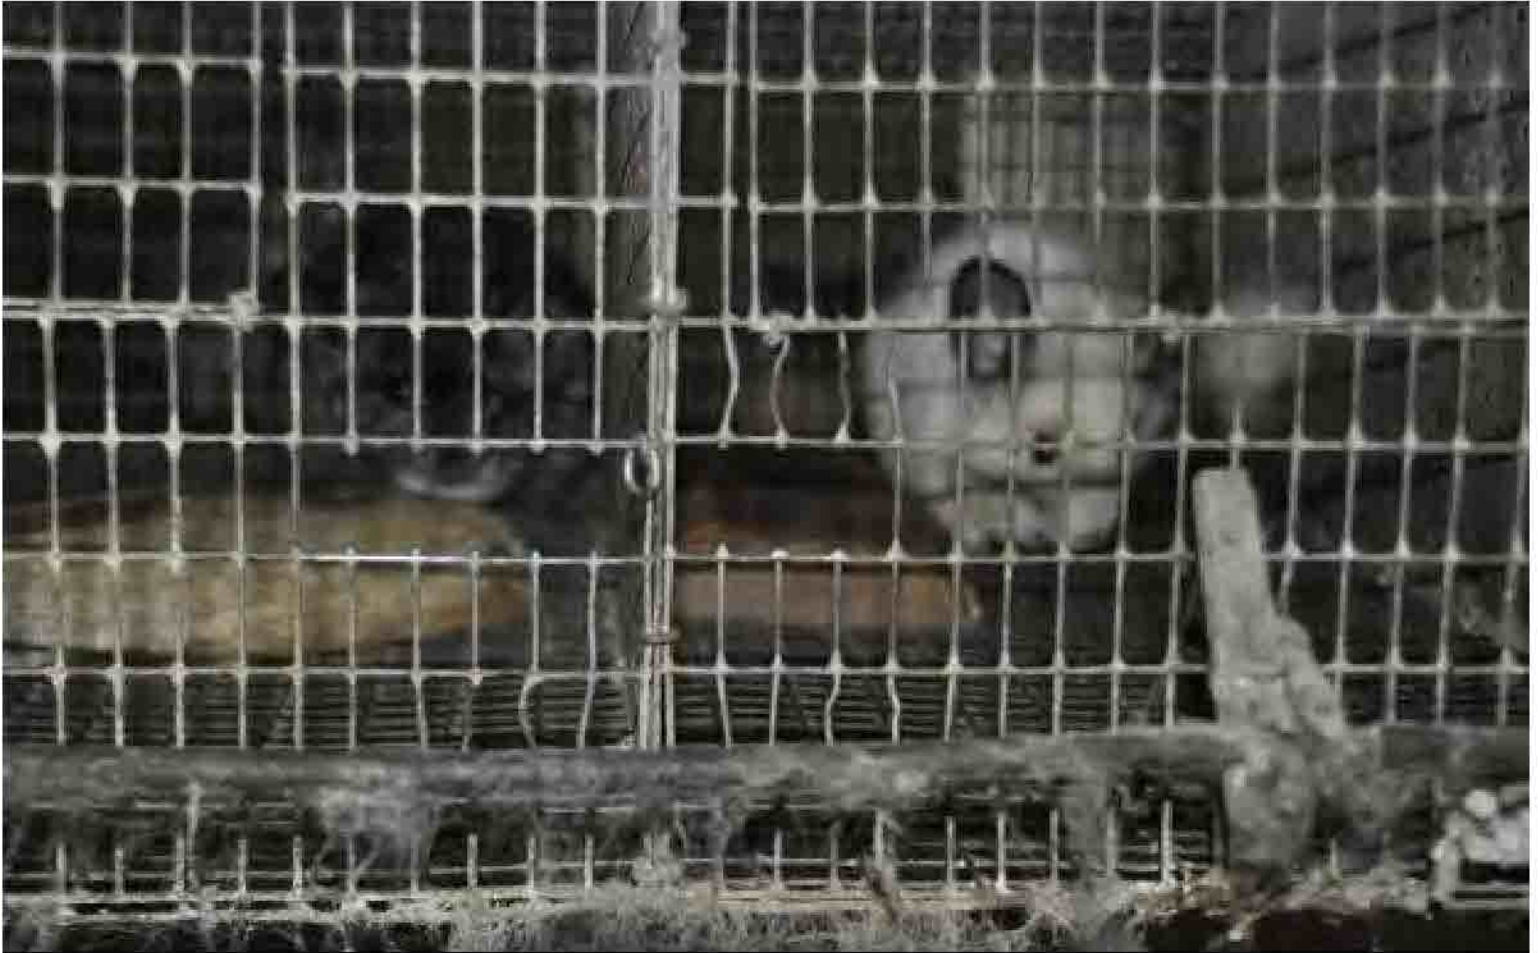
Photographer:	Scott Welch	Legal Name:	41-B-0239
Photo Taken:	Wed, Jun 22, '16	DAN MOULTON	
Inspection:	181161057380243		
Description:	Wire points removed from two affected cages; however, note soiled water-line with hair and soiled material on it.

Photographer:	Scott Welch	Legal Name:	41-B-0239
Photo Taken:	Wed, Jun 22, '16	DAN MOULTON	
Inspection:	181161057380243		
Description:	Wire points removed from two affected cages; however, note soiled water-line with hair and soiled material on it (towards bottom of photo).

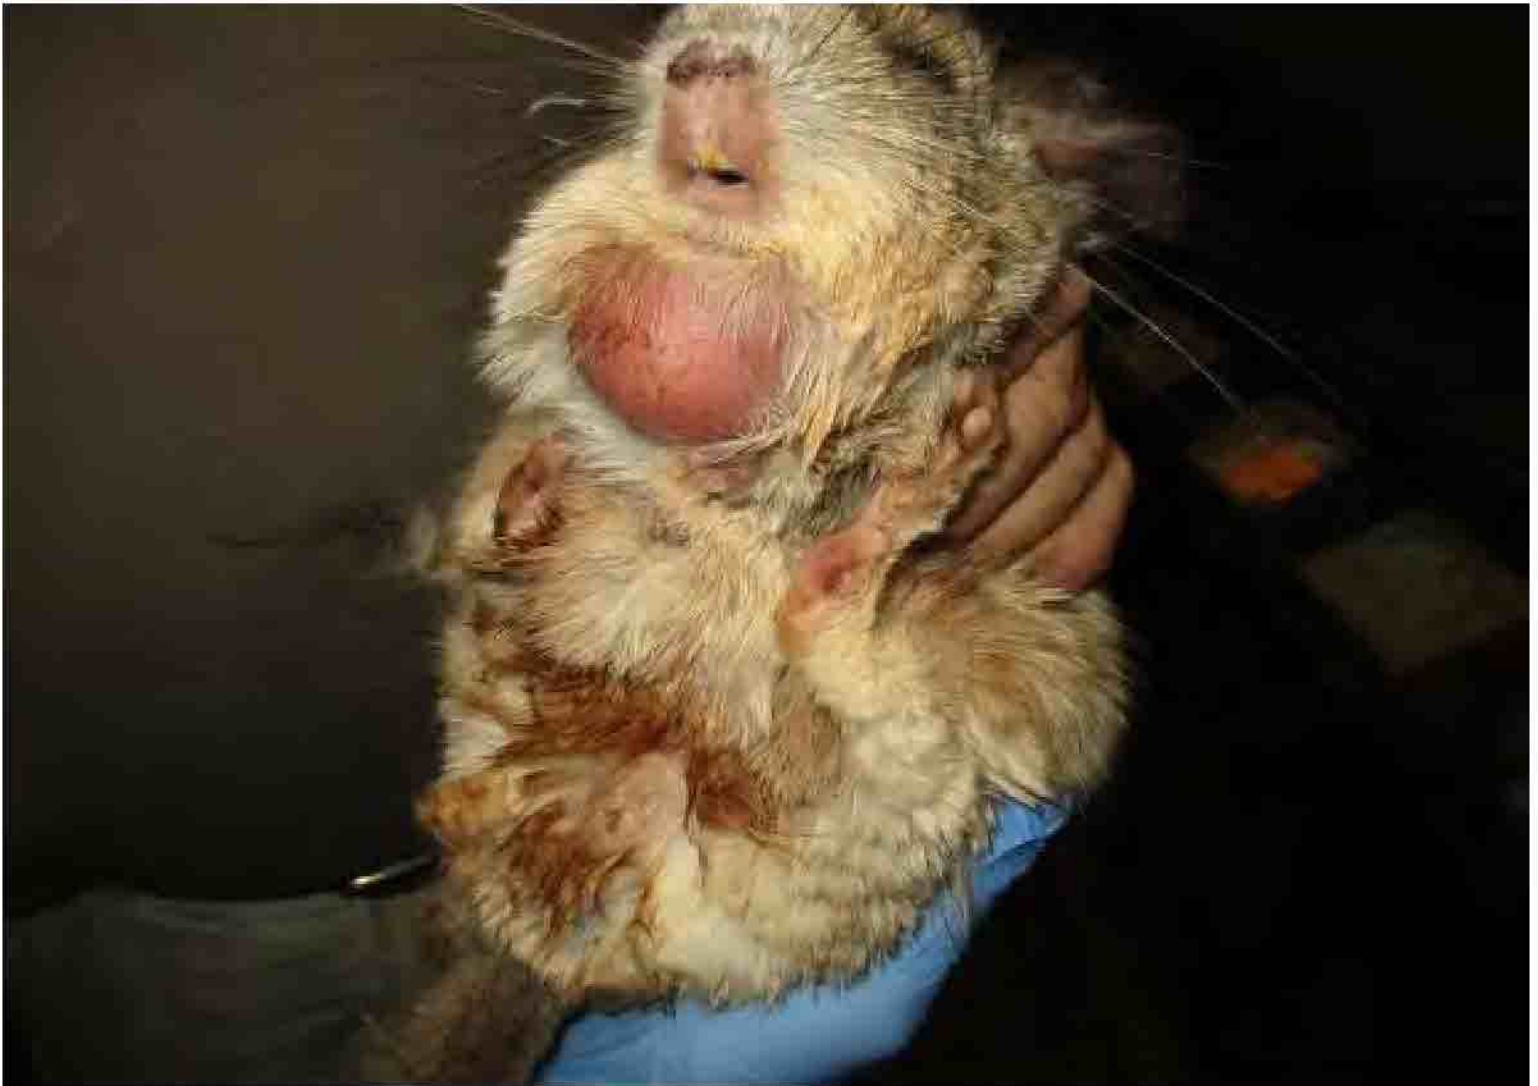
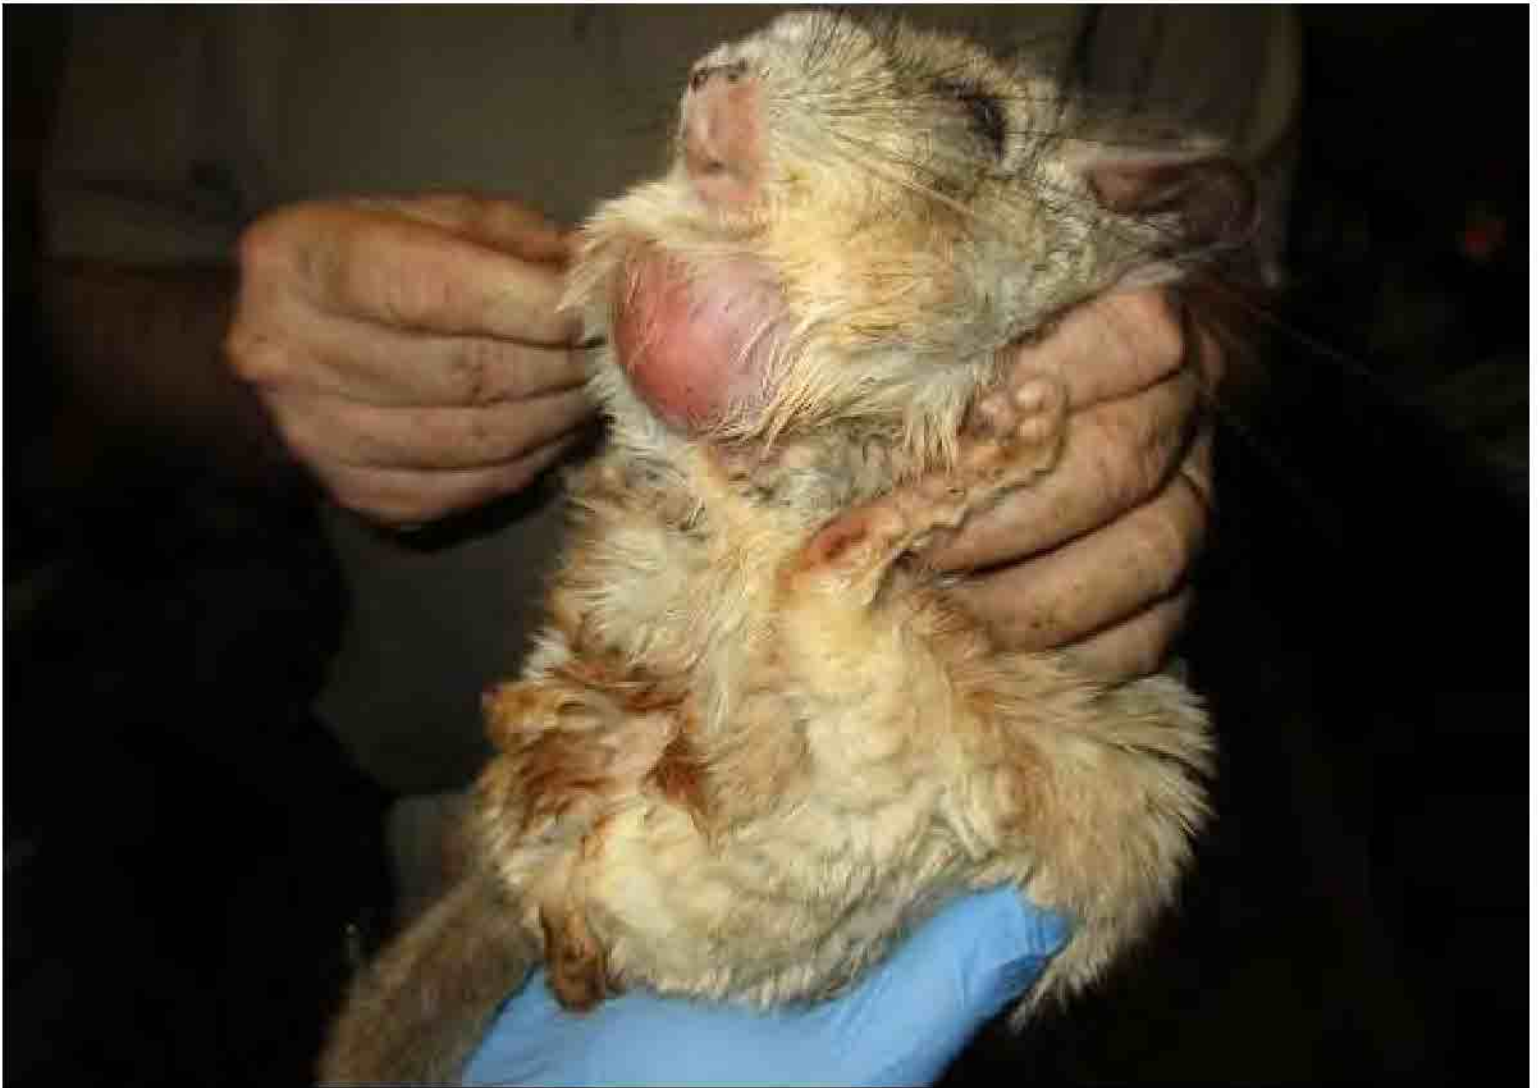
- Male cream with ear tag GROS 375; had a large, hairless swelling under its chin that was firm and had reddened skin indicating inflammation. The chinchilla would vocalize each time the swelling was lightly touched indicating the swelling was painful.

Photographer:	Kevin Wilken	Legal Name:	41-B-0239
Photo Taken:	Wed, Jun 22, '16	DAN MOULTON	
Inspection:	181161057380243		
Description:	Male cream eartag GROS 375; large reddened hairless swelling under chin.

**Untreated medical problems can cause ongoing pain in affected animals and can be contagious to other animals in the building. The veterinarian must be contacted to properly diagnose and treat each animal's health problem and the facility must follow the recommended treatment. Documentation of the diagnosis and treatment plan for animals must be available for APHIS officials for future inspections.
