Inspection Report

Customer ID: **2401**
Certificate: **41-B-0239**
Site: 001
DAN MOULTON

Type: ROUTINE INSPECTION
Date: 25-FEB-2020

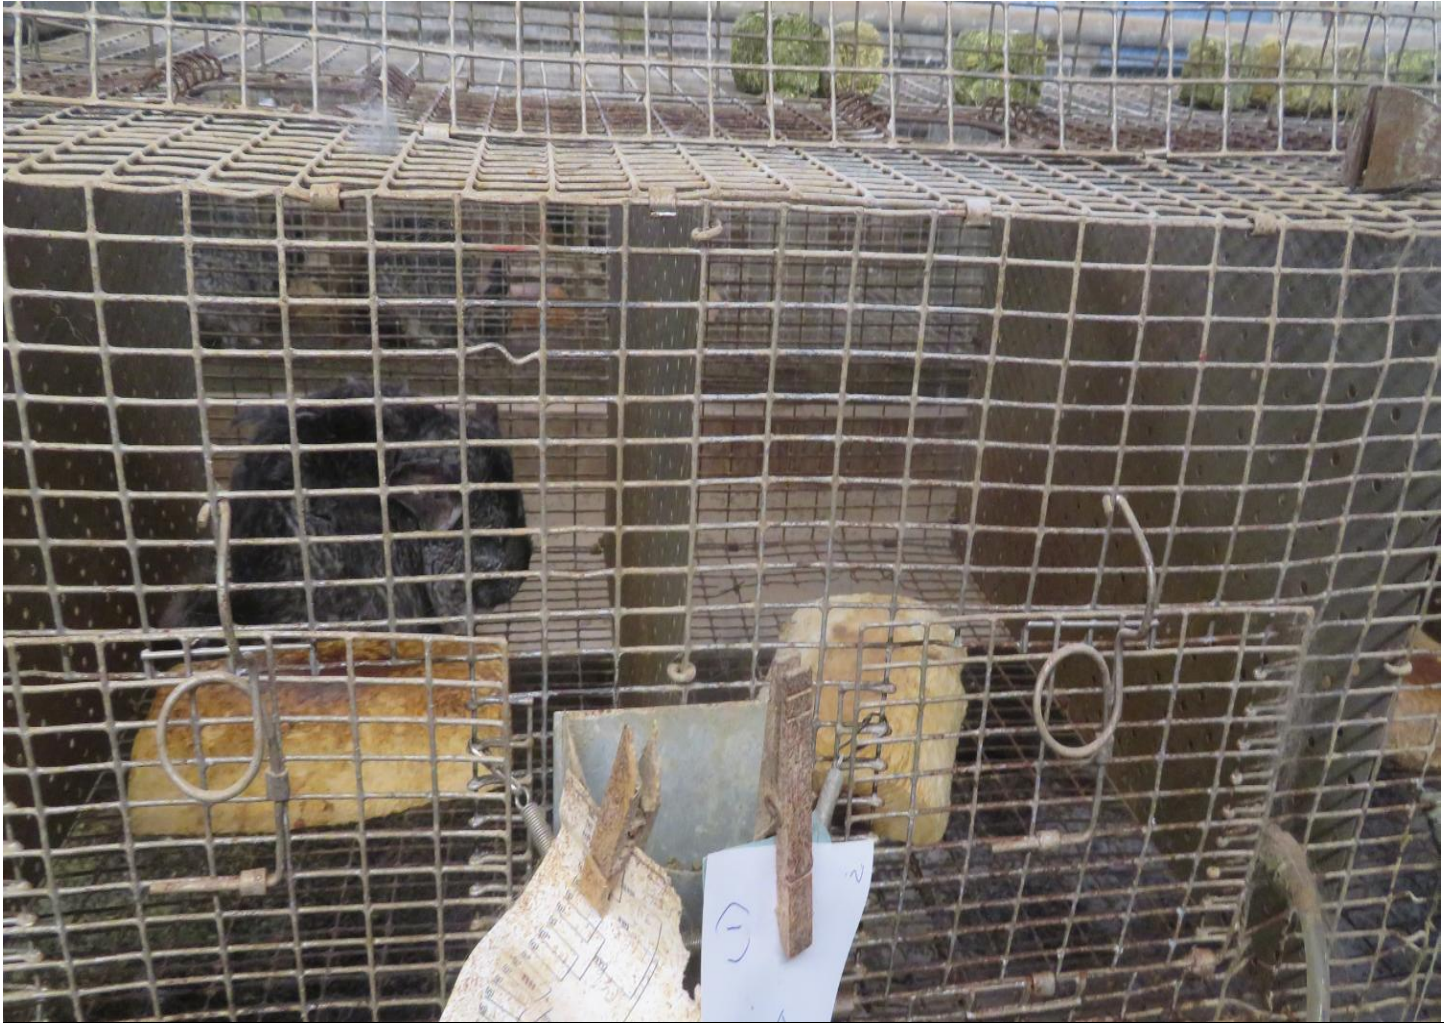
Enclosure 4B with hole in floor behind block of wood (right side of picture); licensee had moved chinchilla to new enclosure when hole was pointed out.

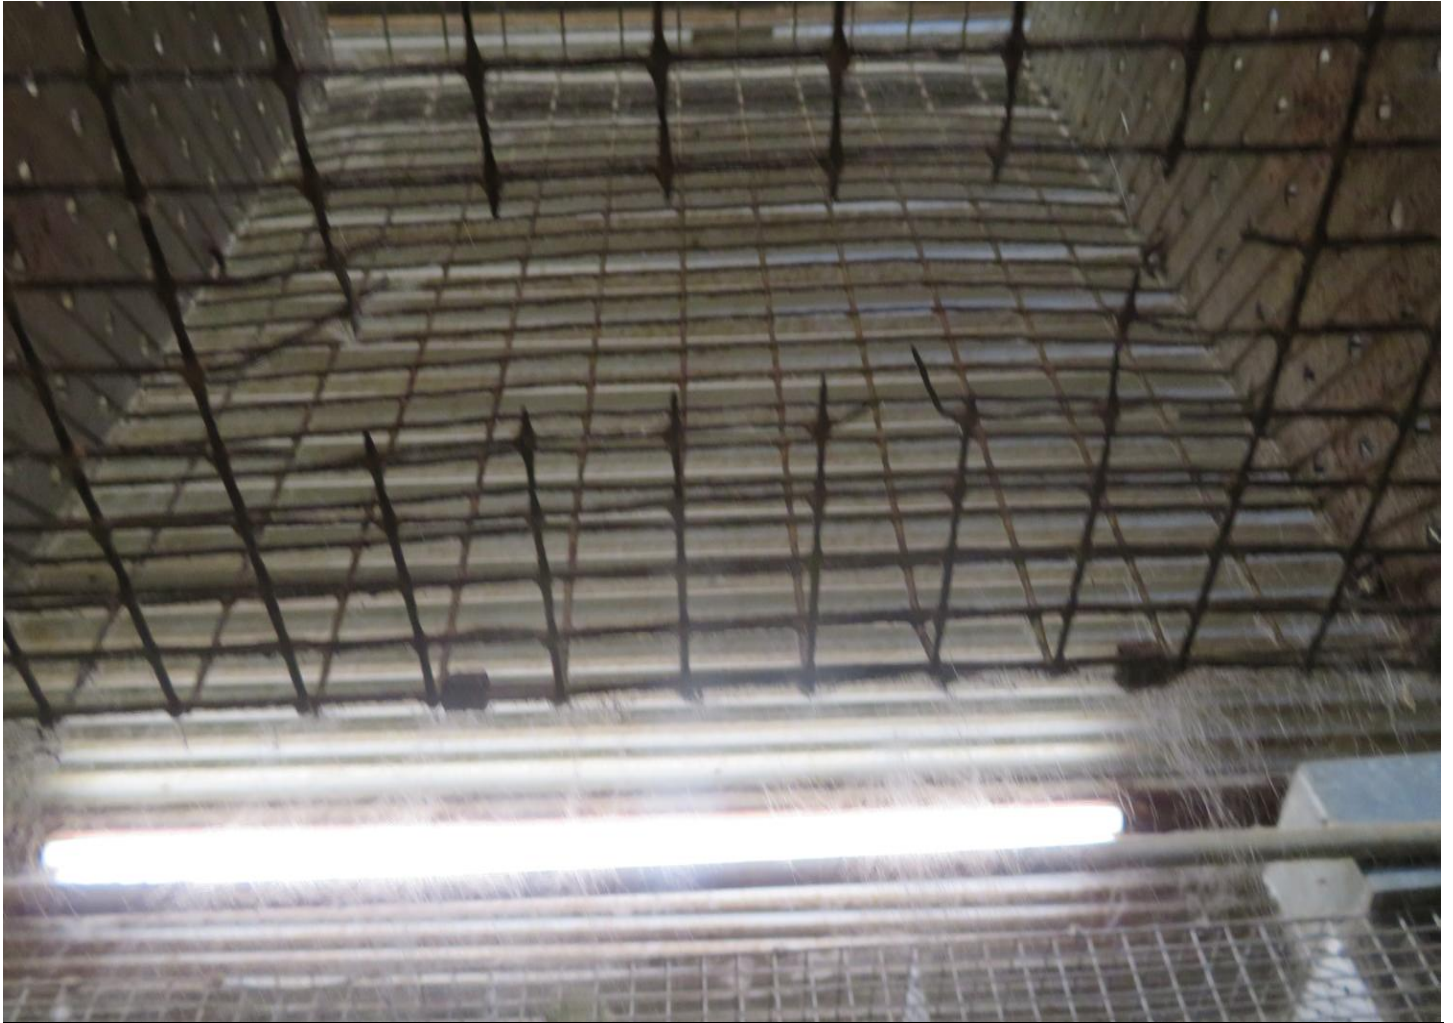
Enclosure 4B; looking up through hole in floor.

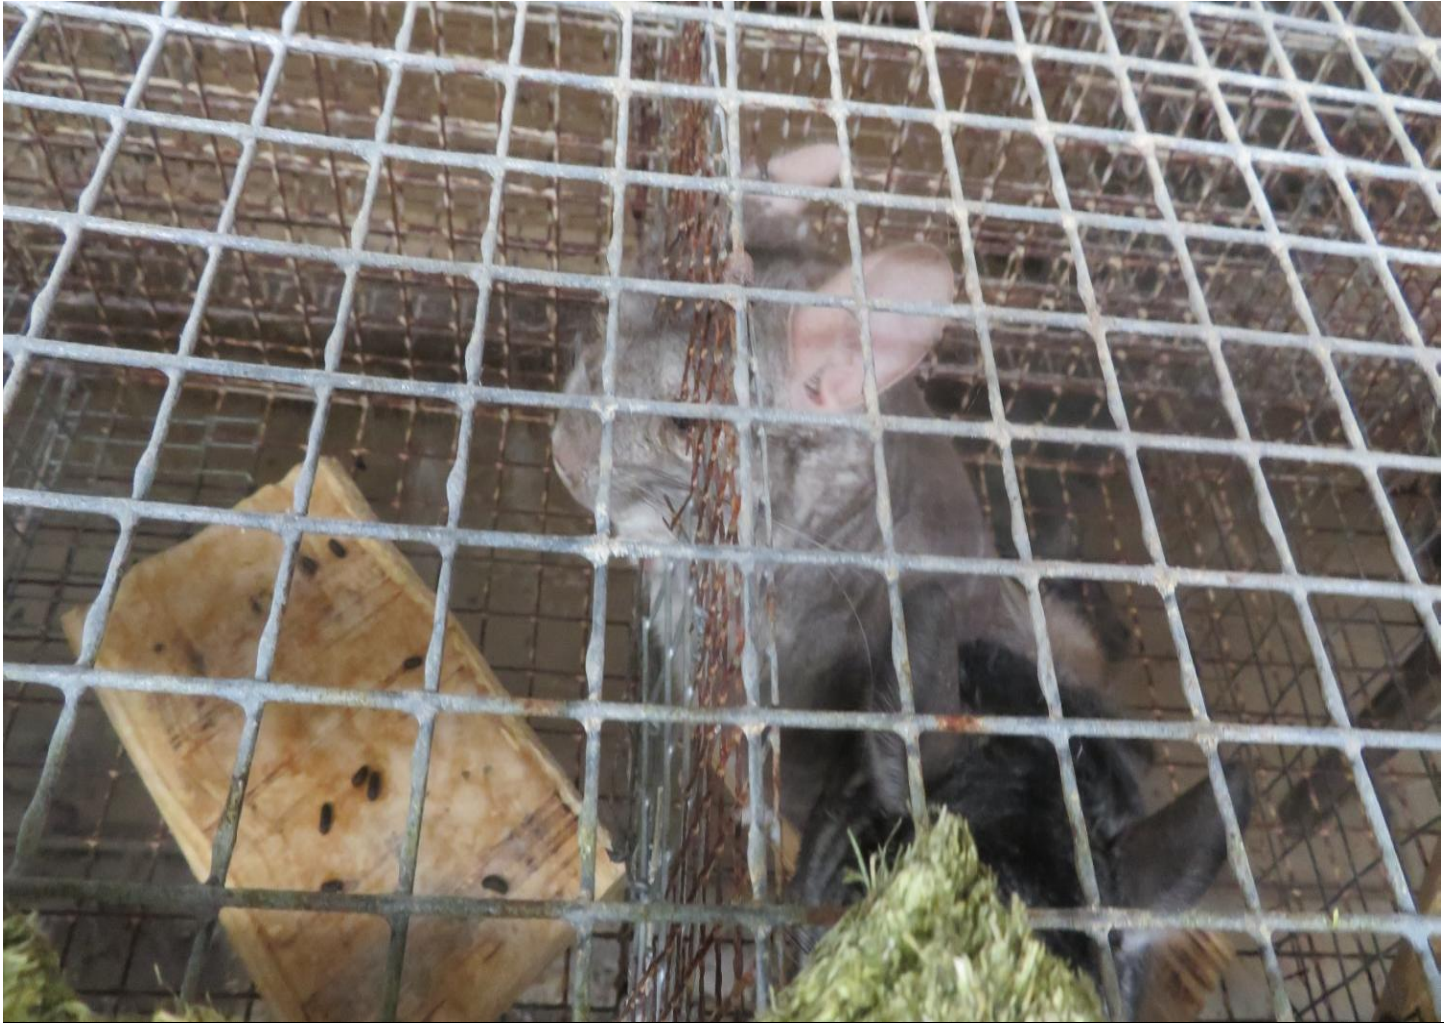
Middle room enclosure with hole in divider towards back of enclosure; chinchilla's nose is through hole.

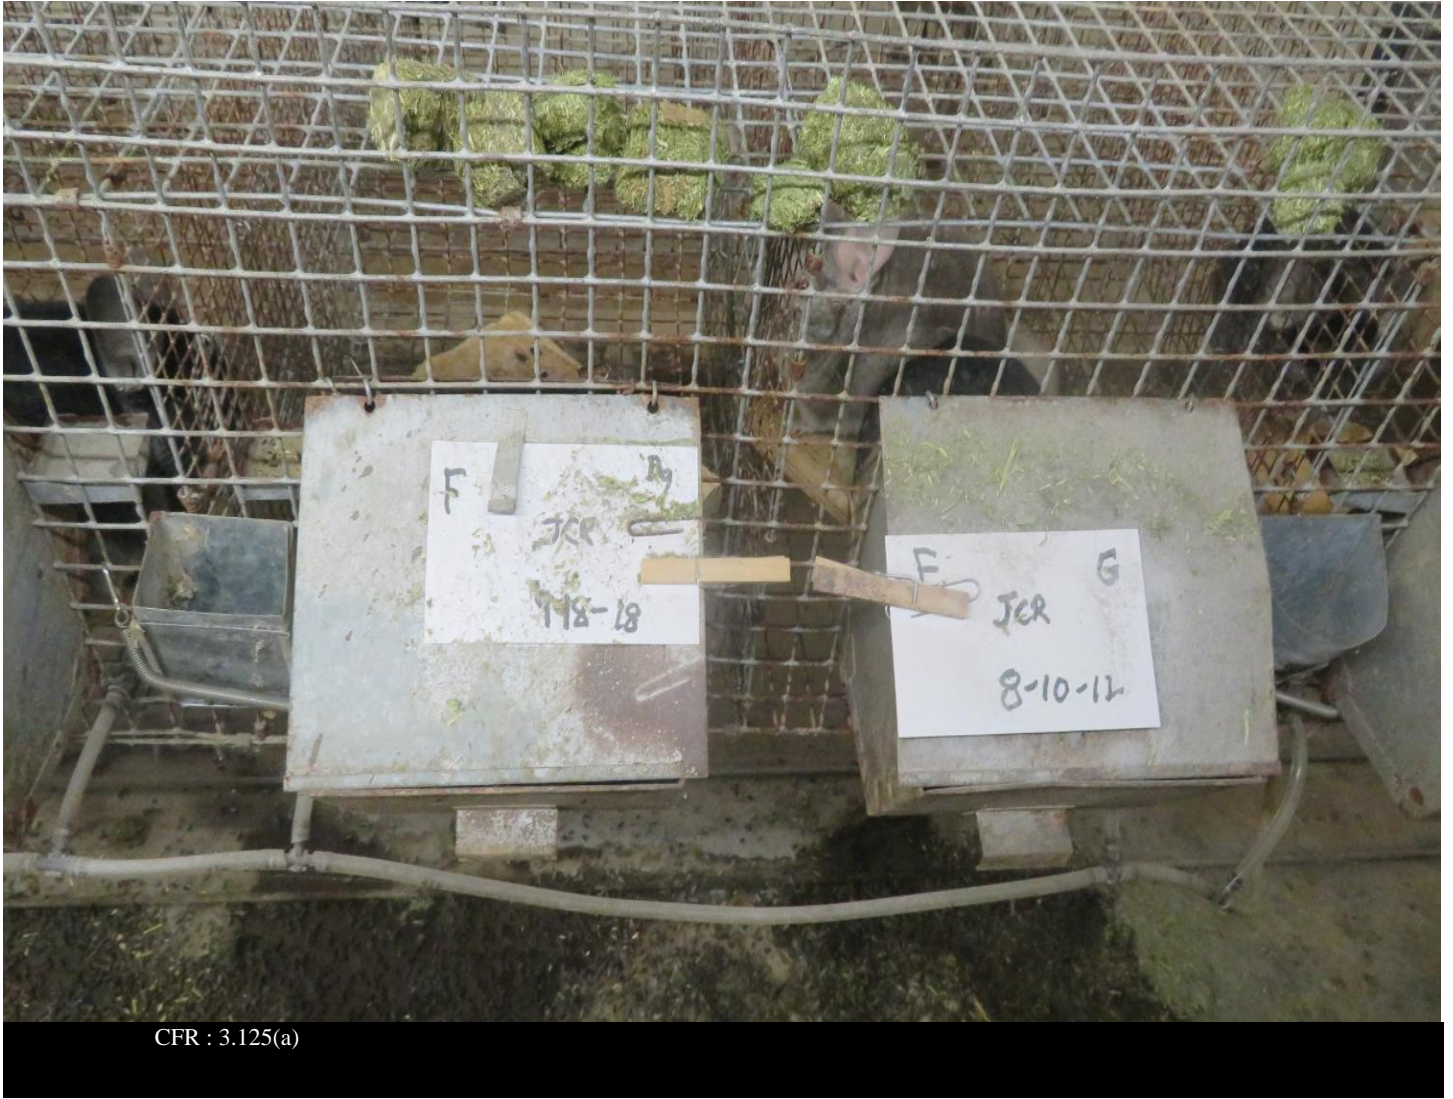
Enclosure in middle room with a hole in the divider towards back of enclosure;
photo for location purposes. Chinchillas were seen passing back and forth through
the hole.

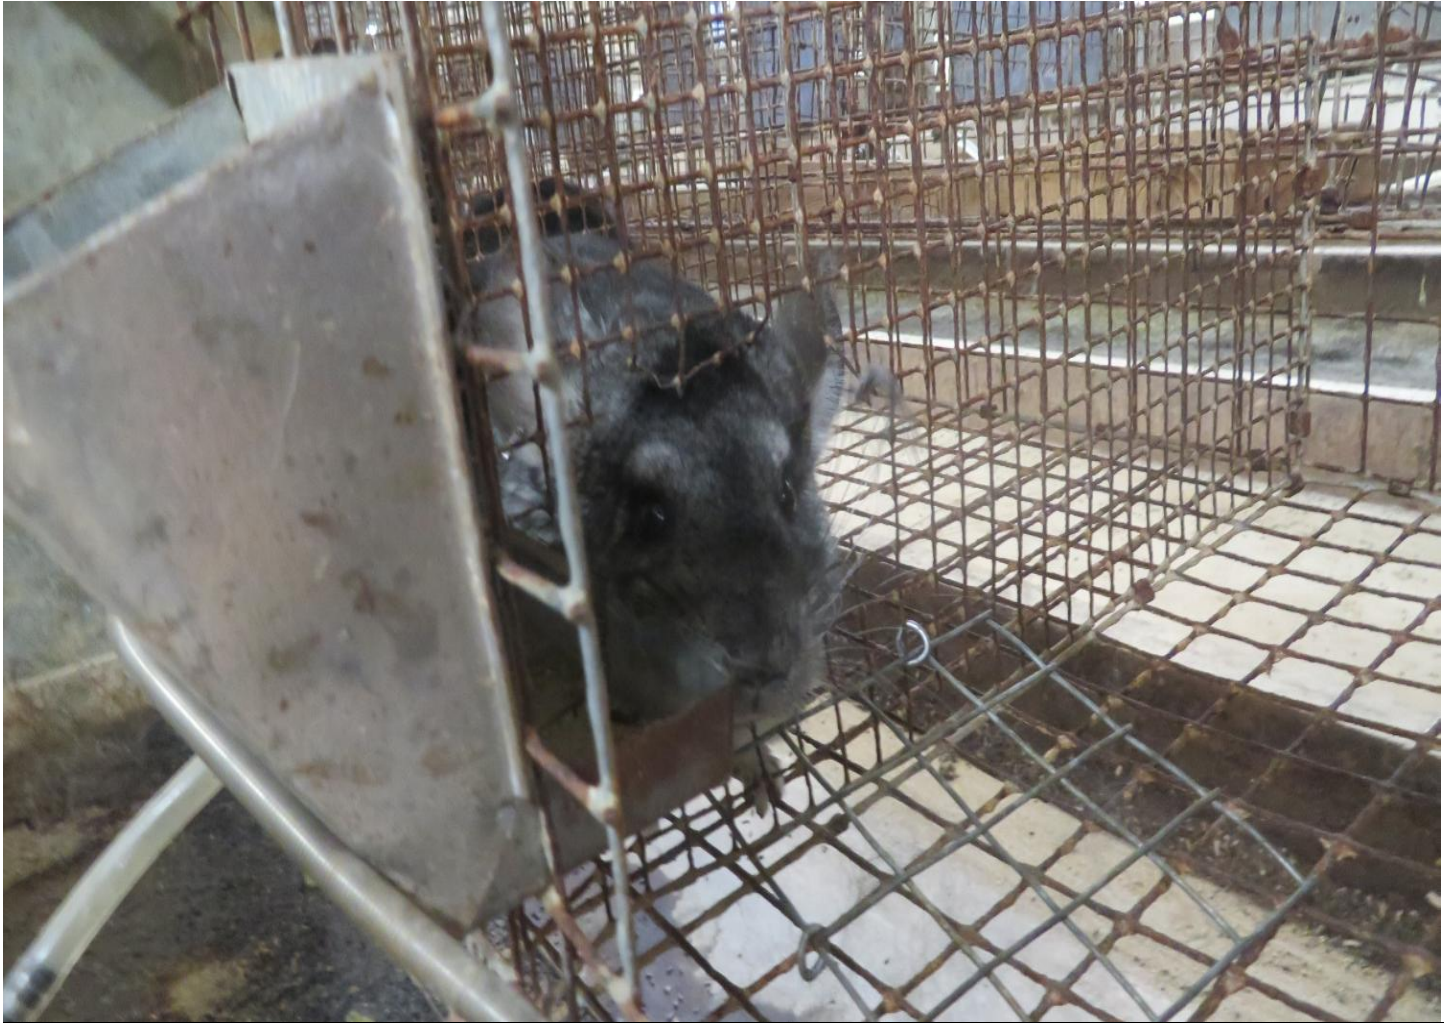
Second enclosure in middle room with a hole in divider between two enclosures close to front of enclosure.

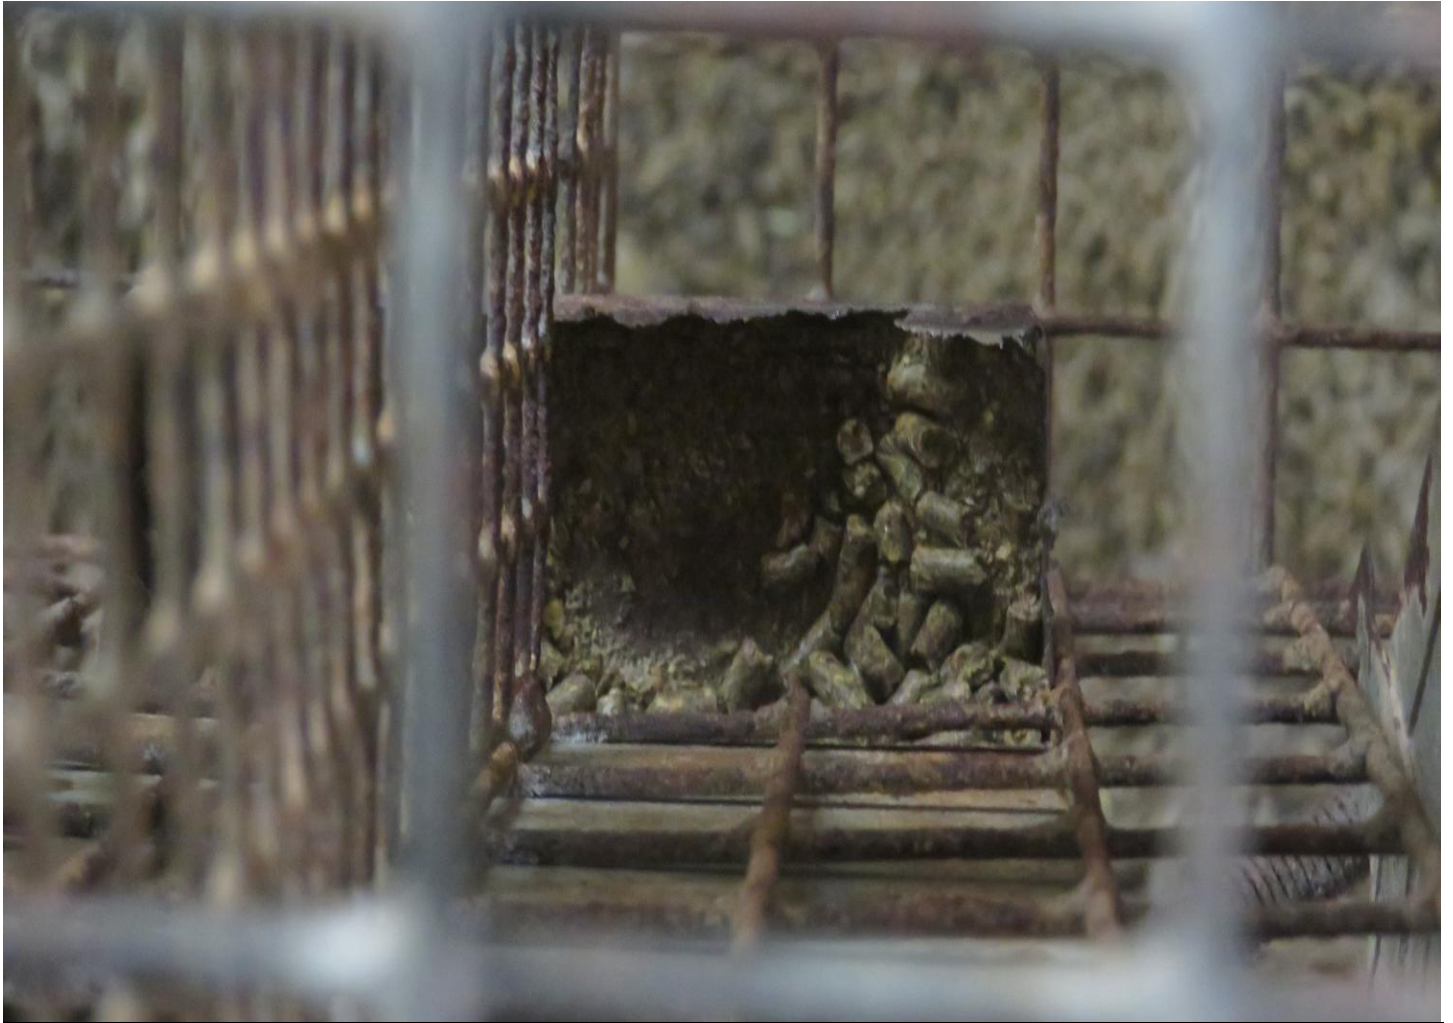
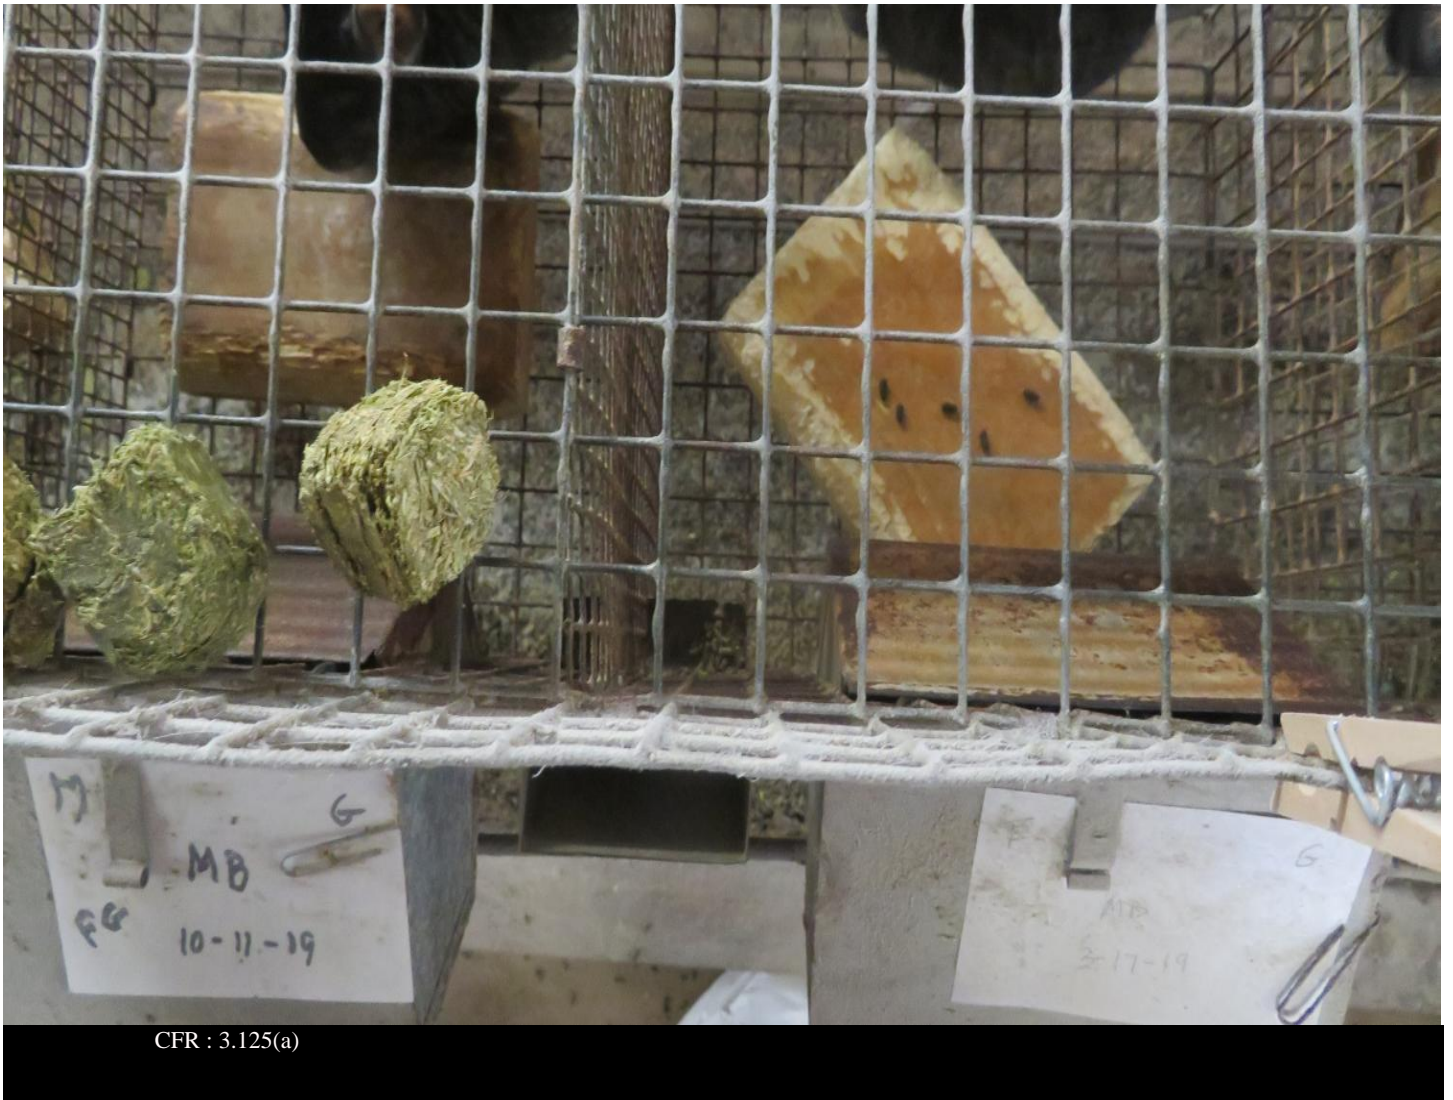
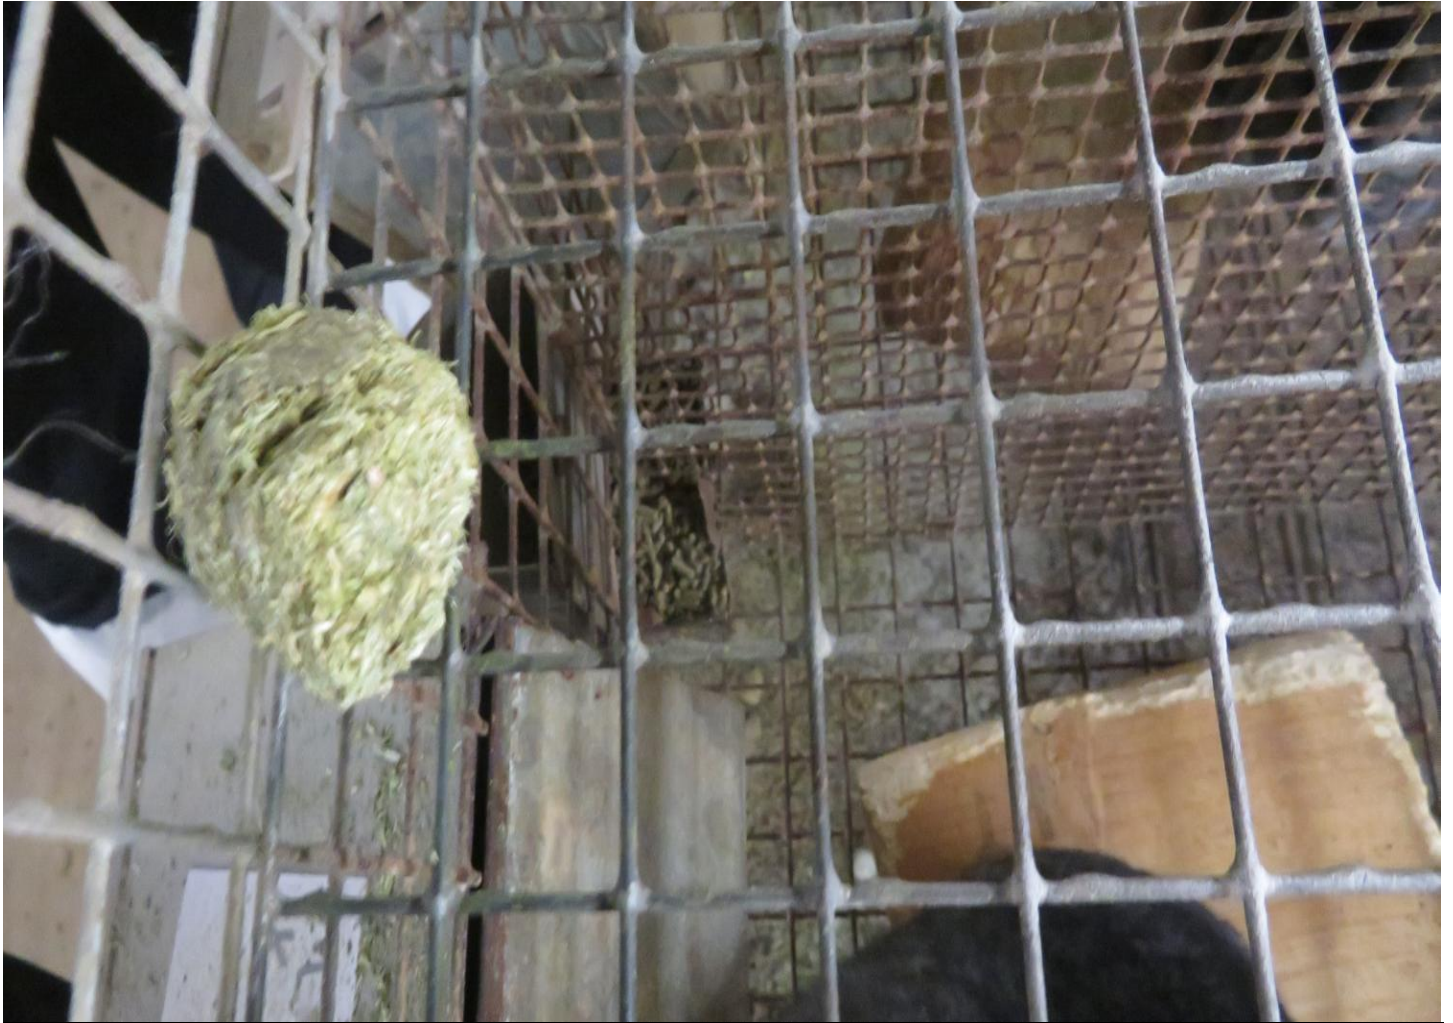
Feeder with rusted edges that were rough and sharp; representative of the feeders we pointed out during inspection that need repaired or replaced.

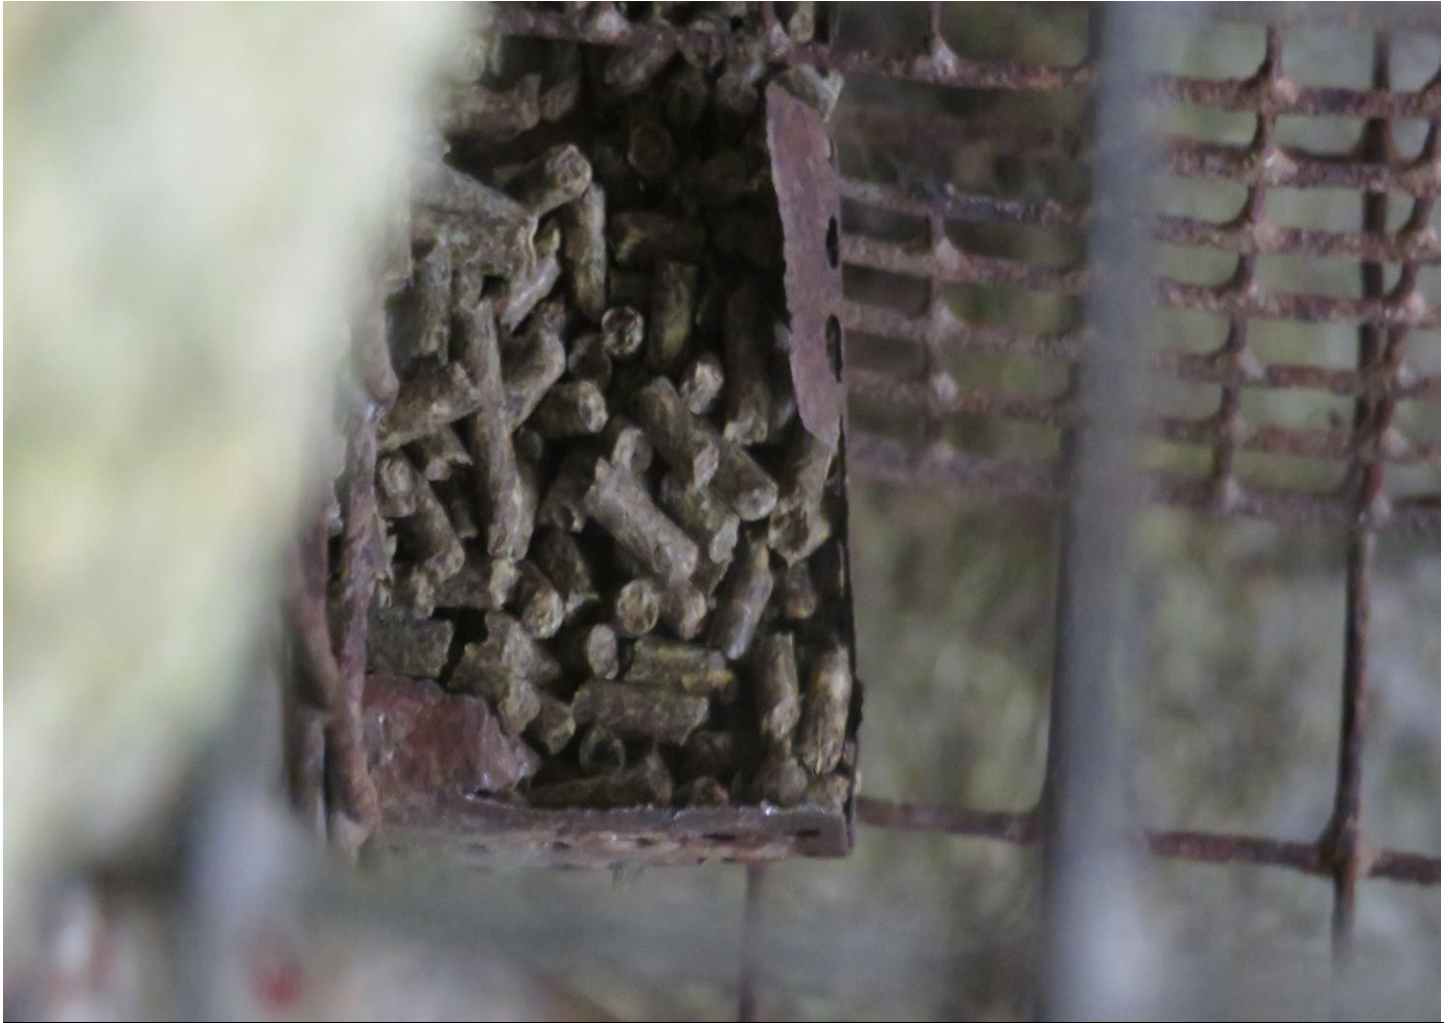
Close-up of feeder with rusted edges that were rough and sharp; representative of the feeders we pointed out during inspection that need repaired or replaced.

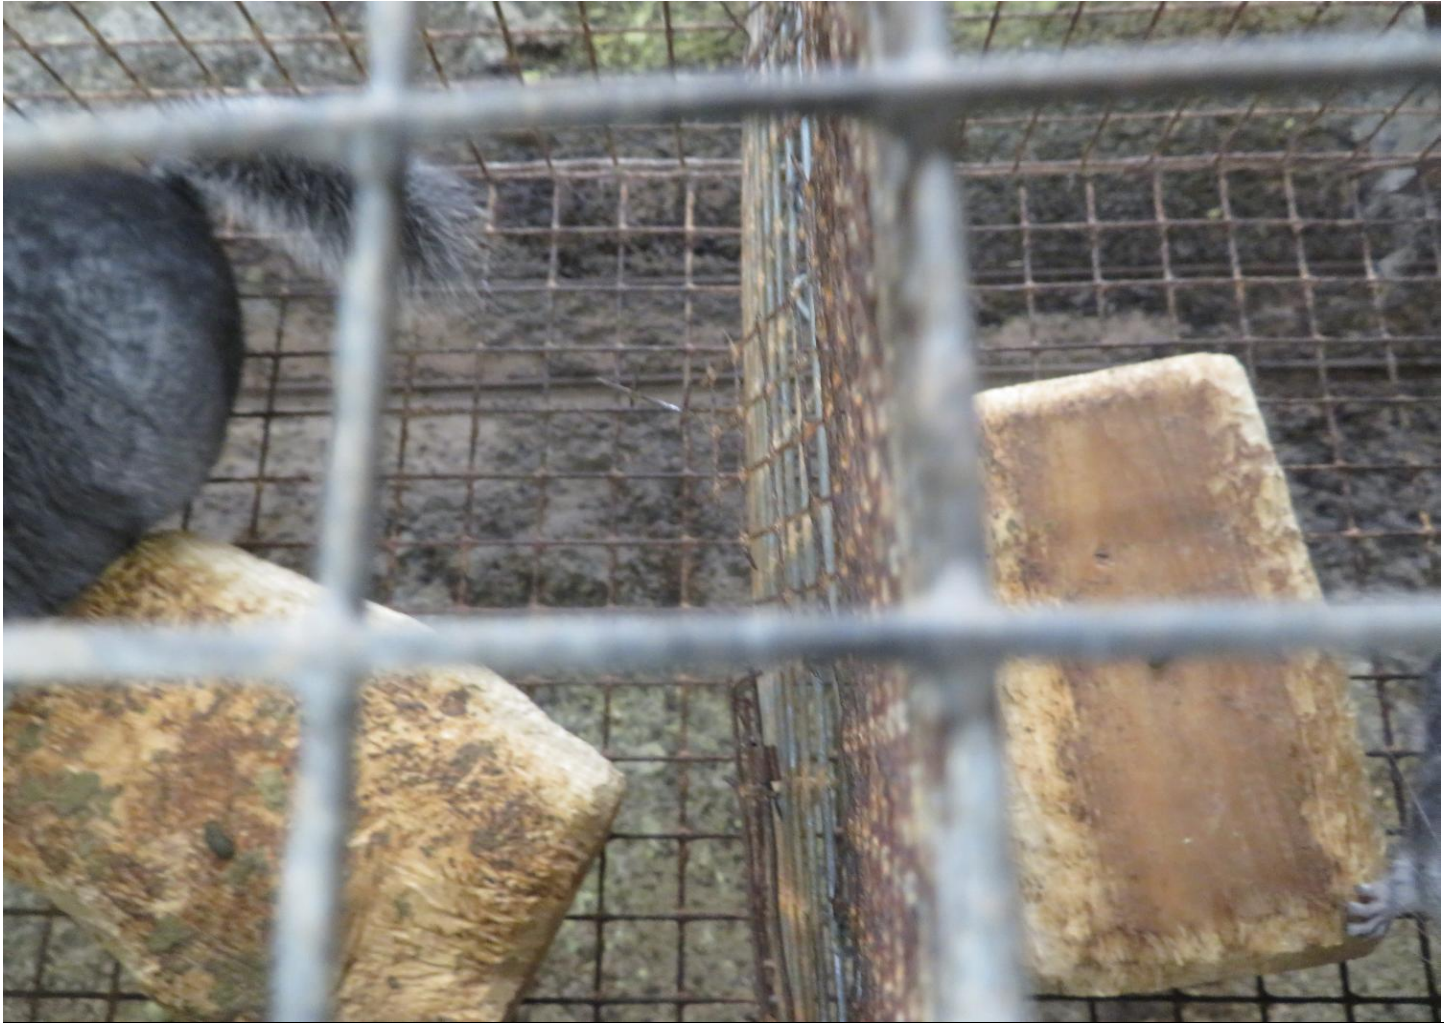
Enclosure divider with a loose wire point.

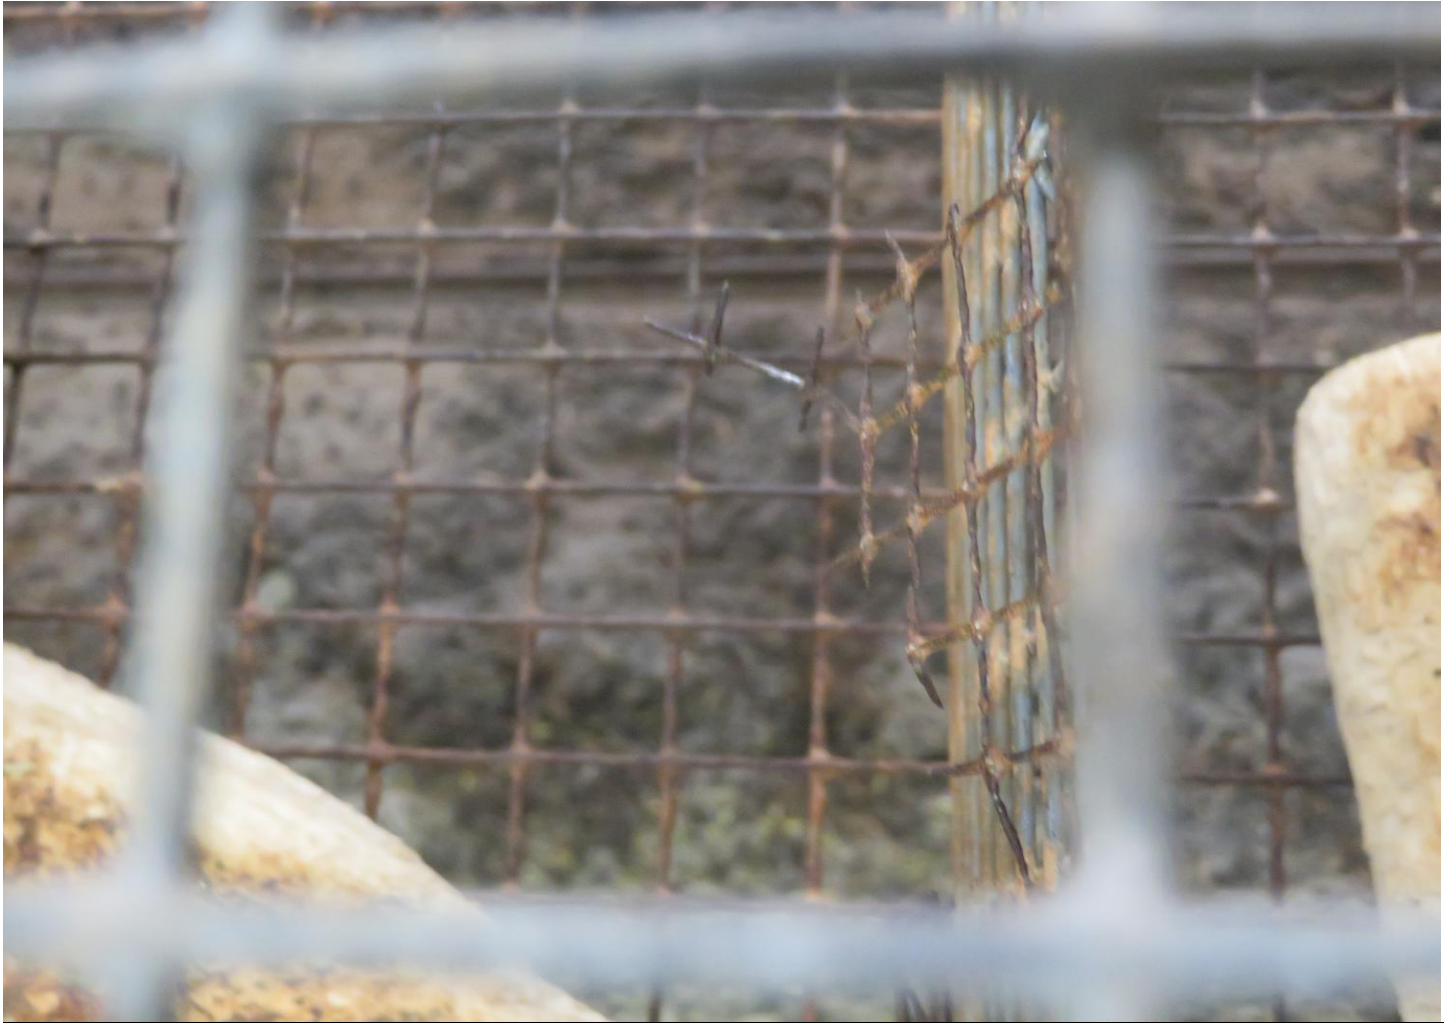
Close-up of enclosure divider with a loose wire point.

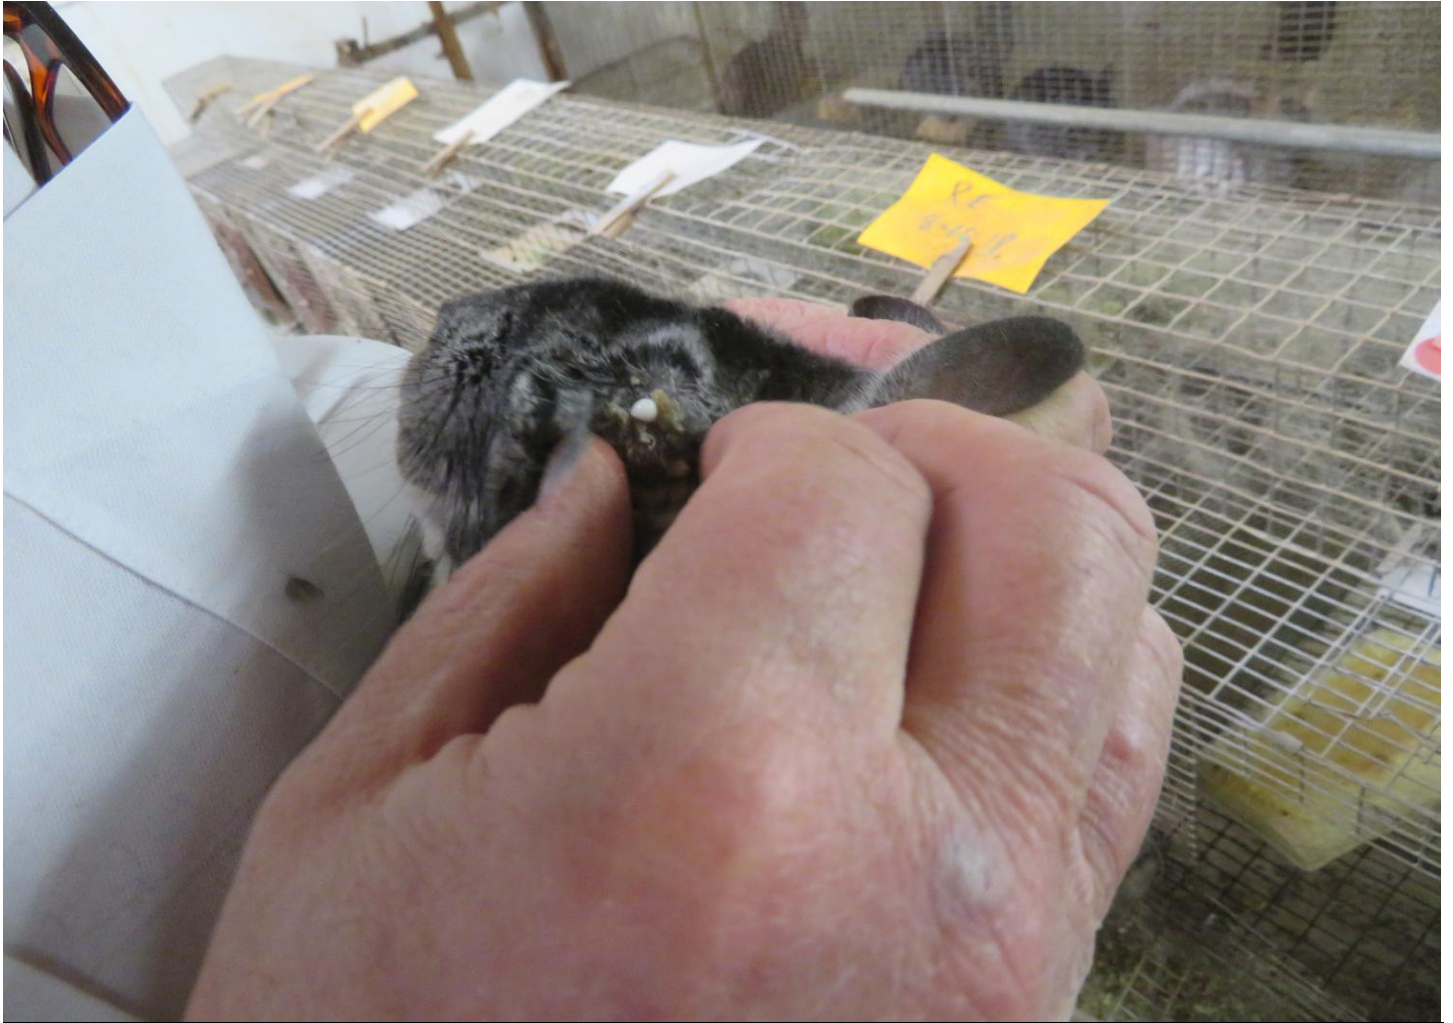
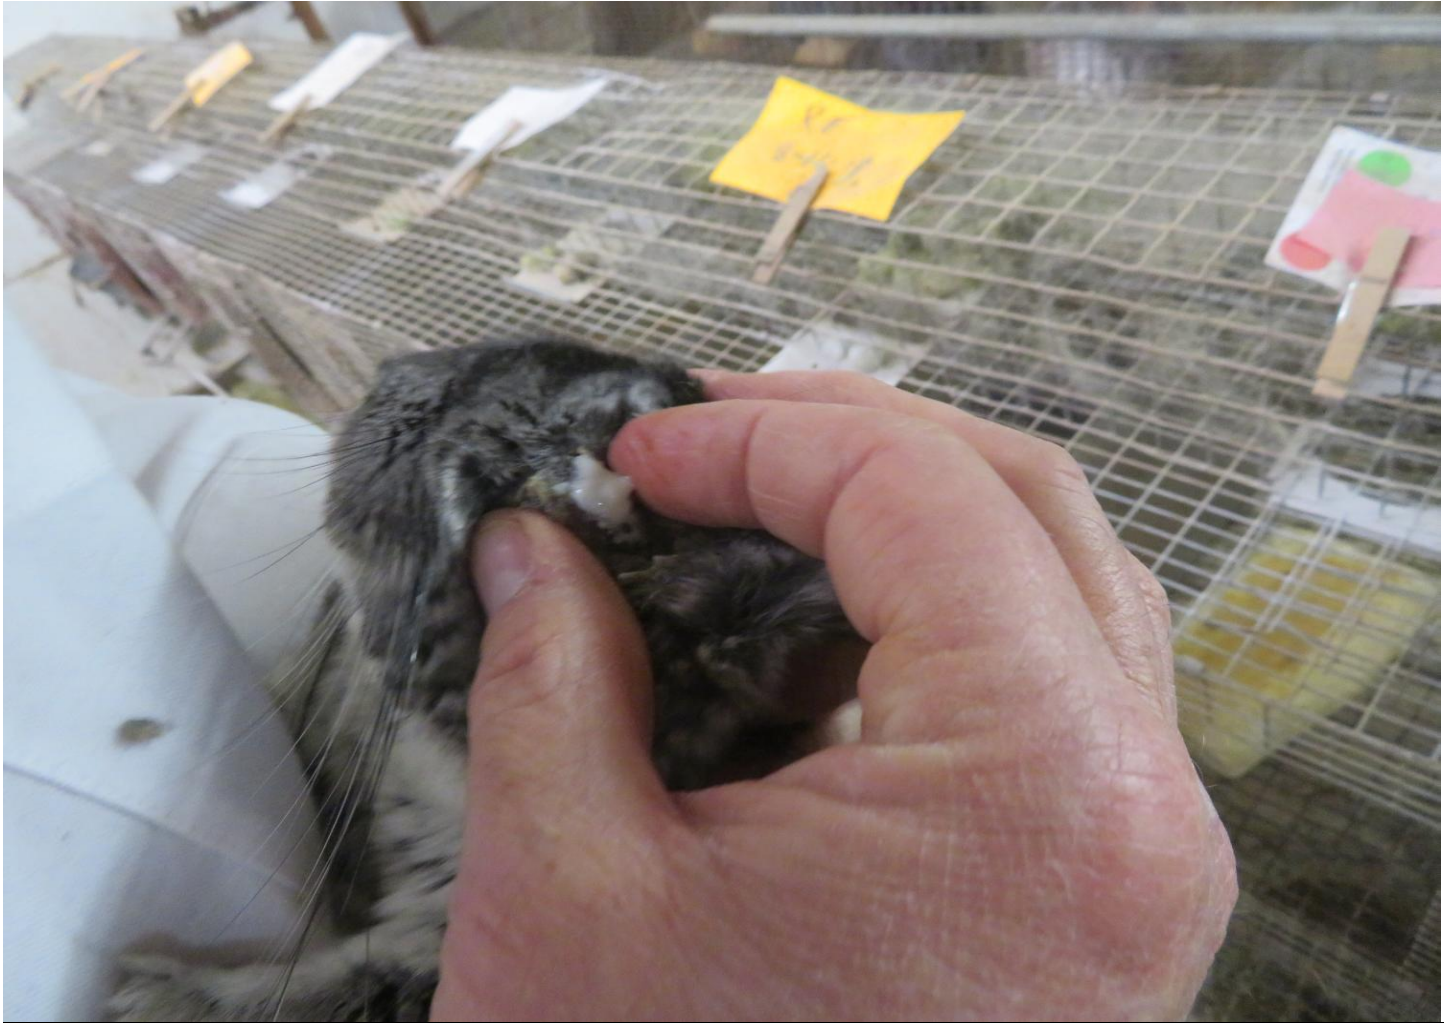
Chinchilla labeled with paper card RVDK J144 and housed close to bank 29 had eyes that were crusted shut. Its right eyelids were swollen and had some hair loss. The licensee handled it to look closer and the eyes had a thick pale discharge. The licensee treated it and added it to the treatment plan.

RVDK J144's left eye that has thick pale discharge when licensee handles it.

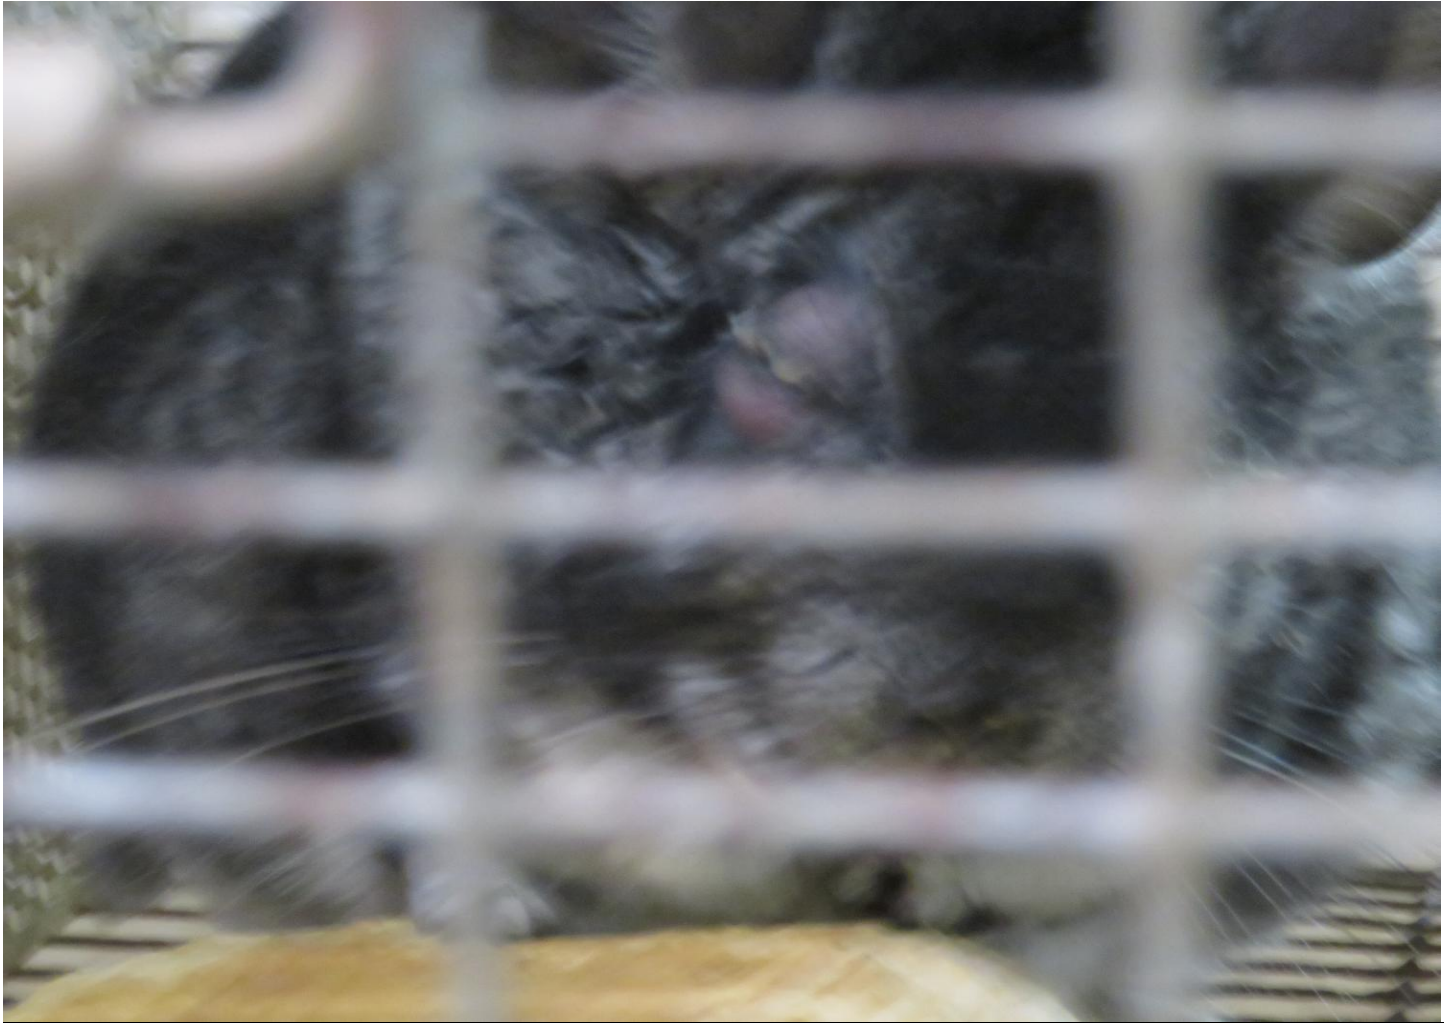
RVDK J144's right eyelids that are are swollen, have hair loss.

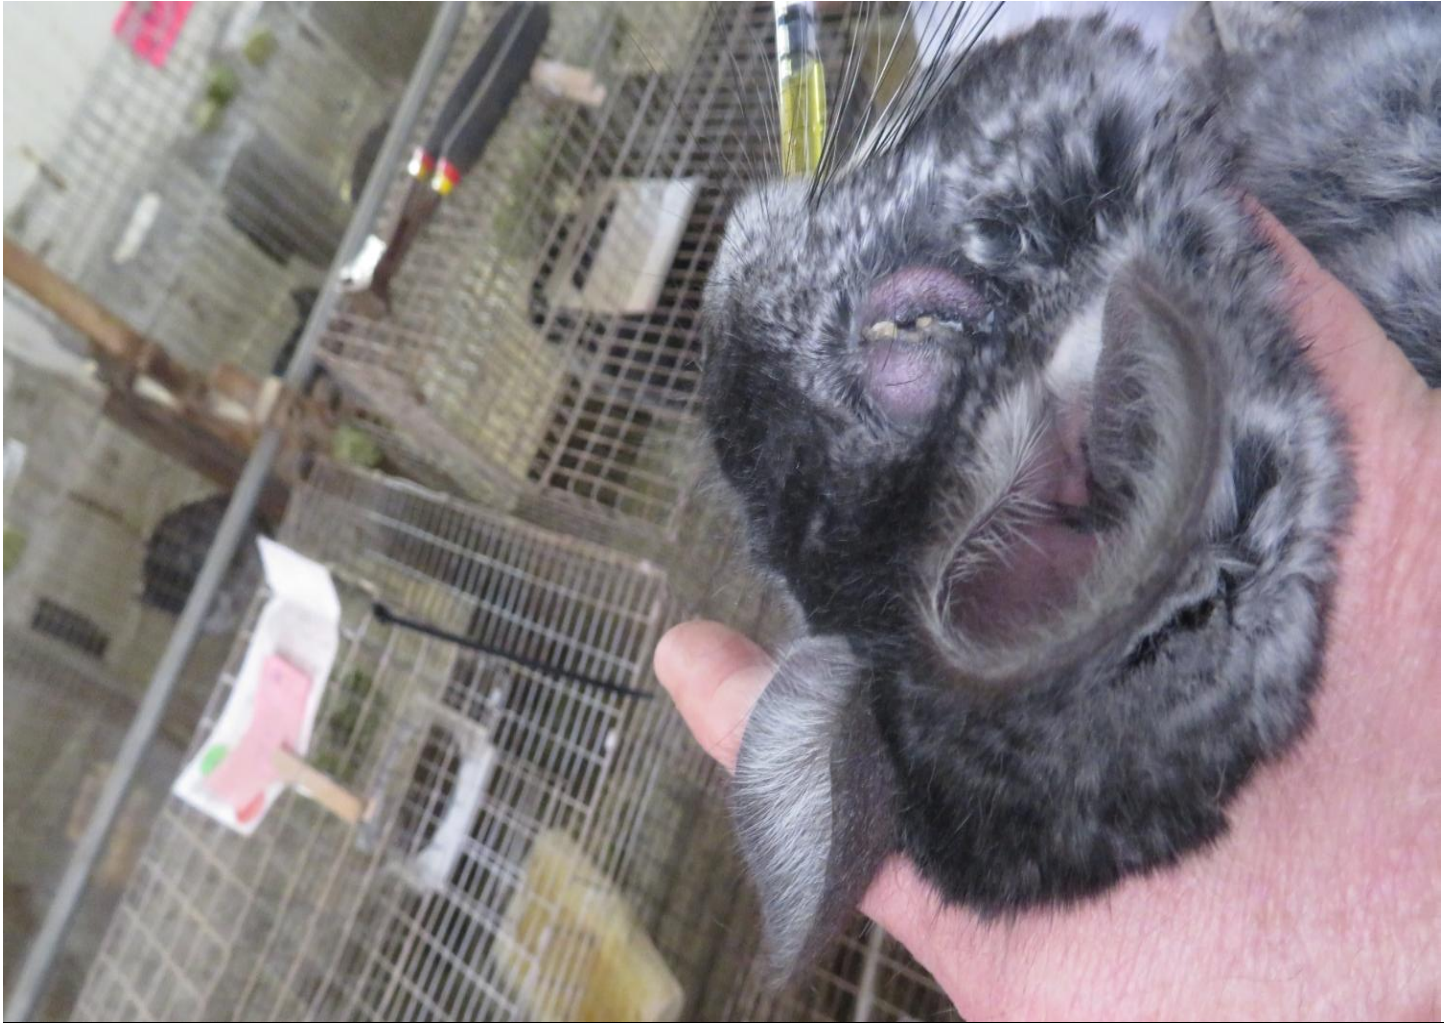
RVDK J144's right eye; close-up image taken while licensee administered treatment. Right eyelids are notably swollen and have hair loss.
