Inspection Report

Customer ID: **2401**
Certificate: **41-B-0239**
Site: 001
DAN MOULTON

Type: ROUTINE INSPECTION
Date: 25-FEB-2020

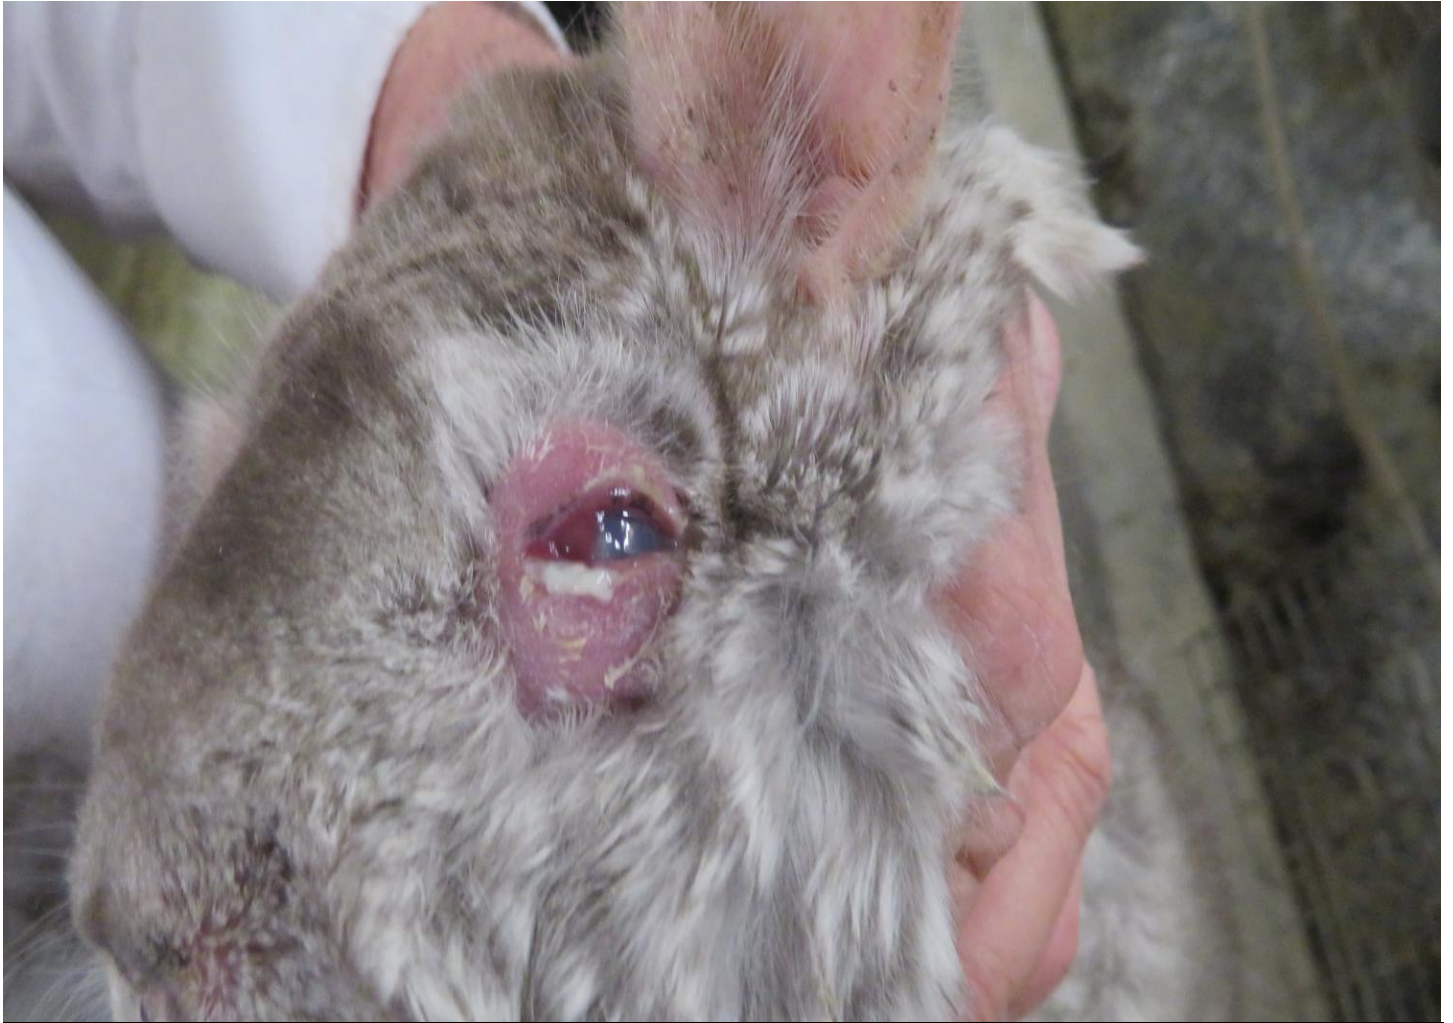
White female chinchilla housed in 30C: one eye (its left) had eyelids that were swollen, had hair loss around the eyelids, and it had some discharge in the eye. It was added to the treatment plan by the licensee.

White female chinchilla in 30C; her left eyelids are swollen and have hair loss.

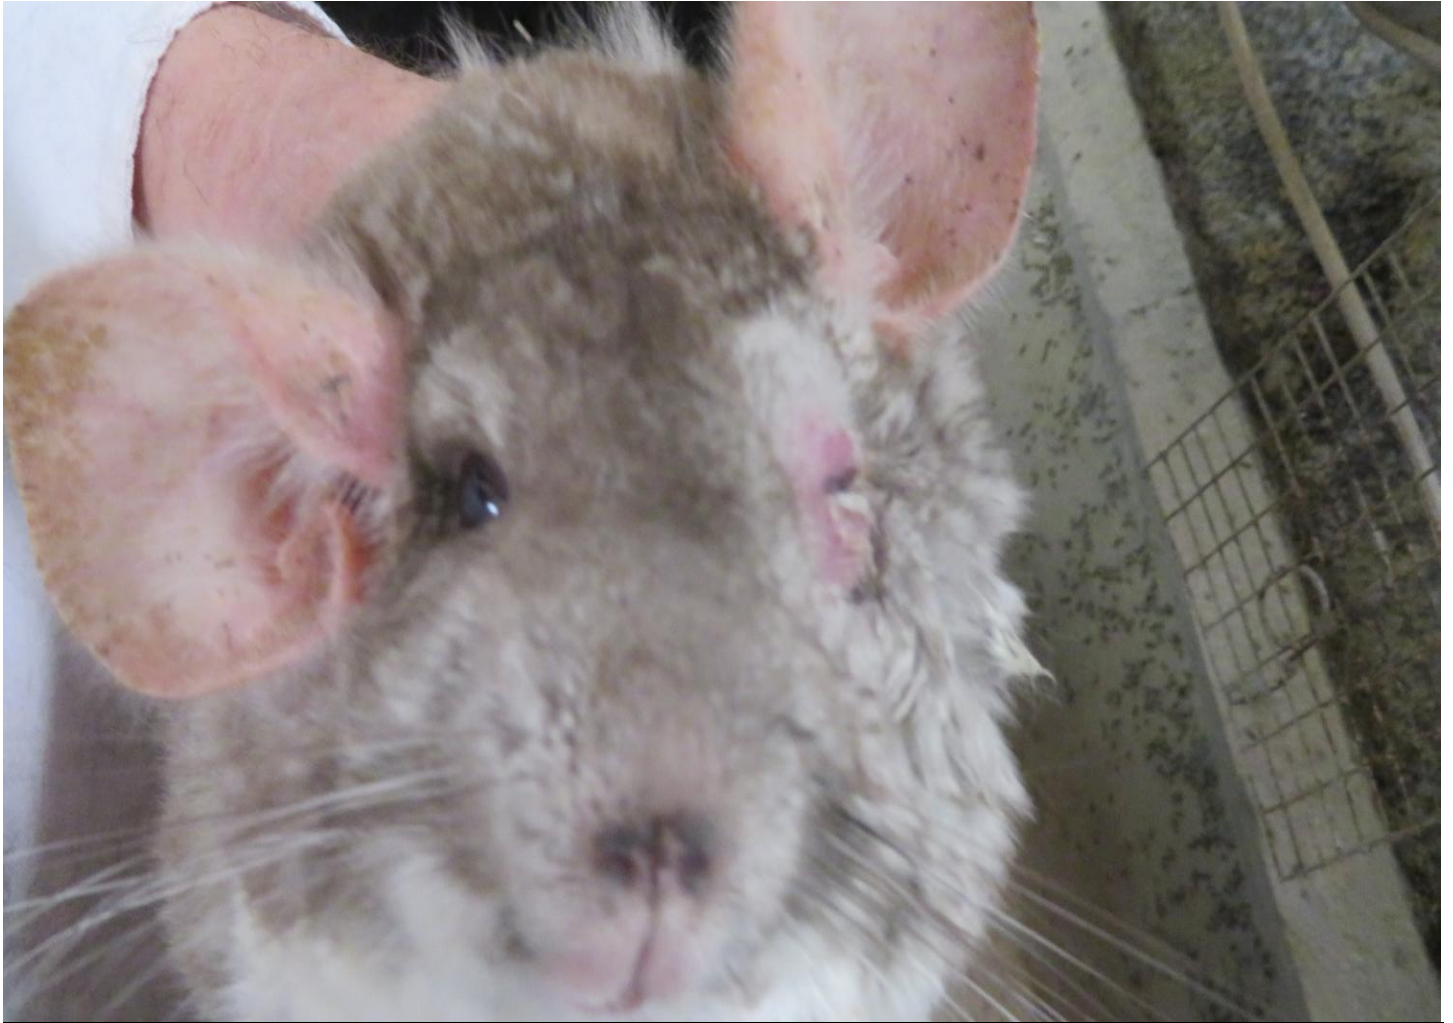
White female chinchilla in 30c; her affected left eye can be seen in comparison to her normal right eye.

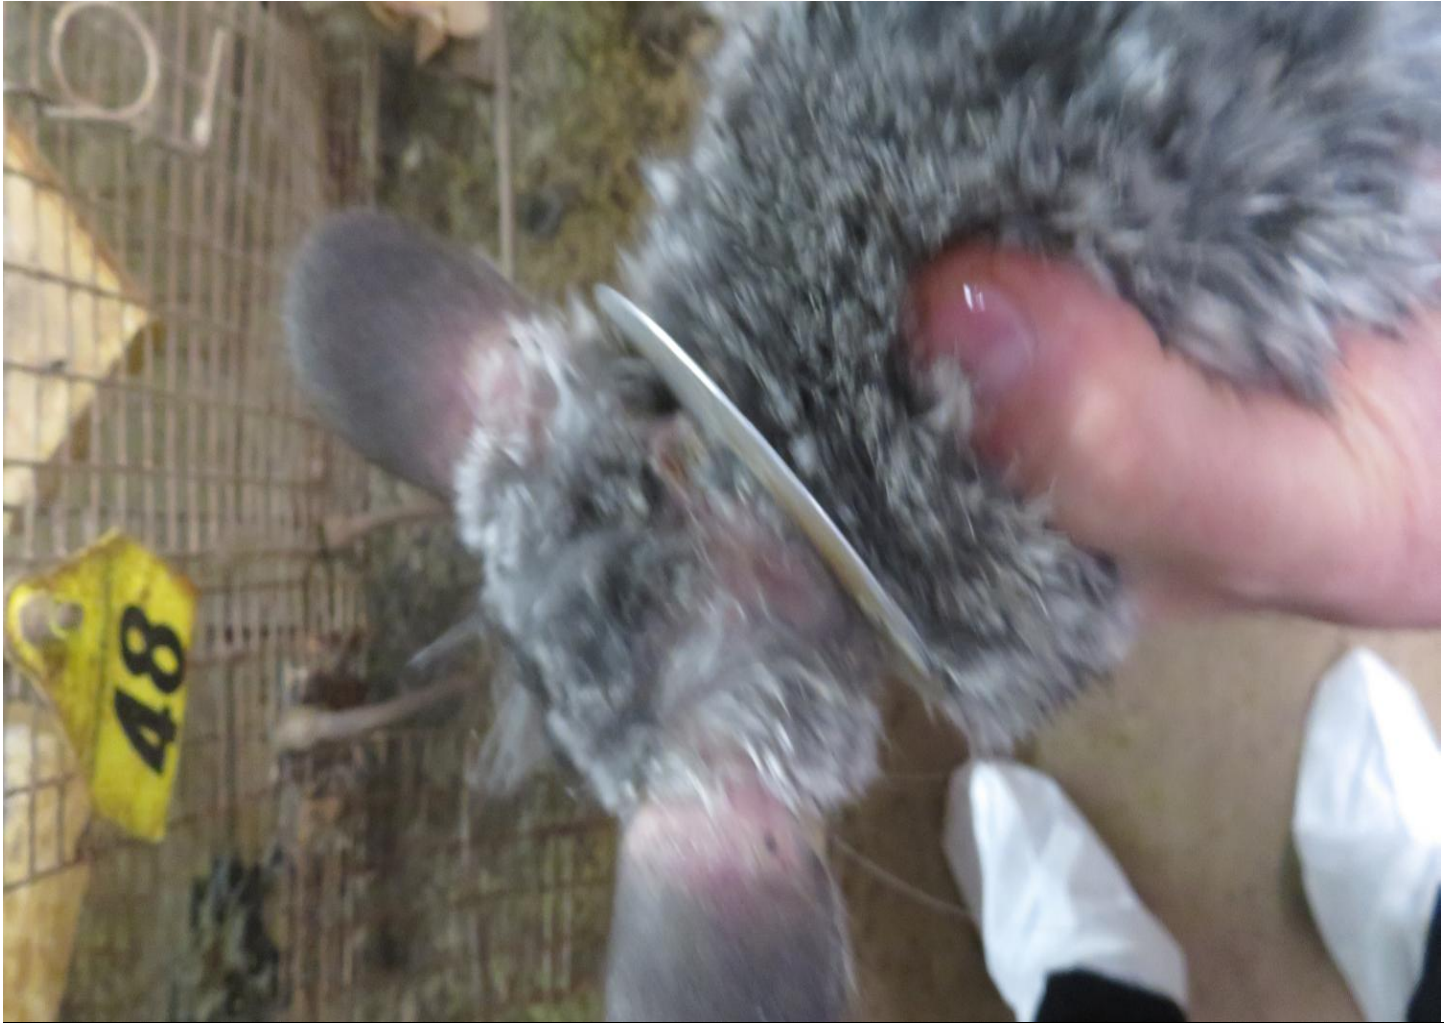
Grey female chinchilla housed in 47D was unkempt and had a scab under its collar. We asked the licensee to handle it so we could look closer and found that the underside of the collar was embedded into the neck. The licensee removed the collar; and I observed hair loss, a putrid odor, and a granular and liquid pale discharge in the area where the collar had been embedded. Ensure that the attending veterinarian's treatment plan is followed for this chinchilla.

Grey female in 47D; scab on top (dorsal) of neck under collar.

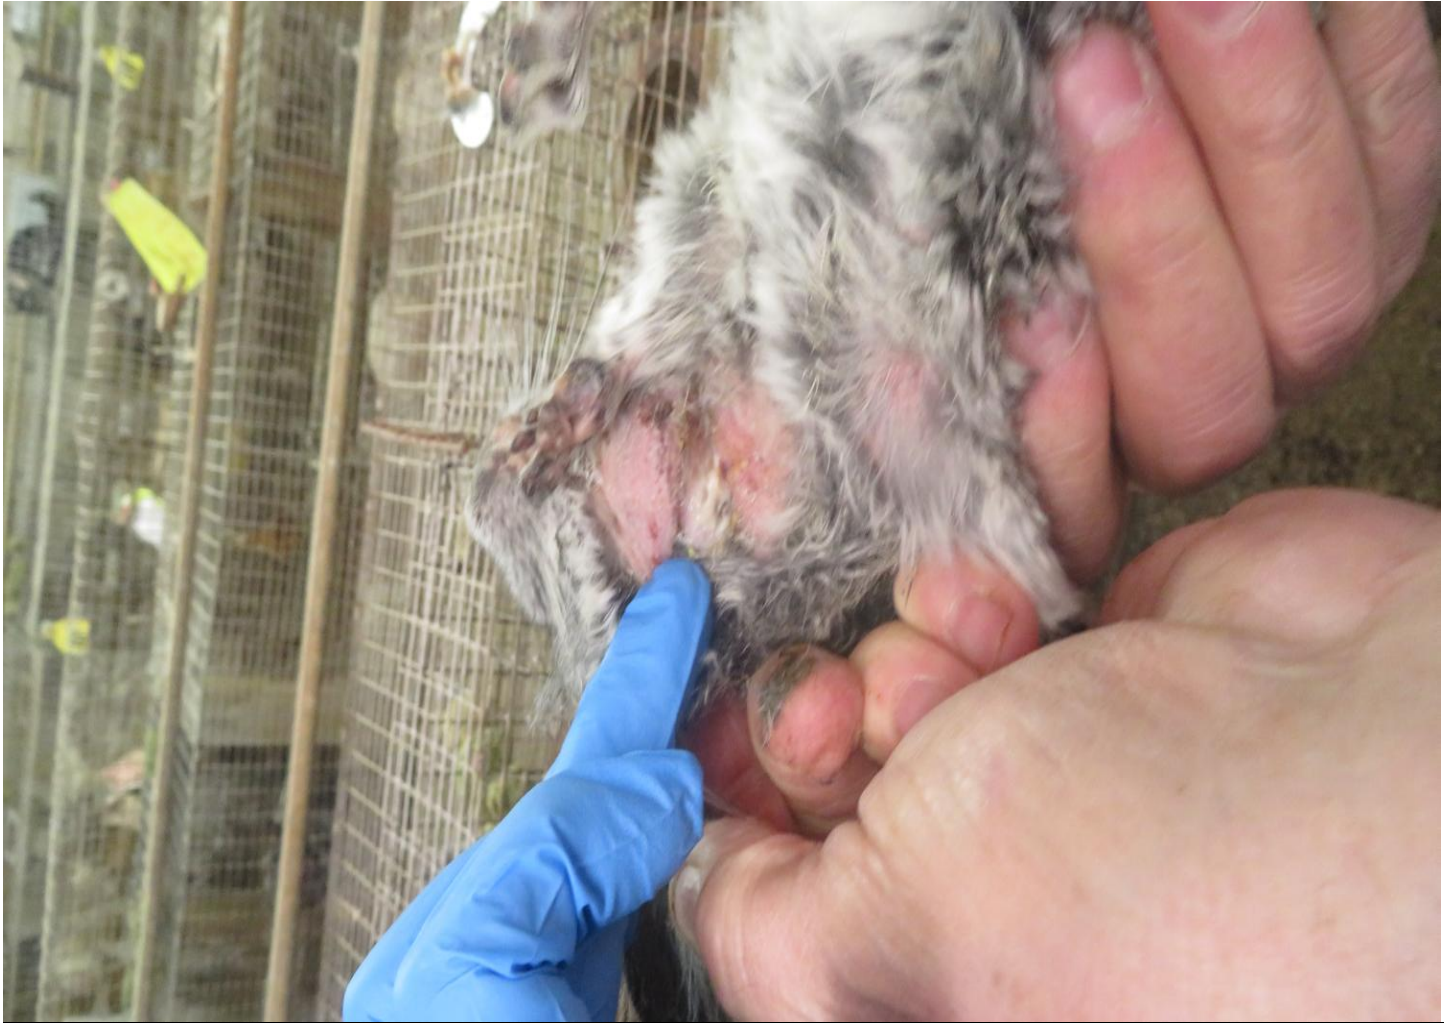
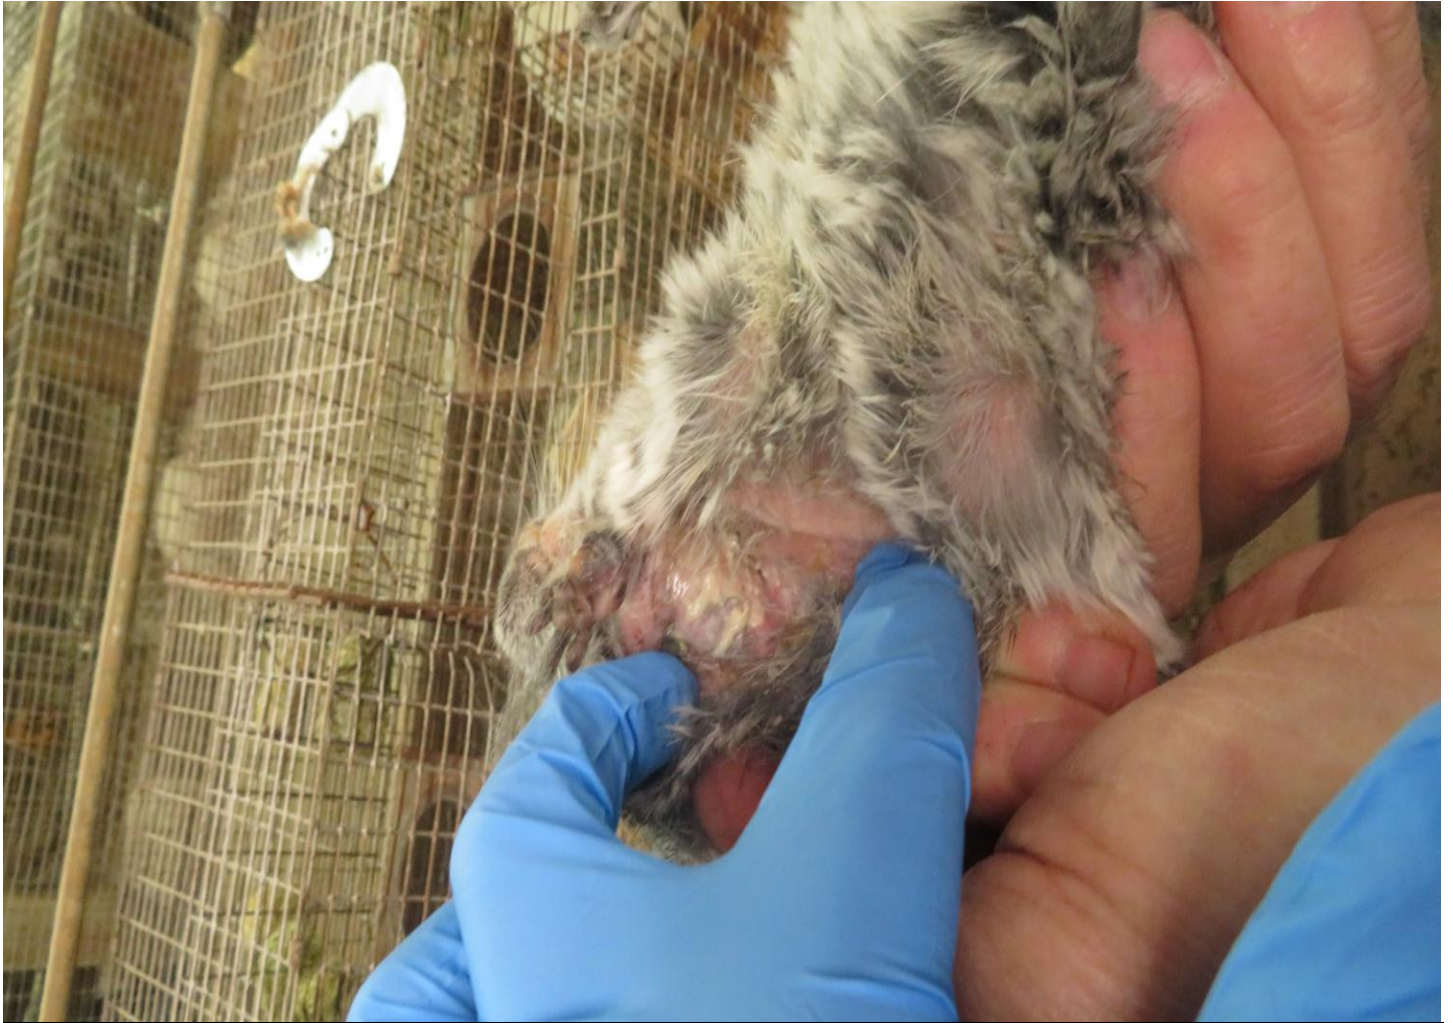
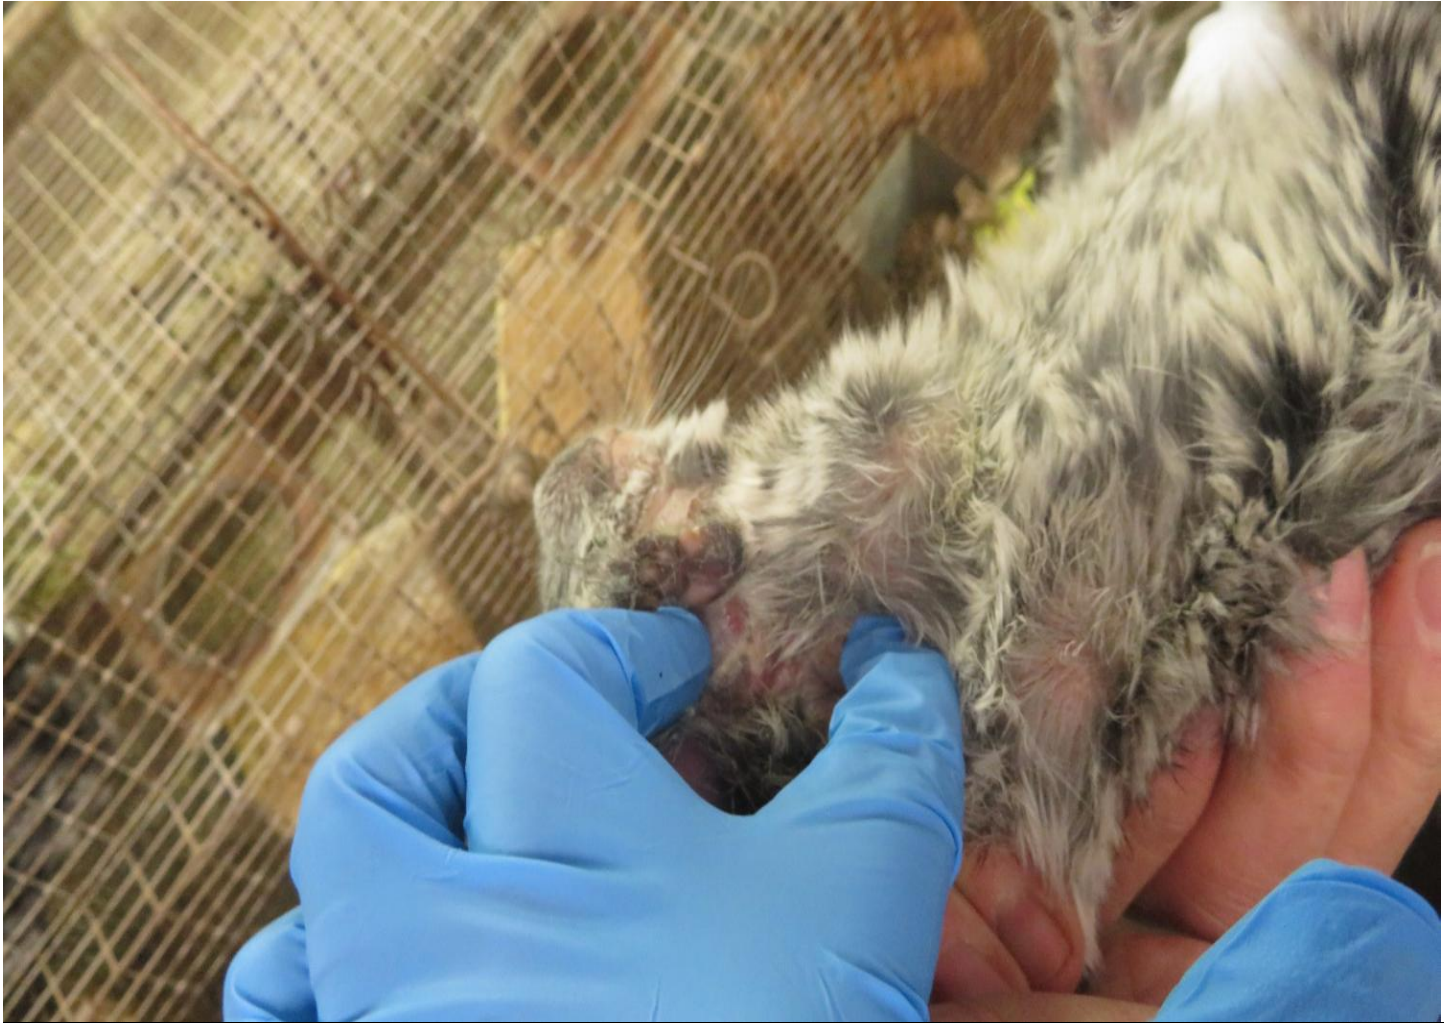
Grey female in 47D; underside (ventral) of neck after collar removed. Pale moderate granular and liquid discharge is noted in area between gloved fingers.

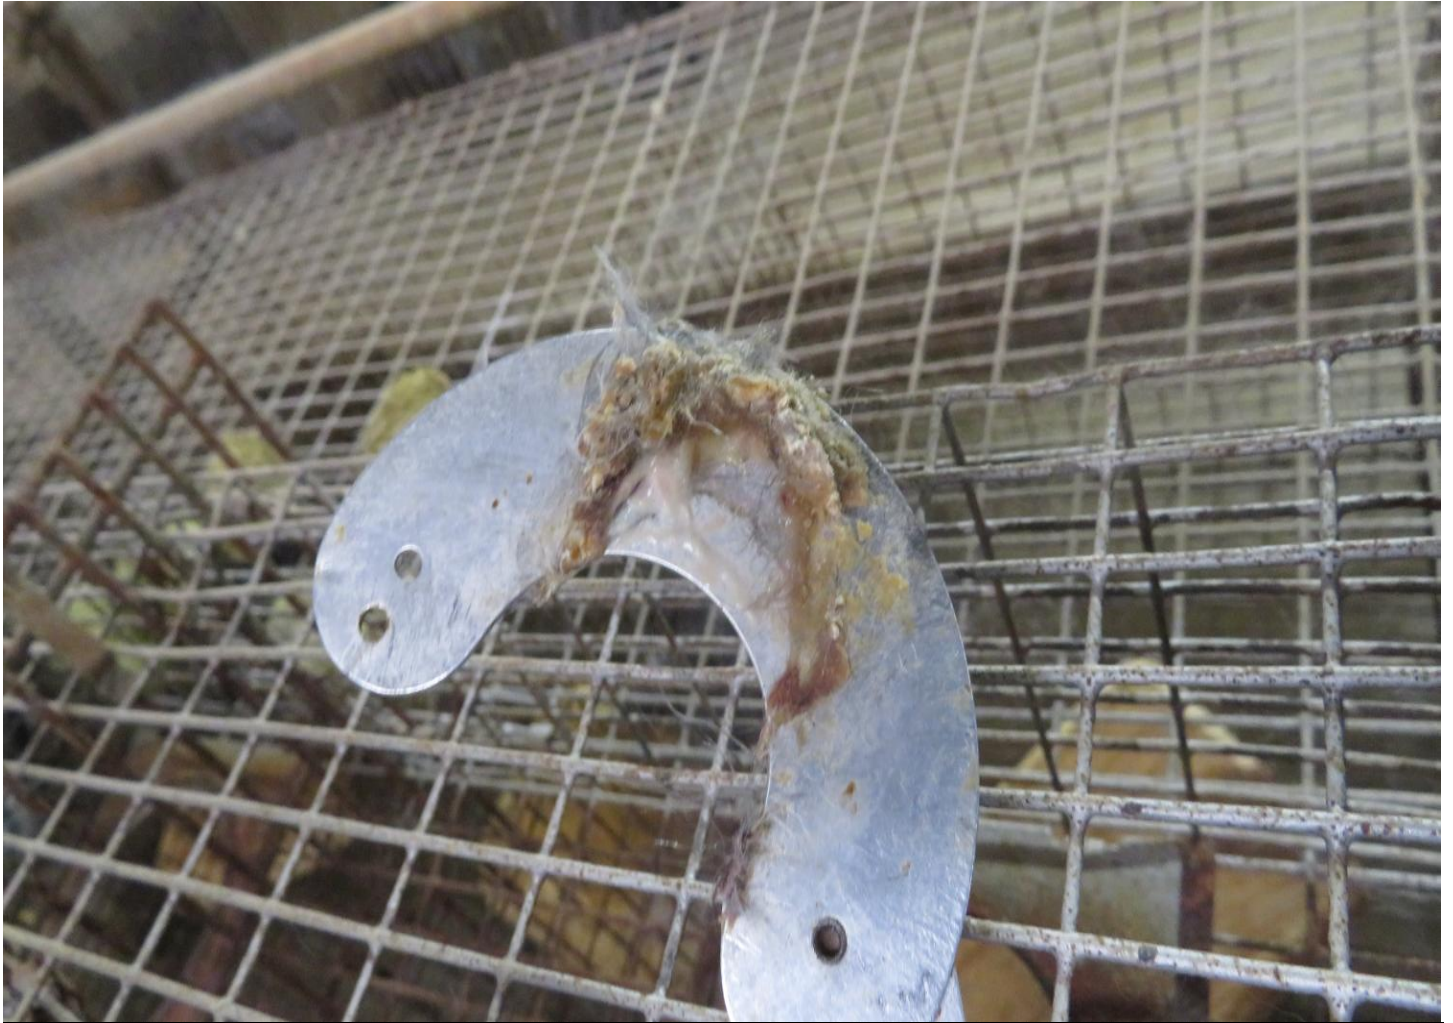
Collar that was on 47D female; crusted tissue and pale liquid discharge on area of collar that was embedded in neck.

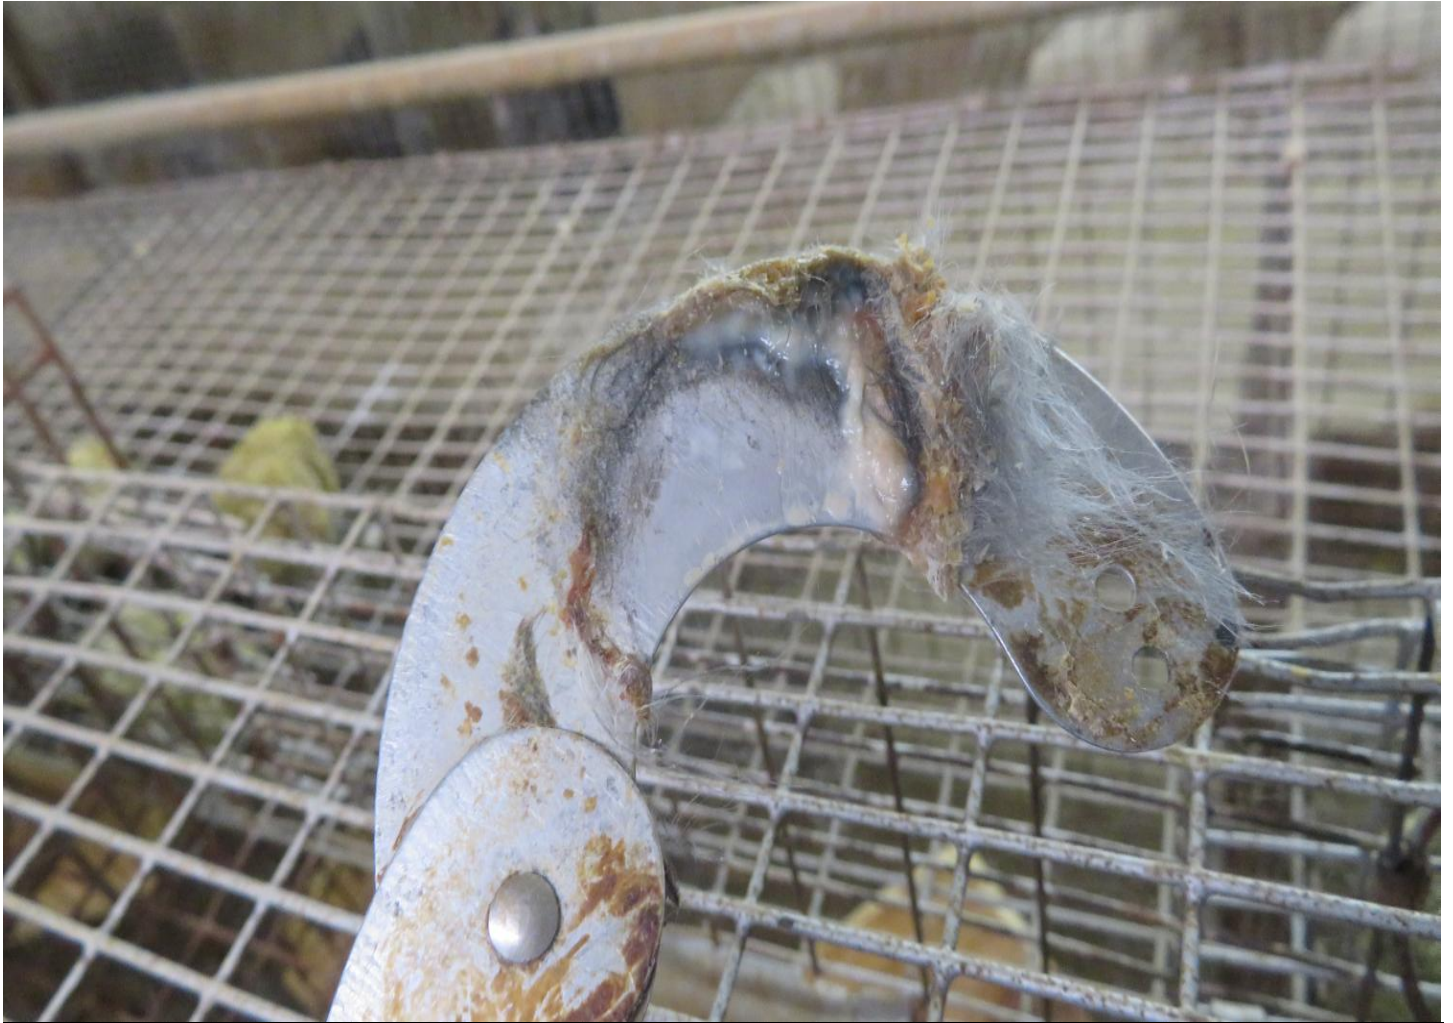
Flip-side of collar that was on 47D female; crusted tissue and pale liquid discharge on area of collar that was embedded in neck.

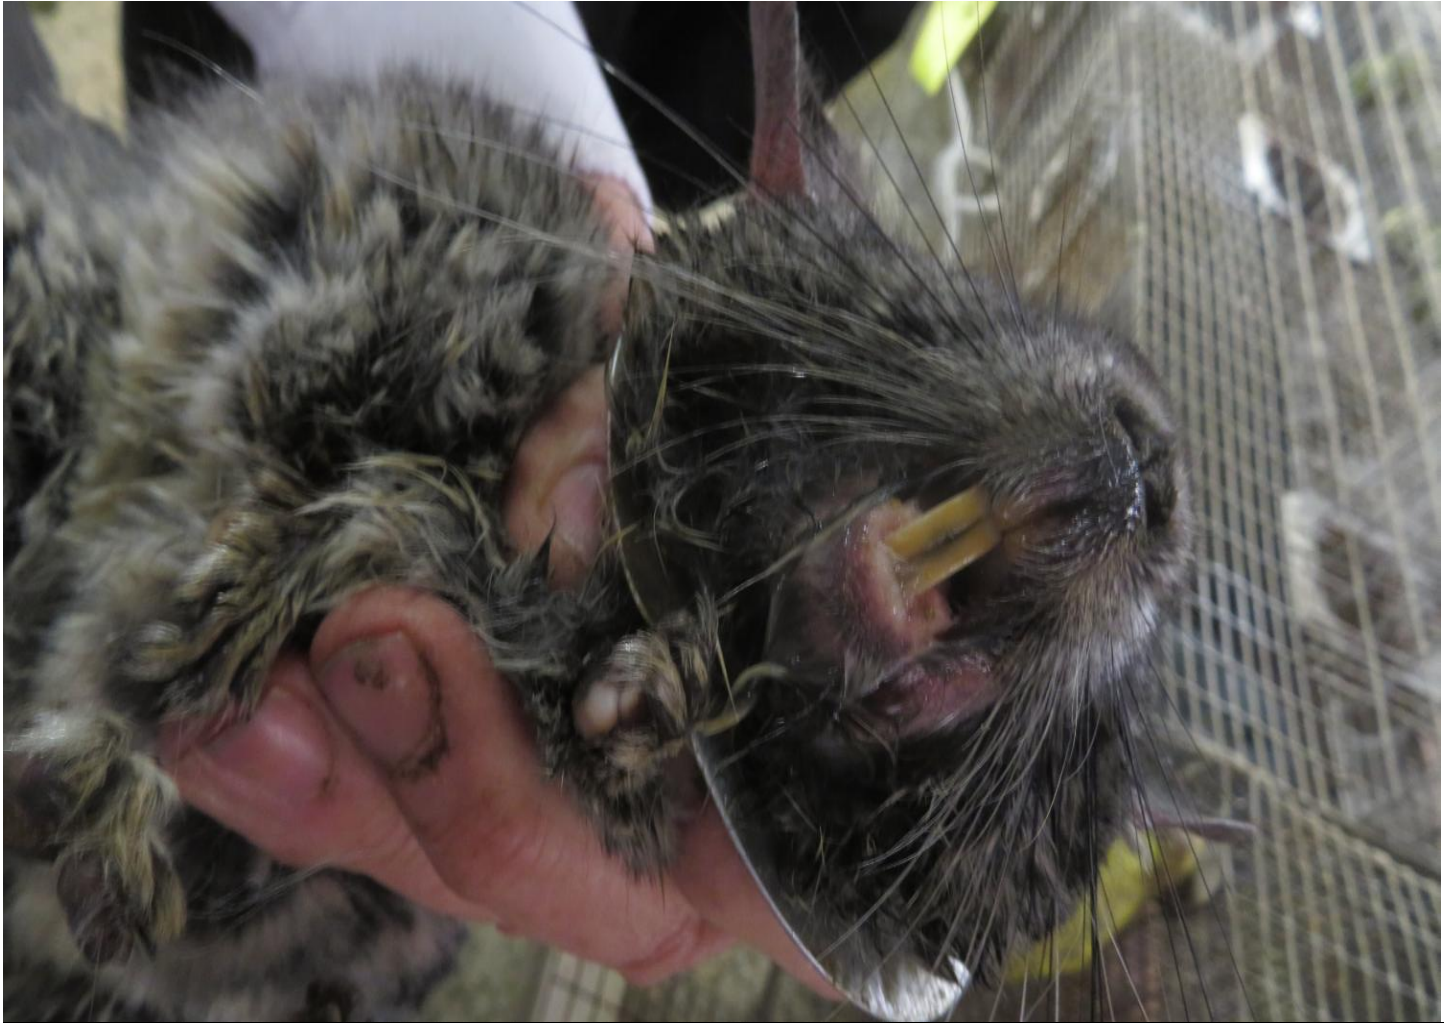
A female chinchilla housed in 75 was noted to be excessively drooling and not chewing its food properly. The licensee handled it for a closer look and we saw that its lower front (incisor) teeth were long and did not allow the chinchilla close its mouth in a normal manner. Overgrown teeth can be painful and can cause improper chewing and lead to malnutrition. Ensure that the attending veterinarian's treatment plan is followed for this chinchilla.

Overgrown teeth in female that is housed in 75; drooling/wet hair noted under her chin and she was not able to close her mouth likely because her lower teeth were too long and hitting the upper gums.

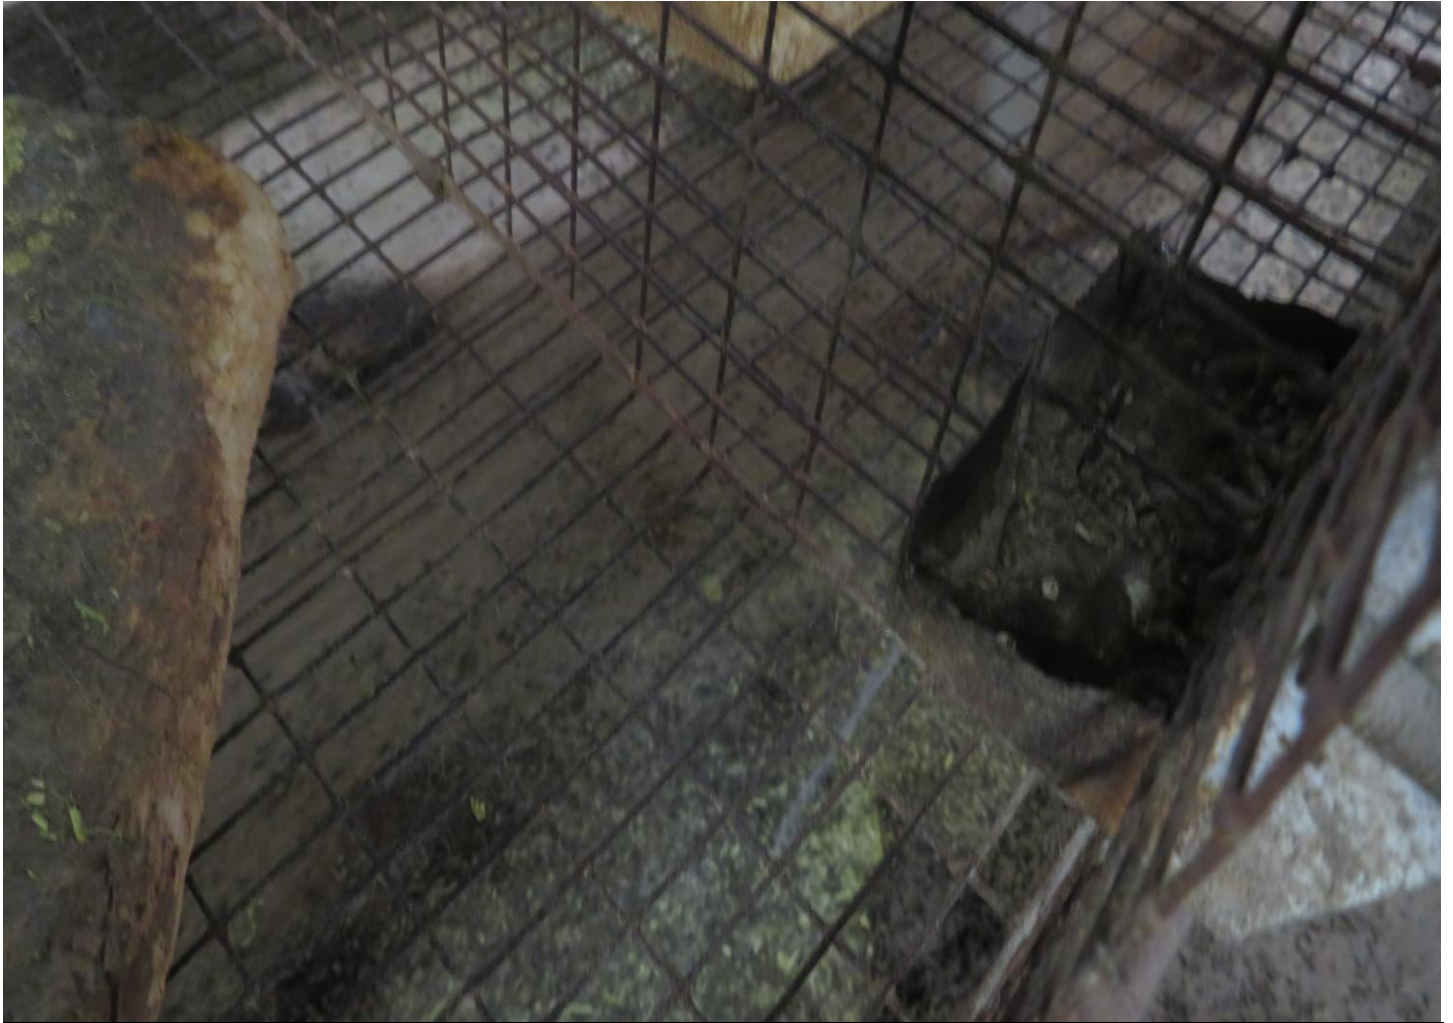
Close-up of a feeder with rusted edges that make the edges rough and sharp.

Representative of feeders seen that need replaced/repared.
