# **Puppies On Wheels**

**February 11, 2010 Inspection Report**

**Prepared By: Minnesota Humane Society**

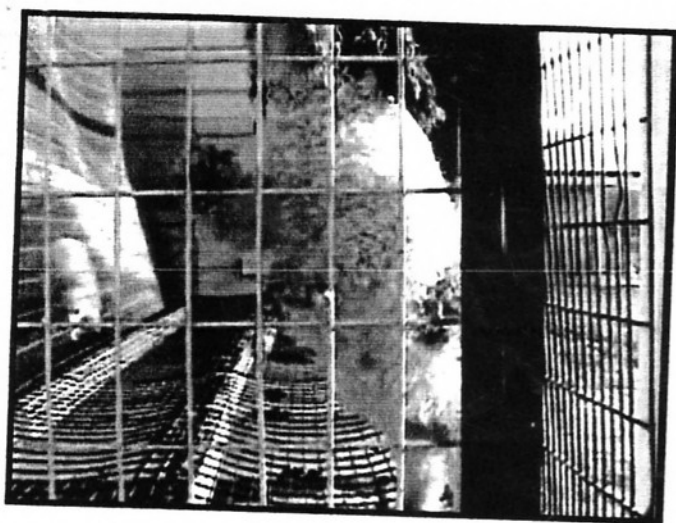
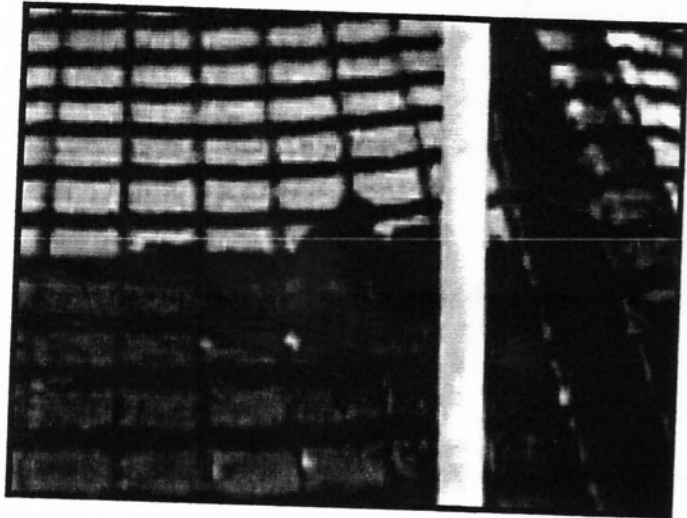
- The construction of the cages allows for fecal matter to catch up under the cage; removal of this fecal matter is nearly impossible (see photographs on following page).

**Pursuant to Minnesota Statute 346.39, Subd. 12, "wastes must be disposed of properly" and "outdoor enclosures must be kept clean."**

**Pursuant to USDA Regulation 3.11(a), "Excreta and food waste must be removed from primary enclosures daily, and from under primary enclosures as often as necessary to prevent an excessive accumulation of feces and food waste..."**

**Recommendation:**

**Increase the staff to dog ratio to enable more frequent cleaning of dog kennels. Reconstruct the supports under the cages to allow access for staff to clean or to prevent the fecal matter from getting stuck.**

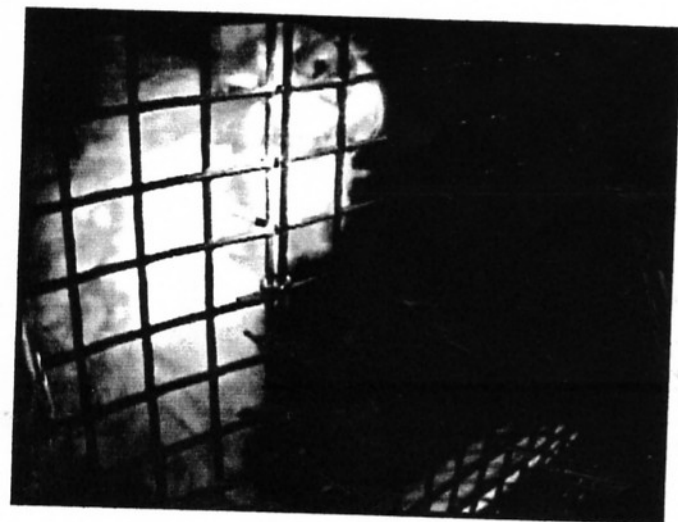
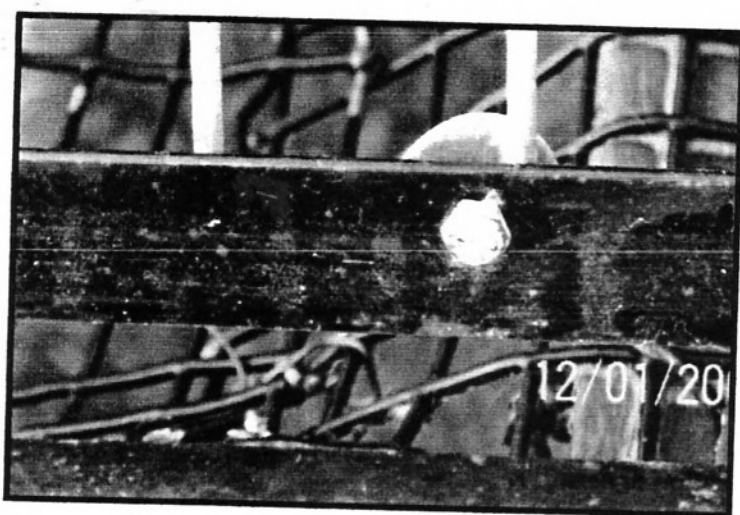
- The kennels, both outside and inside, had sharp wire sticking out into the cages, which could cause injury to the dogs. Inspection team members observed dog fur on the wire, indicating the dogs are in contact with the wire (see photographs below and on the following page).

**Pursuant to Minnesota Statute 346.39, Subd. 10, dog and cat confinement and exercise area surfaces must "protect the animal from injury and be kept in good repair."**

**Pursuant to USDA Regulation 3.1 (c)(ii), housing facilities in general must be "free of jagged edges or sharp points that might injure the animals."**

**Pursuant to USDA Regulation 3.6 (2)(i), primary enclosures must "have no sharp points or edges that could injure the dogs and cats."**

**Recommendation:**

**Switch the wire to plastic zip ties.**

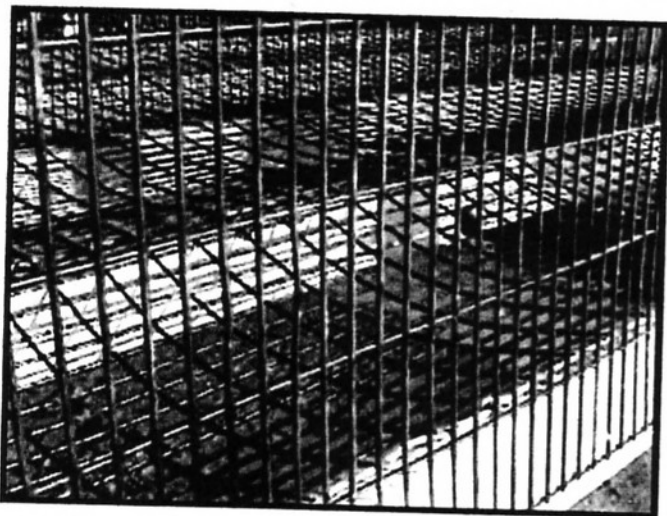
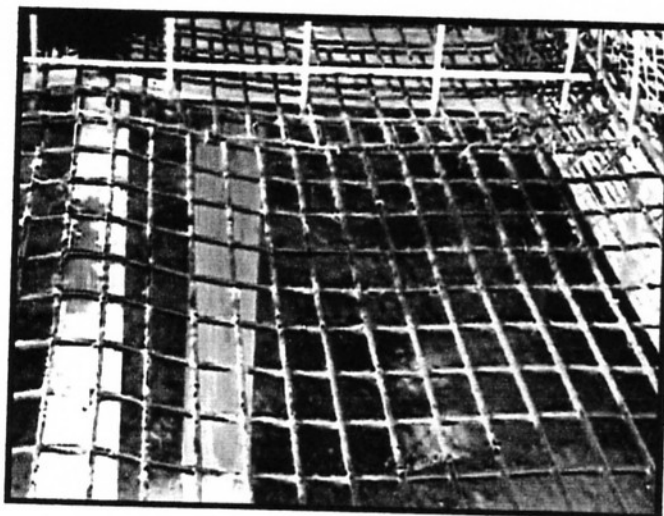
- The flooring of the raised outdoor cages sagged (see the photograph above and photographs below).

***Pursuant to USDA Regulation 3.6 (2)(xii), "the suspended floor of any primary enclosure must be strong enough so that the floor does not sag or bend between the structural supports."***

**Recommendation:**

**Fix cage flooring so it does not sag.**

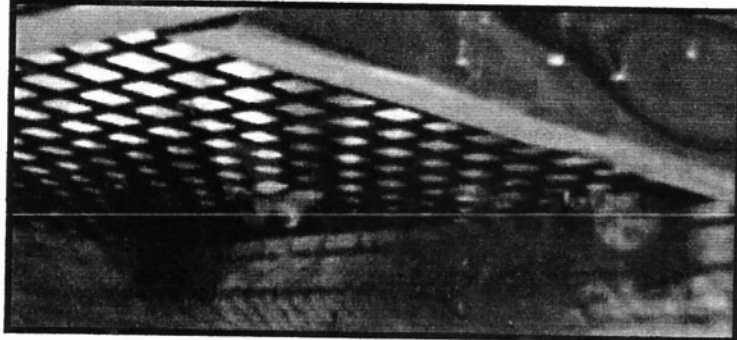
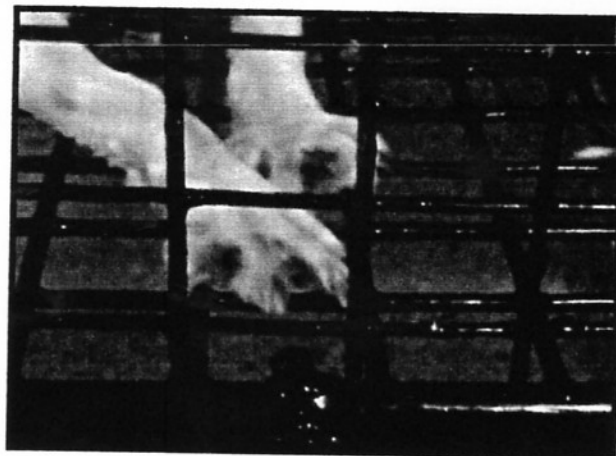
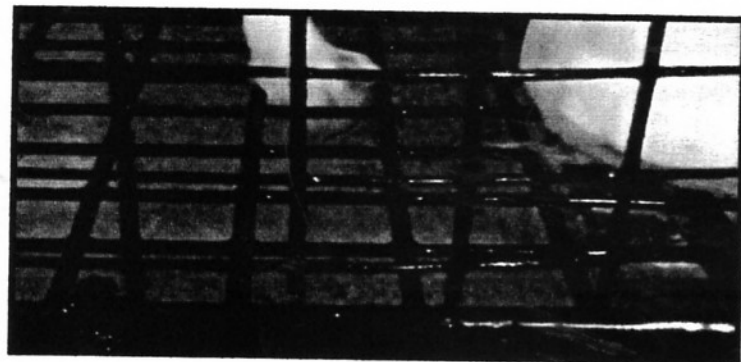
- The stalls in the room housing dogs were replaced with raised metal cages with floor openings of either 1½ inches x 1½ inches or 1 inch by 1 inch. It was noted that the majority of the dogs' paws were passing all the way through the cage floor. This results in a dangerous situation that can lead to unnecessary injury to feet and legs. It was also observed that the dogs were standing in the cages with their paws splayed at all times which is a guarded stance to protect themselves from falling through the cage floor openings (see photographs on the following page).

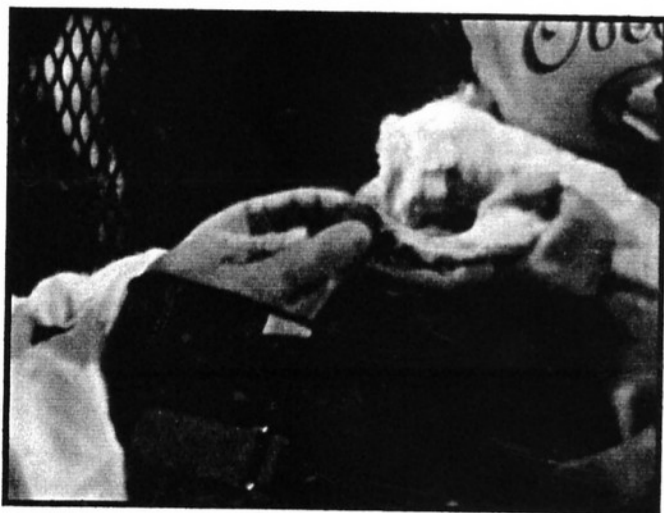
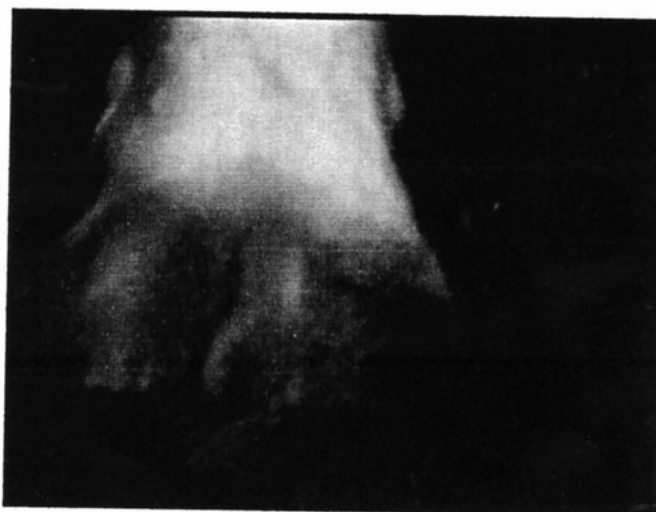
- Many dogs had red, sore areas between their paws caused by the wire floor of the cages. One dog was observed to have a bleeding front paw. Kathy Bauck removed the dog from the cage and the paw was examined and cleaned up by Dr. Gumbusky and Kathy Bauck.

**Pursuant to Minnesota Statute 346.39, Subd. 10, confinement and exercise areas "must protect the animal from injury..."**

**Pursuant to USDA Regulation 3.6(a)(2)(x), "Primary enclosures must be constructed and maintained so that they have floors that are constructed in a manner that protects the dogs' and cats' feet and legs from injury, and that, if of mesh or slatted construction, do not allow the dogs' and cats' feet to pass through any openings in the floor."**

**Recommendation:** Decrease the opening size of the cages' wire floors or house the dogs in kennels with solid floors.

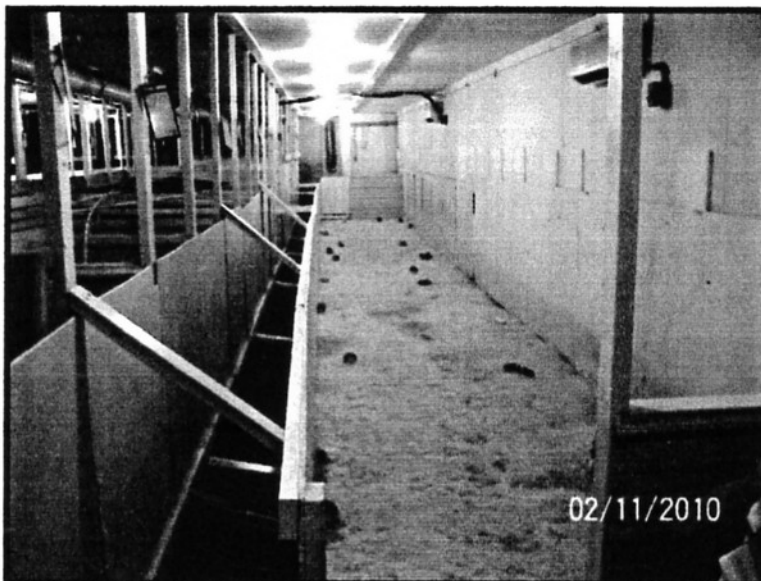
**Exercise pen in the Red Barn**

- While there was an indoor "exercise area" added to one of the empty rooms in the Red Barn, no dogs were observed in the exercise area between 11:00 a.m. and 3:30 p.m. (see photographs below). The exercise area is 6 feet wide by 54 feet.

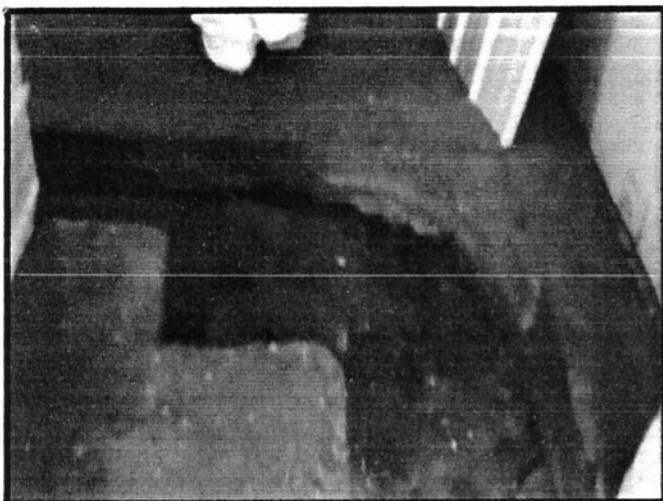
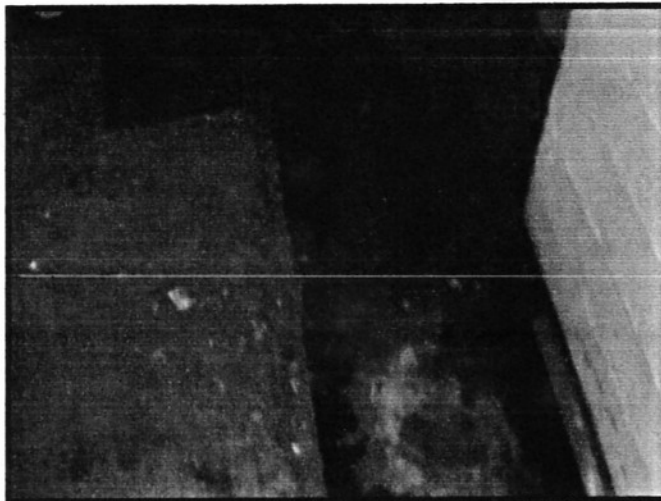
**Route from the cages to the exercise pen in the Red Barn**

- Additionally, the path for the dogs to get from their cages to the exercise area is dangerous and difficult for a small dog to navigate due to the wide, deep canals in the floor. There is a potential for them to be injured in route to the exercise pen (see photographs on following page).

**Pursuant to Minnesota Statute 346.39, Subd. 10, confinement and exercise areas "must protect the animal from injury..."**

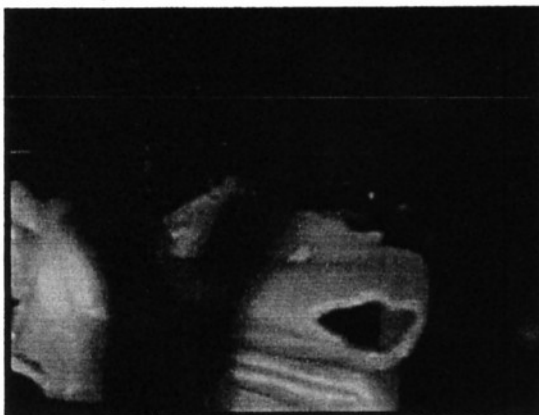
- Some of the toys in the cages were unsafe for the dogs and had chewed off sharp, jagged edges, which could pose a severe health threat to the dogs. Inspection team members are concerned that the dogs might have already ingested the chewed off pieces of the toy. Ingestion of the toys could cause the dogs to suffer intestinal irritation or intestinal blockage, which is both painful and life threatening (see photograph below).

**Recommendation:**

It is generally recommended that dogs be supervised when playing with toys. Toys should be removed from cages at night when there is no supervision. Any damaged toys should be immediately removed from cages. Increasing the staff at the facility would allow more supervision and monitoring of the dogs.

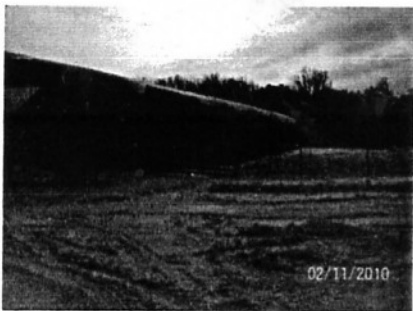
The Bread and Butter Barn, pictured to the left, houses the larger breed dogs such as Golden Retrievers, Huskies, Beagles, Pugs, Shar Peis, Bulldogs, German Shepherds, Labrador Retrievers and Mastiffs. The larger dogs are housed in kennel runs on concrete with both indoor and outdoor access. Concerns/violations noted at time of inspection:

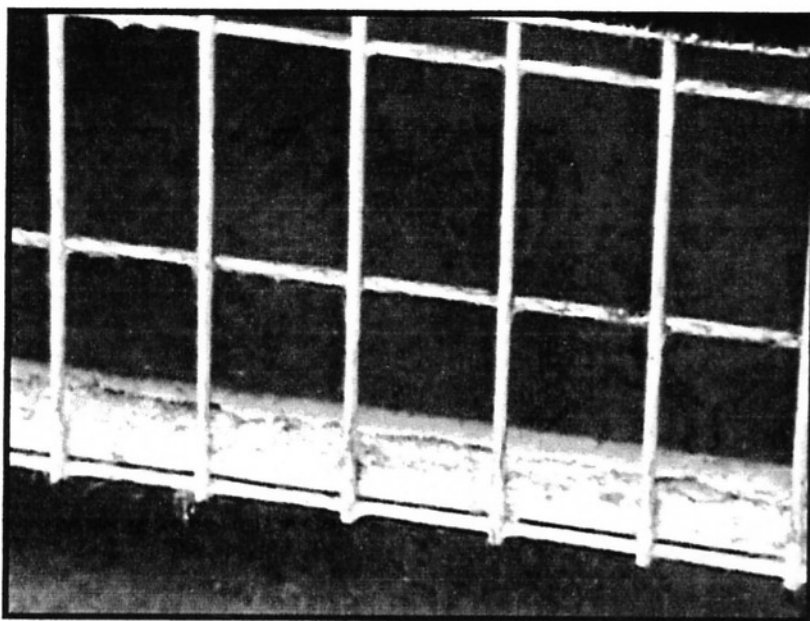
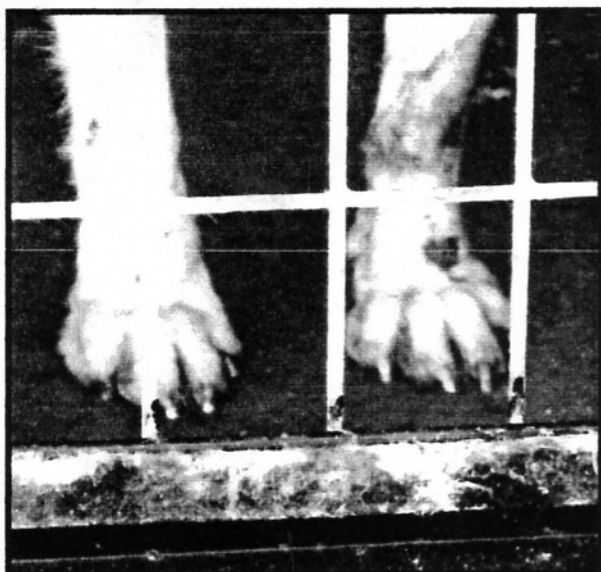
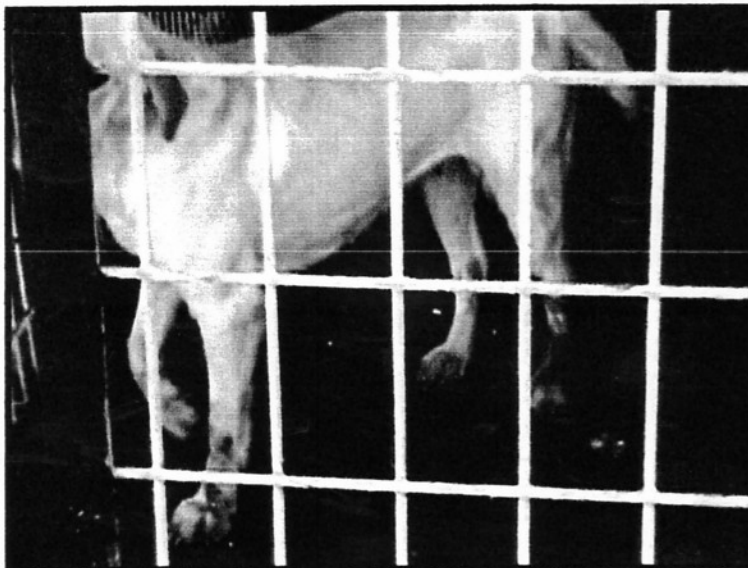
- Several dogs, particularly two Yellow Labrador Retrievers, had bloody sores on their paws. Allan Bauck indicated it was from the dogs sliding on the slippery outdoor kennel run floor and their paws slipping under the front panel of the kennel; the front panel of the kennel has sharp points (see photographs below).

***Pursuant to Minnesota Statute 346.39, Subd. 10, dog and cat confinement and exercise area surfaces must "protect the animal from injury and be kept in good repair."***

***Pursuant to USDA Regulation 3.1 (c)(ii), housing facilities in general must be "free of jagged edges or sharp points that might injure the animals."***

***Pursuant to USDA Regulation 3.6 (2)(i), primary enclosures must "have no sharp points or edges that could injure the dogs and cats."***

**Recommendation:** Modify the bottom of each run to eliminate any sharp edges/points.

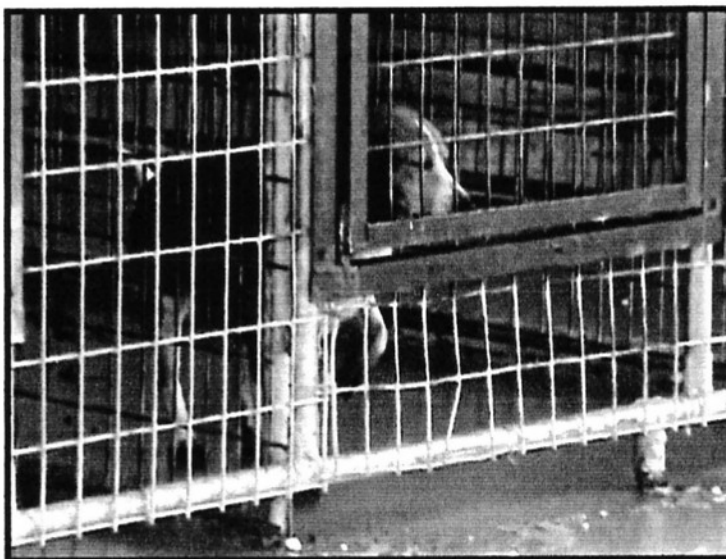
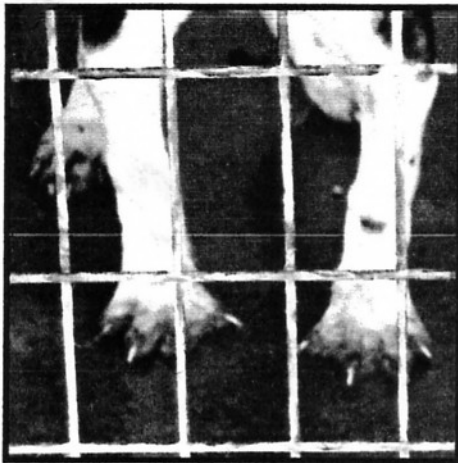
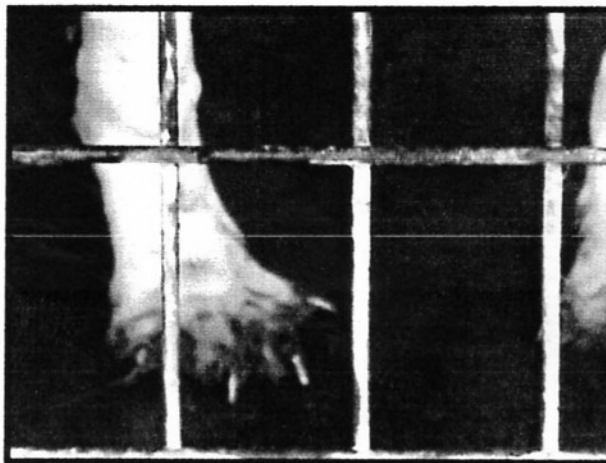
- The outdoor kennel floor was wet and slippery and the dogs' paws were wet, red and discolored. The dogs were observed slipping and sliding, shivering and holding their paws up (see photographs below and on the following page). Fur discoloration is caused by excessive moisture. A likely cause would be the wet kennel run floors. Other possible causes would be excessive licking due to boredom or injury and staining from fecal matter

**Pursuant to Minnesota Statute 346.39, Subd. 11, "a suitable method must be used to rapidly eliminate excess fluids from confinement areas."**

**Pursuant to USDA Regulation 3.11(f), "housing facilities must be equipped with disposal facilities and drainage systems that are constructed and operated so that animal waste and water are rapidly eliminated and animals stay dry."**

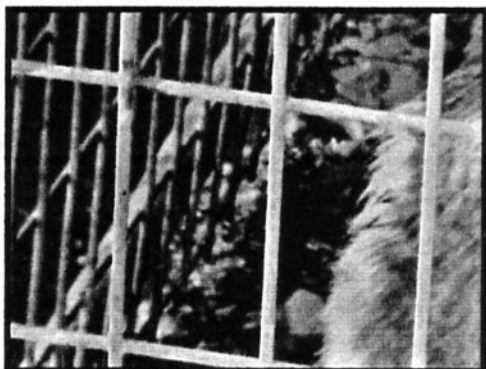
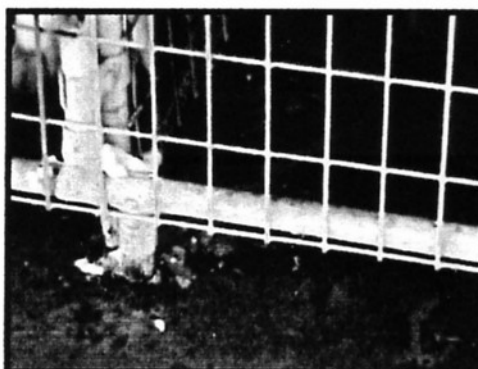
- There was an accumulation of urine soaked snow and ice on the floor of the runs and stuck under the dividers of the kennel runs (see photographs below).

**Pursuant to Minnesota Statute 346.39, Subd. 12, "wastes must be disposed of properly" and "outdoor enclosures must be kept clean."**

**Pursuant to USDA Regulation 3.11(a), "Excreta and food waste must be removed from primary enclosures daily, and from under primary enclosures as often as necessary to prevent an excessive accumulation of feces and food waste..."**

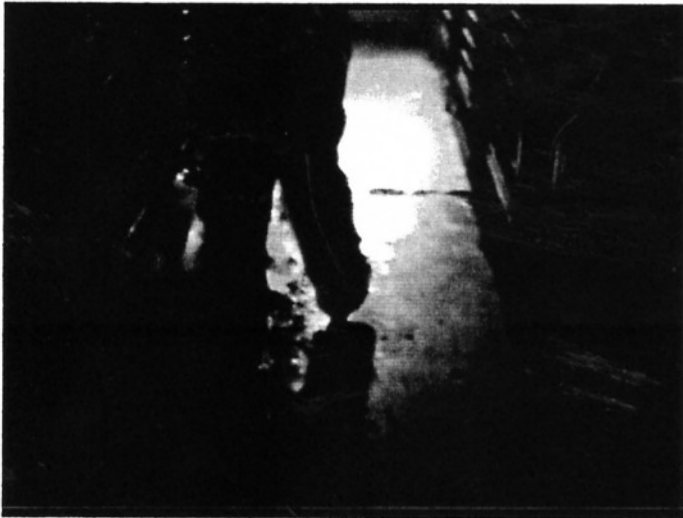
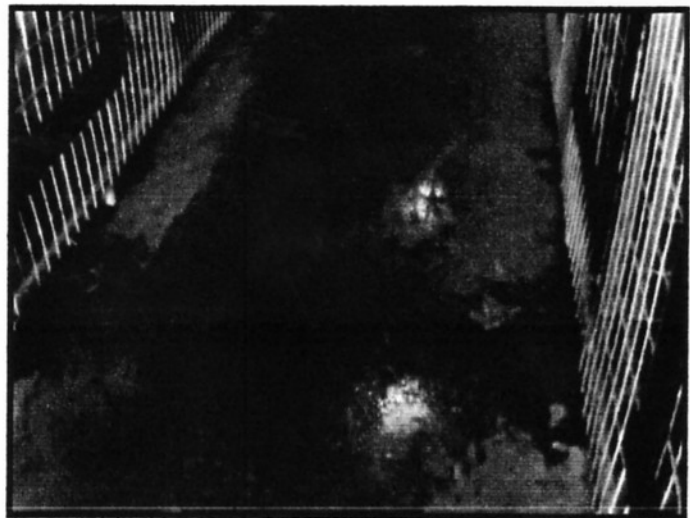
- The floor was wet in the Bread & Butter Barn and in some cases there was standing water on the floor (see photographs below). All dogs were observed to have wet paws (see photographs on previous page).

**Pursuant to Minnesota Statute 346.39, Subd. 11, "a suitable method must be used to rapidly eliminate excess fluids from confinement areas."**

**Pursuant to USDA Regulation 3.11(f), "housing facilities must be equipped with disposal facilities and drainage systems that are constructed and operated so that animal waste and water are rapidly eliminated and animals stay dry."**

**Recommendation:** To adequately make recommendations for these problems, we feel the inspection team needs to watch the cleaning process from start to finish.

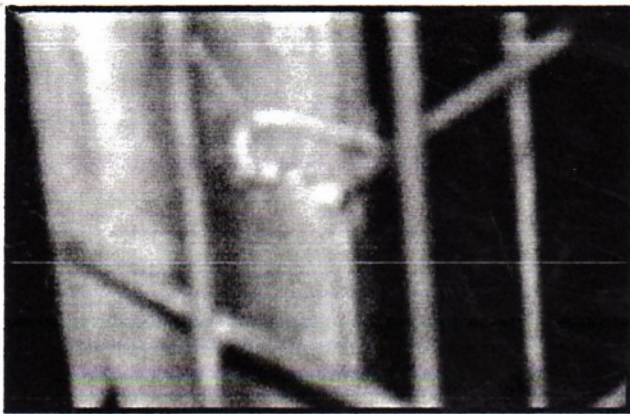
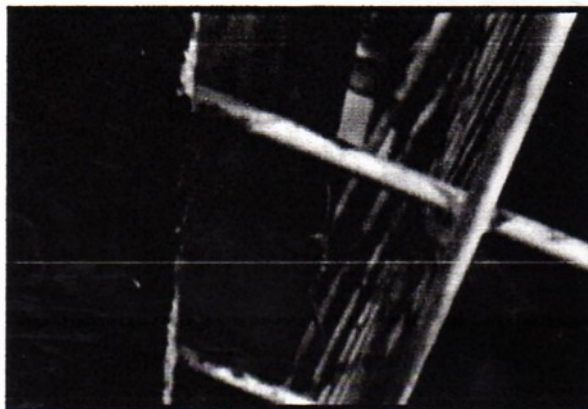
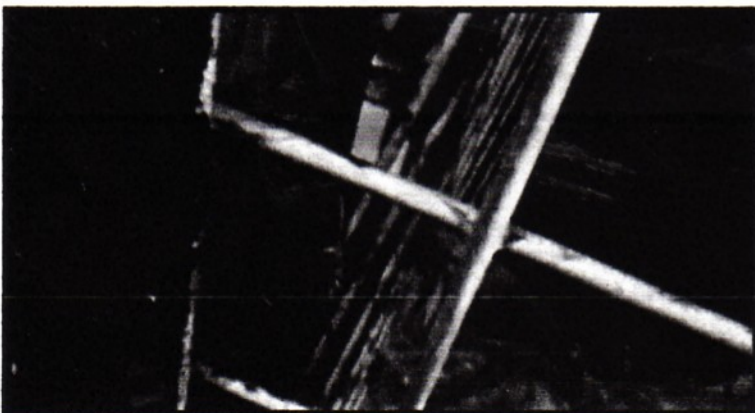
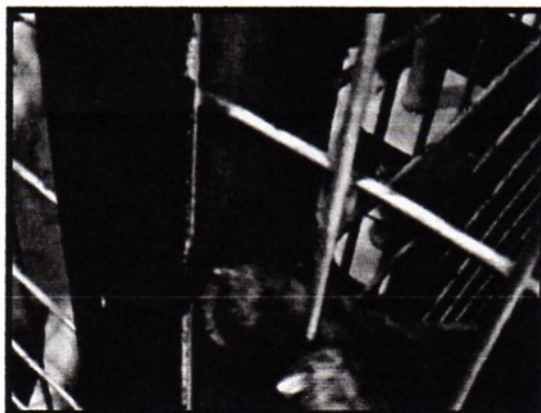
- Sharp wire protrudes into both the outdoor and indoor runs and could cause injury to the dogs (see photographs on the following page). The first photograph on the left shows wire in an outdoor run. The last three photographs are of wire sticking into an indoor run. One shows the wire and the other two show a bulldog's paw in close proximity to the sharp wire.

**Pursuant to Minnesota Statute 346.39, Subd. 10, dog and cat confinement and exercise area surfaces must "protect the animal from injury and be kept in good repair."**

**Pursuant to USDA Regulation 3.1 (c)(ii), housing facilities in general must be "free of jagged edges or sharp points that might injure the animals."**

**Pursuant to USDA Regulation 3.6 (2)(i), primary enclosures must "have no sharp points or edges that could injure the dogs and cats."**

**Recommendation: Replace wire with plastic zip ties.**

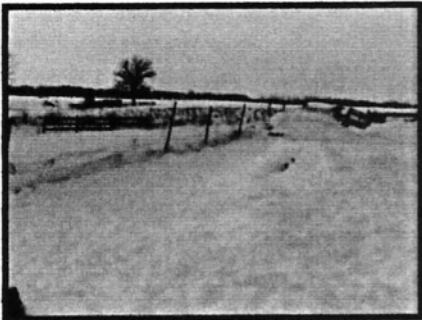
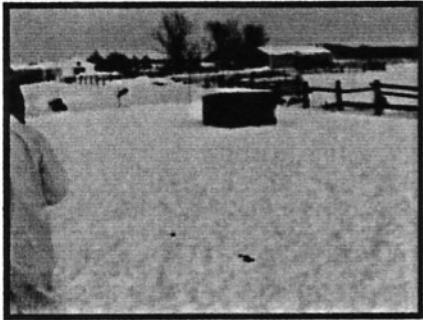
- Outdoor fenced in exercise areas were added to each side of the Bread & Butter Barn (see photographs on the following page). Each exercise area is 120 feet long by 60-80 feet wide. While the inspection team was conducting the inspection, the same two Huskies were out in the exercise area; no other dogs were let out for exercise. Allan Bauck indicated to team members that the Huskies and Beagles get out the most and since the Bulldogs and the German Shepherds do not do as well in groups, they do not get out very often. The inspection team is concerned that with the current staff to dog ratio and only two exercise areas, all dogs are not able to get regular, adequate exercise.

**Recommendation:** Those dogs not able to exercise with other dogs should have a separate exercise area where staff can engage each dog with games such as fetch. Additional exercise areas may need to be constructed in order to facilitate an exercise program conducive to all the dogs at the facility. More staff may need to be hired to carry out the exercise program.

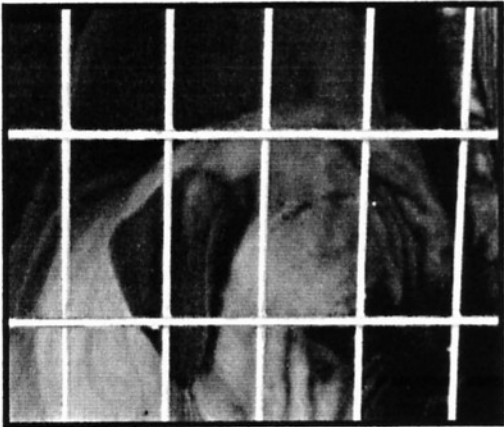
- Food and water is in buckets attached to the cage door and raised off the ground. The height of the buckets was such that the smaller dogs in the building, i.e. Pugs, Bulldogs and Beagles, could have difficulty accessing the food and water. This is particularly true if the buckets are not full (see photographs on the following page).

**Pursuant to Minnesota Statute 346.39, Subd. 12, "food and water receptacles must be accessible to each animal and located so as to minimize contamination by excreta. Feeding and water receptacles must be kept clean."**

**Recommendation:** Lower the food and water containers for the smaller breed dogs in the Bread & Butter Barn.

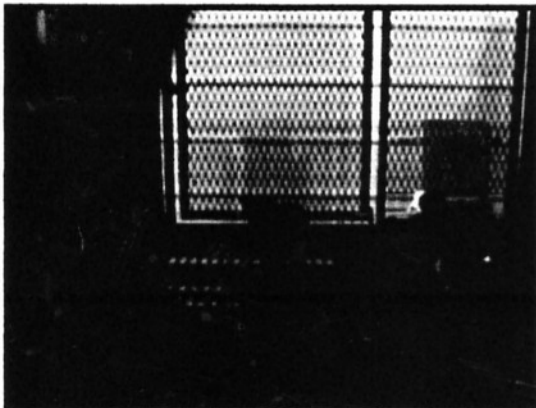
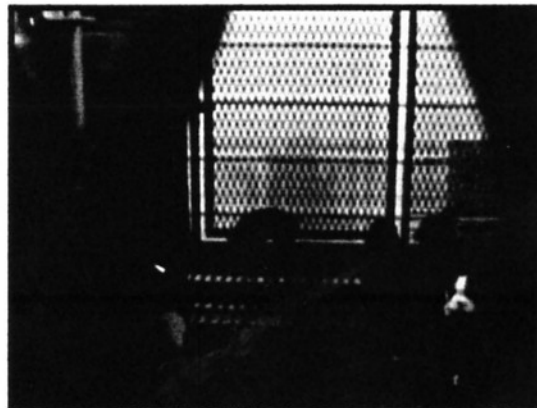
- There were gaps in the cages next to the cage doors. These gaps are large enough for puppies to get their paws or legs caught (see photographs below); this problem was also noted at the December 1st inspection and included in the December 1<sup>st</sup> inspection report.

**Pursuant to Minnesota Statute 346.39, Subd. 10, dog and cat confinement and exercise area surfaces must "protect the animal from injury and be kept in good repair."**

**Recommendation:**

**Replace the cages in the puppy whelping barn with appropriate cages for puppies; cages with no gaps.**

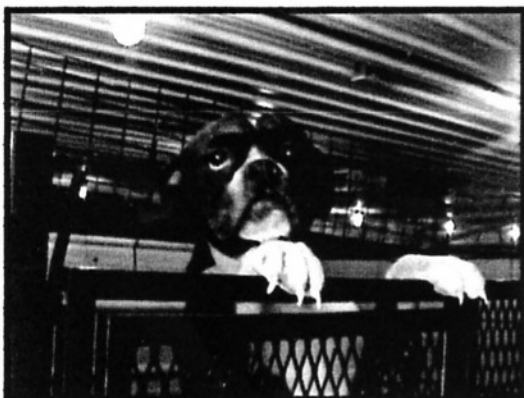
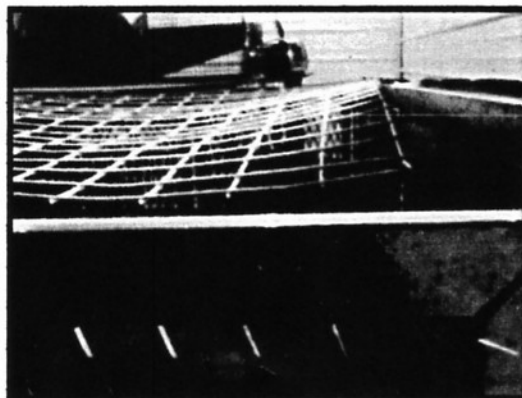
- Although partial cage tops were added to some of the cages, these cage tops could potentially cause injury to the dogs if the dog were to get stuck in the opening or from the sharp points protruding on the ends. Also, there were many cages without tops that were housing medium to large dogs (see photographs below; the first photograph shows a dog standing up in its cage and the second photograph shows a partial cage top).

**Pursuant to Minnesota Statute 346.39, Subd. 10, dog and cat confinement and exercise area surfaces must "protect the animal from injury and be kept in good repair."**

**Pursuant to USDA Regulation 3.6 (2)(i), primary enclosures must "have no sharp points or edges that could injure the dogs and cats."**

**Recommendation: Replace the cages with cages that have taller sides or add complete tops.**

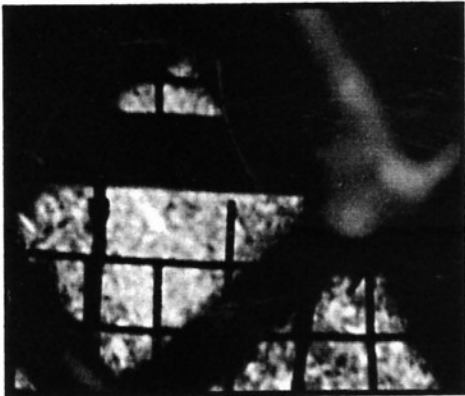
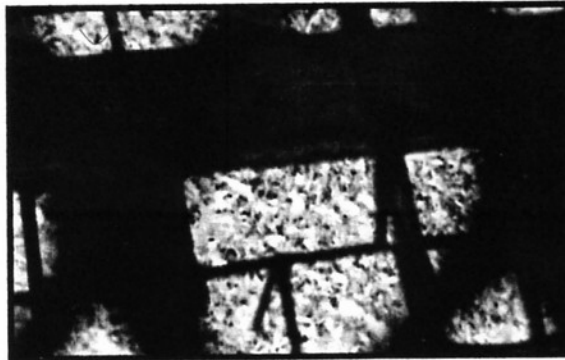
- Numerous cages had broken wire flooring, leaving exposed sharp points in the cage floor.

**Pursuant to Minnesota Statute 346.39, Subd. 10, dog and cat confinement and exercise area surfaces must "protect the animal from injury and be kept in good repair."**

**Pursuant to USDA Regulation 3.6 (2)(i), primary enclosures must "have no sharp points or edges that could injure the dogs and cats."**

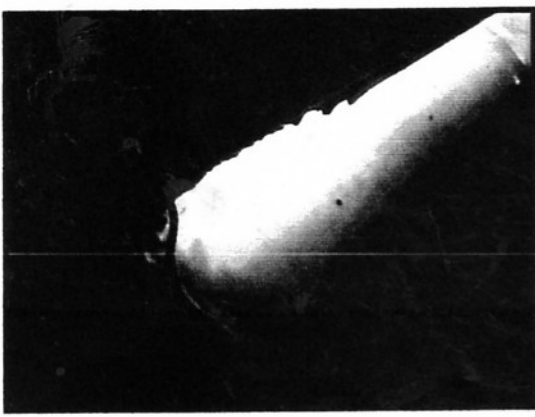
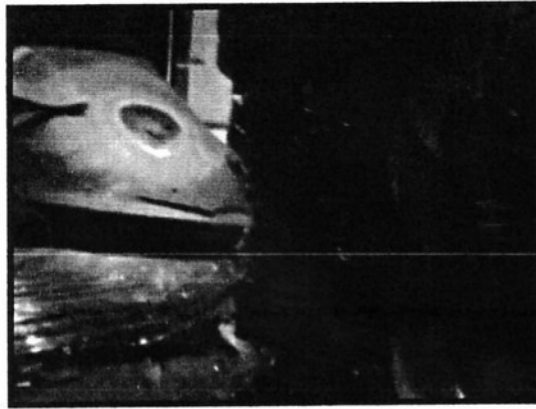
- The largest food storage area is an enclosed building, with an overhead garage door that was not completely closed and was open enough to allow entry of rodents and other small animals. The weather strip on the bottom of the door appears to be chewed by rodents (see photograph on following page). The food bags were stacked one bag on top of another and the bags were not in secure containers. There was one bag of dog food with holes (see photograph on following page).

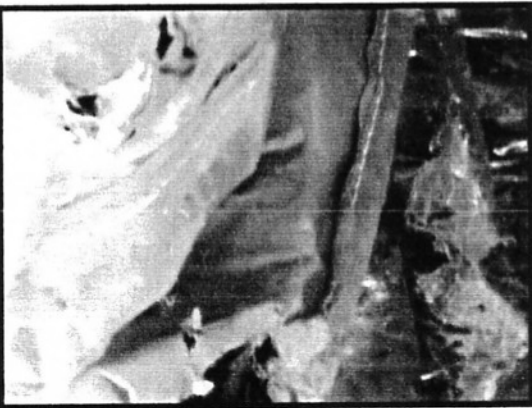
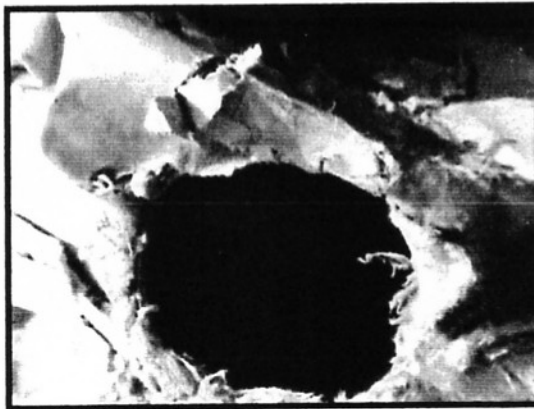
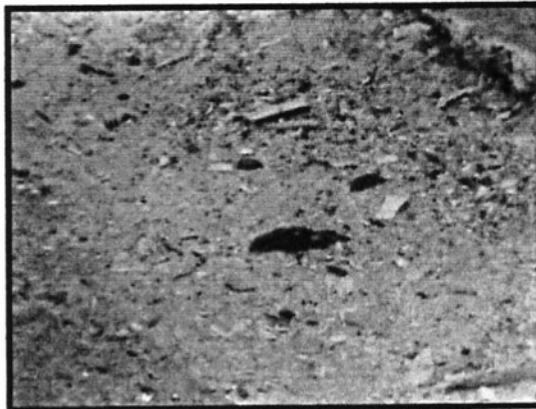
- Another food storage building is located next to the Whelping Barn. This building was open to the air, elements and rodents, with no protection whatsoever. The food bags were stacked one bag on top of another and the bags were not in secure containers. Numerous food bags had been chewed open in the food storage next to the Whelping Barn and there were rodent droppings in close proximity to the food bags (see three photographs below).

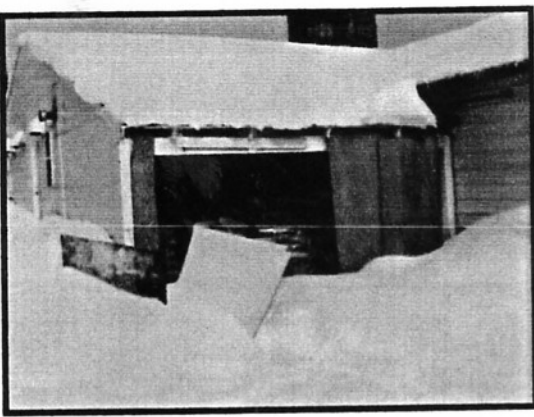
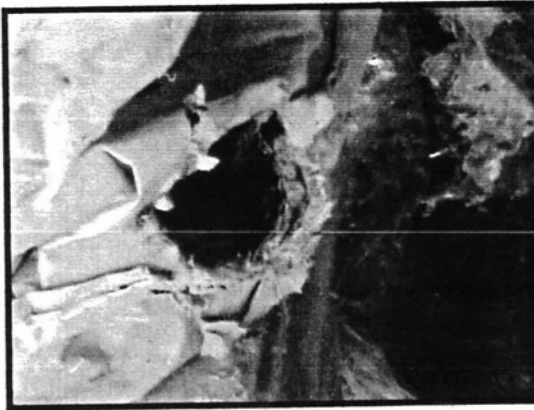
- There was food storage next to the Baucks' house. These bags were also stacked one on top of another and were not in secure containers. Again there were bags of food that had been chewed open (see photographs on the following page).

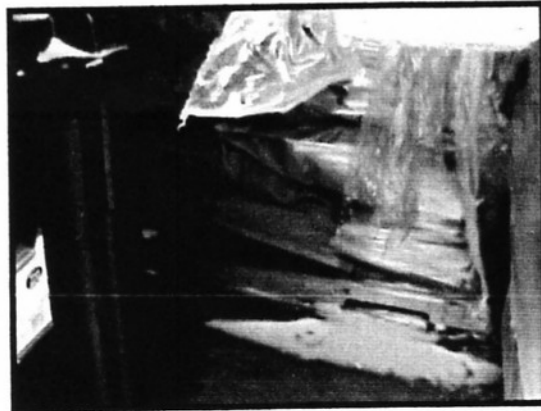
- The dog food stored in the shed was also not in secure containers, but stacked one bag on top of the other (see photographs below).

**Pursuant to Minnesota Statute 346.39, Subd. 1, "dogs and cats must be provided with food of sufficient quantity and quality..."**

**Pursuant to USDA Regulation 3.9, "the food must be uncontaminated, wholesome, palatable, and of sufficient quantity and nutritive value to maintain the normal condition and weight of the animal" and "measures must be taken to ensure there is no molding, deterioration, and caking of feed."**

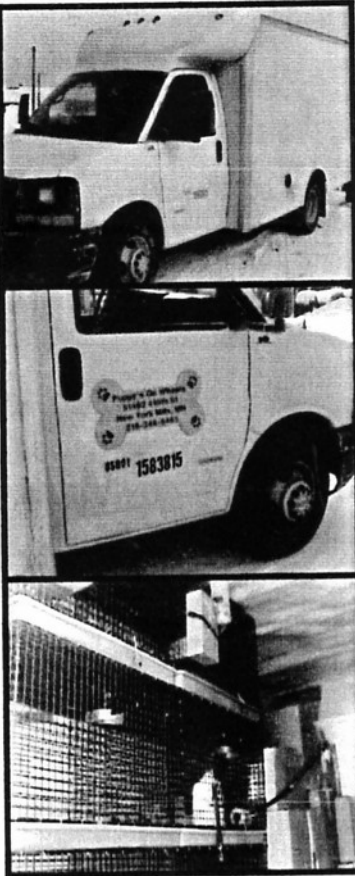
The van pictured to the left is the vehicle used by Puppies on Wheels to transport their puppies to be sold. The van was not available for inspection on December 1, 2009. The van had wire cages on both sides of the cargo area, stacked three high. Per Kathy Bauck, when filled to capacity, 40-50 puppies inhabit the cages in the cargo area. Concerns/ violations noted on inspection of the transport van are as follows:

- The van had been used the day before the inspection to transport puppies and was extremely filthy and appeared to not have been cleaned for some time.
- The van appears to have inadequate ventilation for animal transport. There are no windows in the cargo area where the cages are and the one vent observed appeared to be for the driver's cab only. St. Paul Animal Control has two pop out windows in the cargo area of their transport van.

**Recommendation:** Transport van be tested for adequate ventilation; the inspection team does not have the equipment to do this.
